# WATER STORAGE TANK 2016 ANNUAL INSPECTION REPORT IN COMPLIANCE WITH MASS DEP CHAPTER 8 REQUIREMENTS

### WELLFLEET MUNICIPAL WATER TANK

Inspection Dates: *Nov. 21 & Dec. 14, 2016*

Inspector: *Leo R. Yuskus*

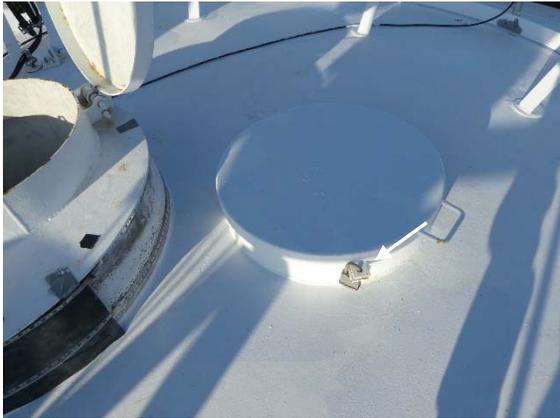
The roof finial (vent) is in very good condition as is the screen and vacuum pallet. (see photos 3) The coating on the two roof hatches is in fair condition with spot delamination on the exterior surfaces and also on the interior surfaces. (see photos 1 and 2)

Locks Opened and Relocked Yes  No  Observed *One hatch opened to gain access to the interior of the roof (see photos 1 and 2)*

Covers Overlap Collar Yes  No  Explain *Covers overlap to prevent storm water entry (see photos 1 and 2)*

Photo 1: Roof Hatch to Bowl Opened, Closed and Relocked

**RECOMMENDATIONS** – We recommend that the condition of the coating on the center roof accessories be monitored during each annual inspection.

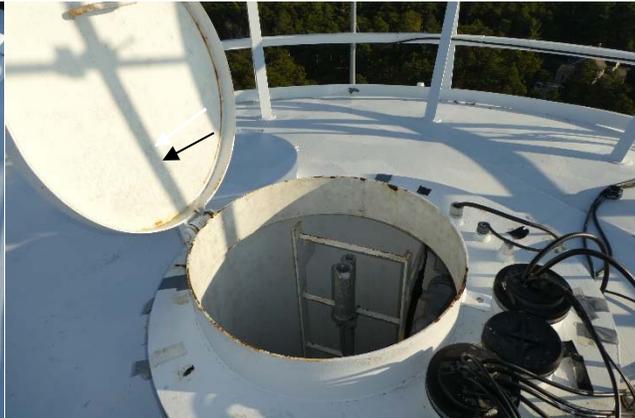
Roof Access Hatch Yes  No  Explain *Roof access hatch closed and secured from interior (see photo 2)*

Photo 2: Roof Access Hatch Opened and Reclosed upon Leaving

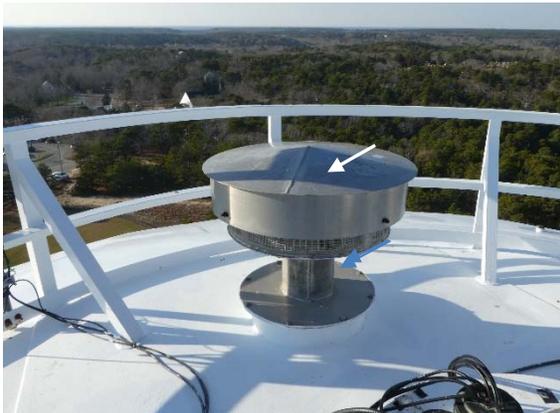
Finial Inspected Yes  No  Condition of Finial *Finial in good condition (See photo 3)*

Finial prevents the entry of Storm Driven Rain Yes  No  Explain *Weather skirt around screen (see photo 3)*

Photo 3: Finial (vent) on Roof with Weather Skirt

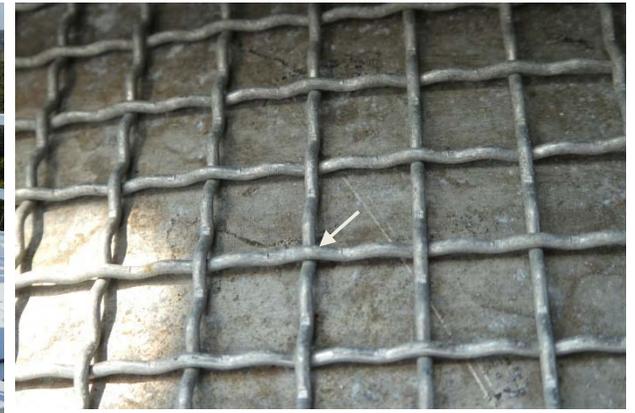
Screen Inspected Yes  No  Condition of Screen *Good condition and vacuum pallet in place (see photos 4 and 5)*

Screen prevents the entry of Birds and Animals Yes  No  Explain *Screen openings prevent entry of birds & animals (see photo 4)*

Screen prevents the entry of Insects and Dust Yes  No  Explain *Screen satisfactory (see photo 4)*

Photo 4: Finial Screen in Good Condition

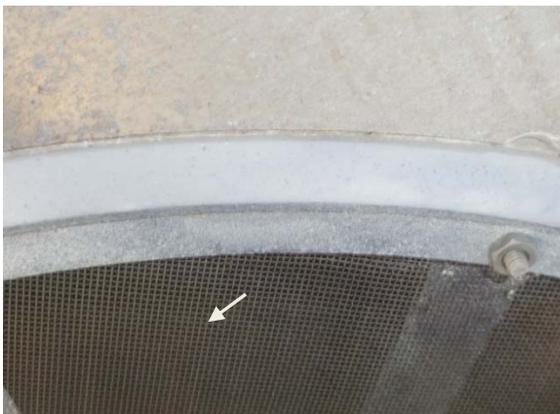
Photo 5: Screened Vacuum Pallet in Good Condition, Positioned Correctly

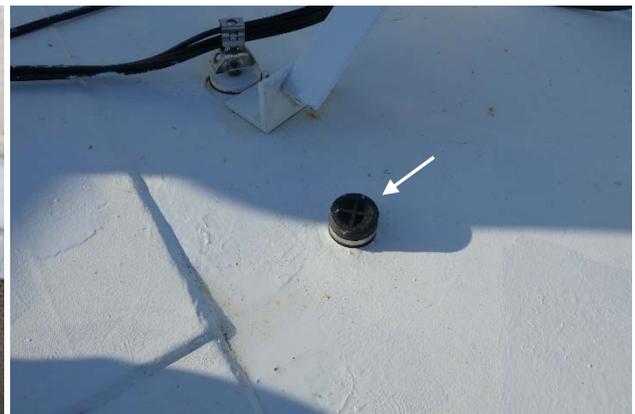
*Six rigging couplings in roof sealed with rubber caps (see photo 6)*

Photo 6: Rigging Couplings in Roof in Good Condition with Rubber Caps in Place

*The roof includes rigging opening plugs made of rubber. Over-time rubber may dry out due to UV exposure and could allow contaminants to enter the tank. We recommend monitoring the condition of the rubber plugs and replace when plugs become damaged due to UV exposure.*

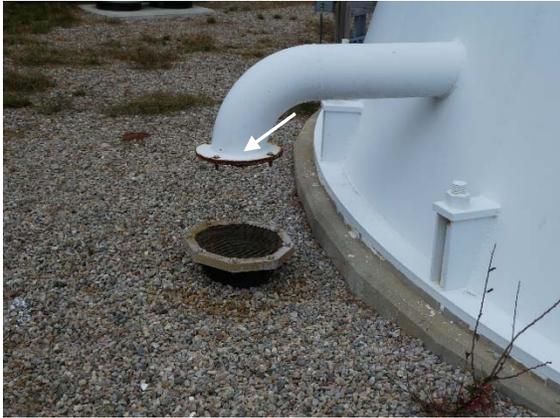
The coating on the overflow piping is in good condition, but the outlet fabrication has active corrosion and associated metal loss. (see photos 7 and 8) The screen appears to be galvanized and shows signs of deterioration, and there appears to be debris inside the overflow screen. (see photo 8)

*Outlet and screen in poor condition due to corrosion and start of deterioration of screen (see photos 7 and 8)*

Photo 7: Overflow Piping Discharge Fabrication in Poor Condition

*We recommend that the outlet screen fabrication be disassembled and any debris within the screen area be removed. It is recommended that consideration be given to replacement of the overflow outlet fabrication in the near future. We recommend that the existing outlet flange be removed and a new standard steel flat face open flange be welded in its place. To this flange a full face gasket can be installed, a stainless steel 4 mesh screen put in place, another gasket installed with a steel flat face open flange, all connected with stainless steel bolts. The flanges should be surface prepared and coated with similar coating products as used on the tank prior to assembly.*

*Consideration should be given to replacing the overflow discharge flanges and screen.*

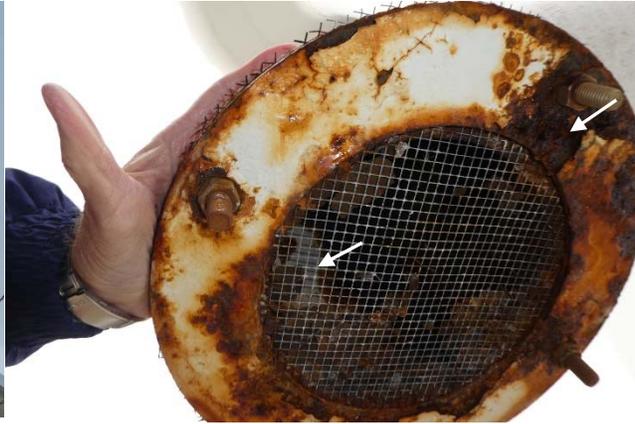
Photo 8: Overflow Discharge in Poor Condition with Active Corrosion & Debris Inside

*MassDEP guidelines call for an additional swing away device to be utilized with a 24 mesh screen on the overflow. Due to the type of receiver to collect this overflow, we are not sure how this additional screen would perform.*

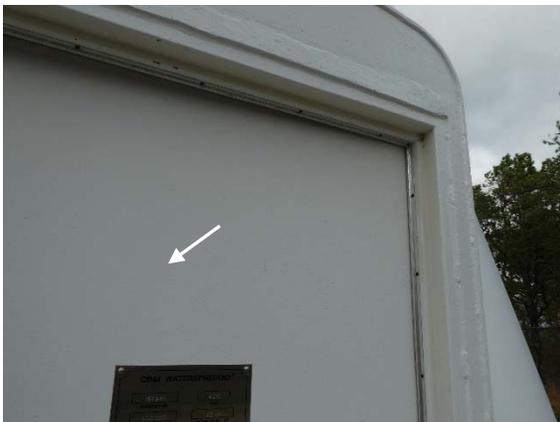
*Door is locked (see photo 9)*

Photo 9: Steel Door in Base Pedestal is Locked

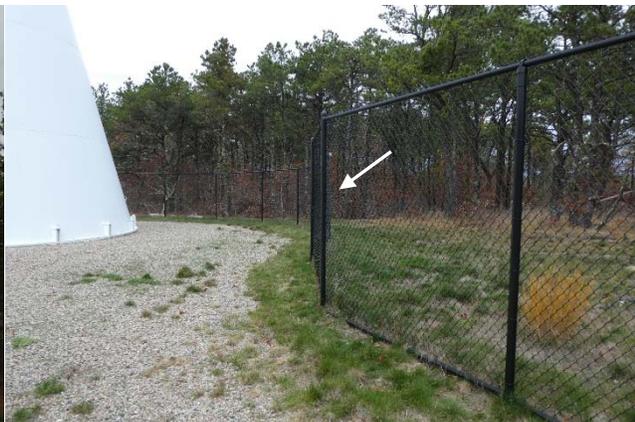
*8' high chain link fence in good condition (see photo 10)*

Photo 10: 8' High Chain Link Fence in Good Condition

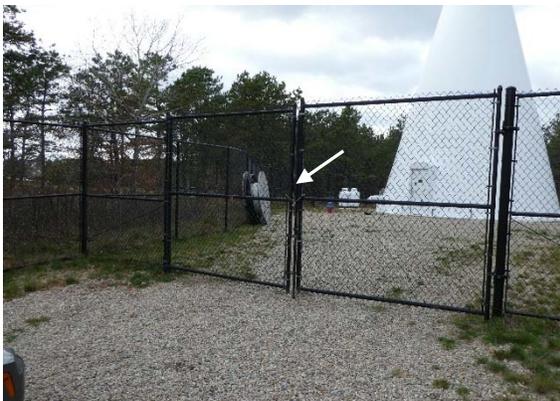
*Gates locked (see photo 11)*

Photo 11: Chain Link Fence Gate in Good Condition and Locked

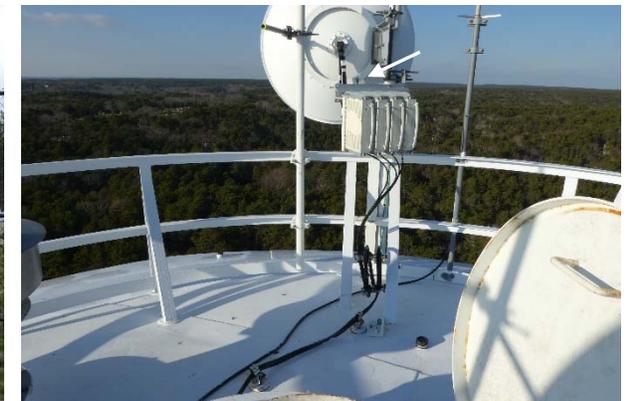
*Fire Department antenna and Open Cape dish and cathodic protection on handrail (see photos 12 and 13)*

Photo 12: Open Cape Antenna (2) Mounted to Roof Handrail

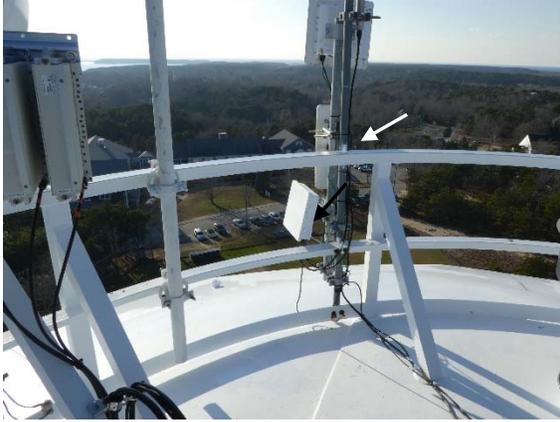
Photo 13: Communications Equipment Mounted to Roof Handrail

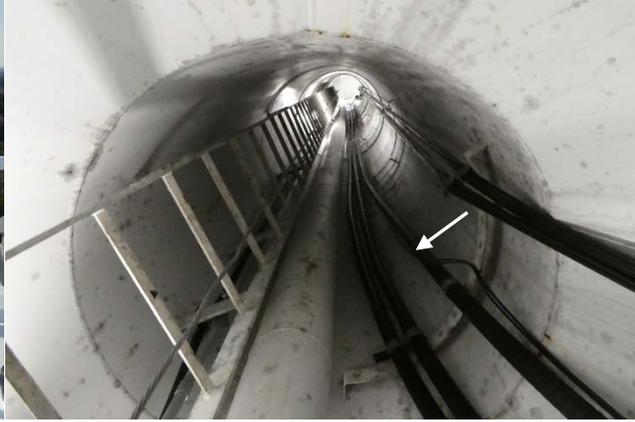
*Communications cables mounted in access tube (see photo 14)*

Photo 14: Communications Cables Mounted in Access Tube

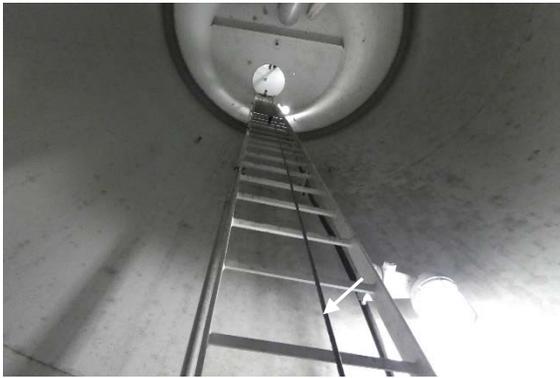
*Steel cable safety climb system on both ladders, cable grab and harness is available for use (see photo 15)*

Photo 15: Safety Climb Cable on all Interior Ladders in Tank

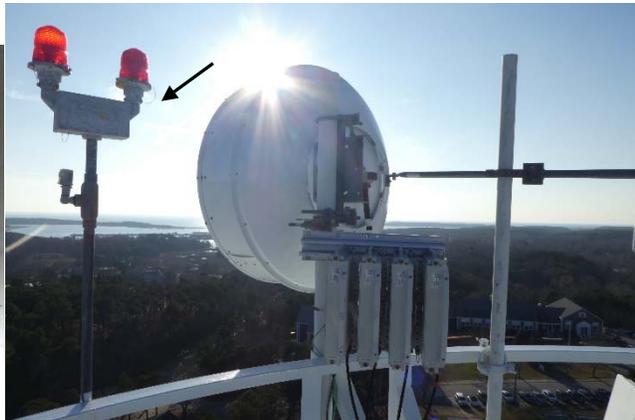
FAA Lighting System on tank Yes  No  List *FAA two light system mounted to roof handrail system, one light appeared to be out (see photo 16)*

Photo 16: FAA Lighting System, One Light Appears to be Out

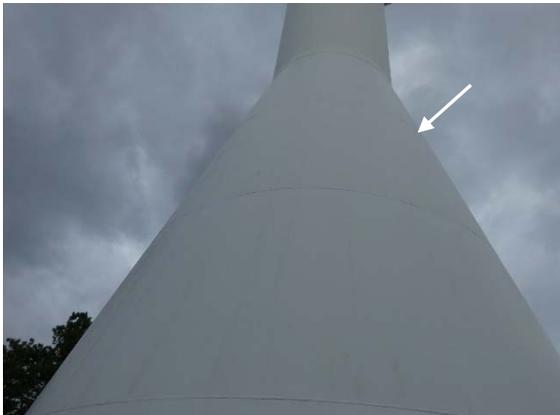
**PEDESTAL BASE** – The coatings on the exterior surfaces of the pedestal base appear to be in very good condition. (see photo 17) There is the start of a light buildup of grime on these surfaces.

Photo 17: Coating on Pedestal in Very Good Condition, some Grime Deposition

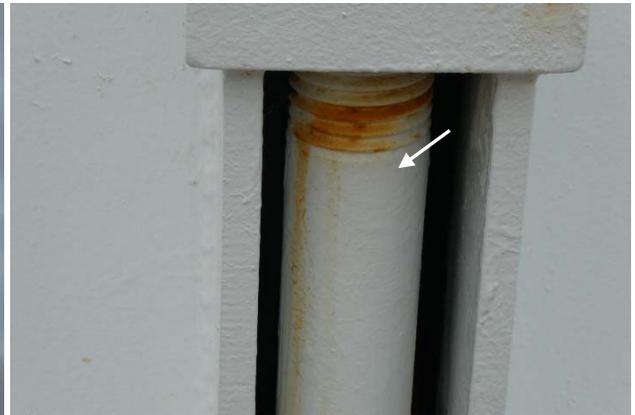
**PEDESTAL BASE ACCESSORIES** – The coating on the access door and frame is in good condition. The coating on the anchor bolt assemblies is in good condition, with the very start of corrosion staining and spot corrosion break through at the nuts and top chair plate. (see photo 18 and 19)

Photo 18: Corrosion Staining from the Upper Portion of the Anchor Bolt

***RECOMMENDATIONS*** – *We recommend that the condition of the coating on the anchor bolt assemblies be monitored during each annual inspection. There is minimal clearance between the anchor chair assembly and the anchor bolts, thus you do not want any corrosion within that assembly that could result in metal loss as it will be quite difficult to repair.*

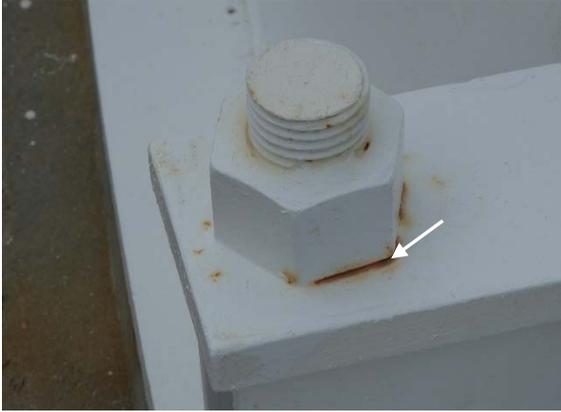
Photo 19: Start of Spot Corrosion on the Anchor Bolt Nut and Top of Chair

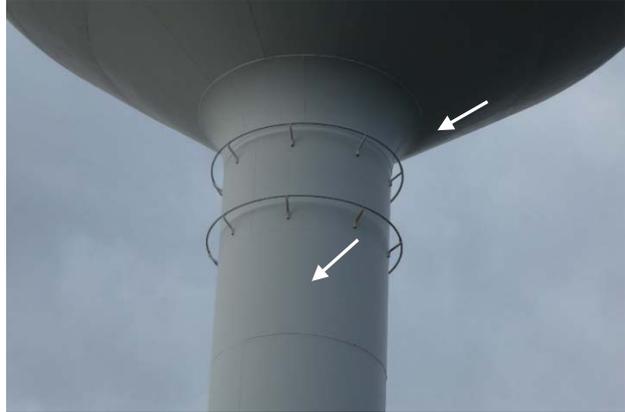
PEDESTAL COLUMN – The coating on the pedestal column appeared to be in very good condition. (see photo 20)

LOWER PORTION OF BOWL – The coating system in the lower portion of the bowl appears to be in very good condition. (see photo 20)

Photo 20: Coating on the Column and Lower Bowl Appears to be in Very Good Condition

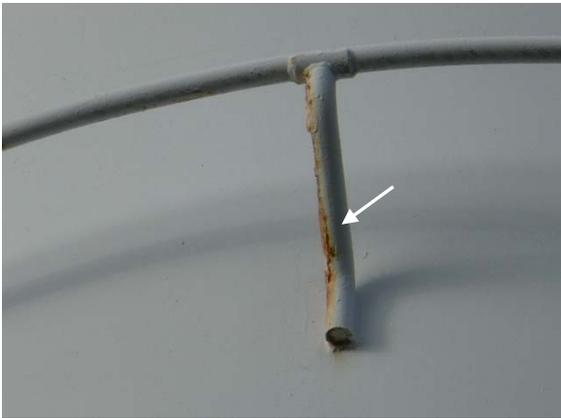
PEDESTAL COLUMN ACCESSORIES – The pedestal column contains two painter's rails, the coating system on the painter's rails is in poor condition with coating deterioration, corrosion bleed through and active corrosion in some areas. (see photos 21 and 22) The access manway to reach the painter's rail also has coating deterioration and the start of corrosion on the hinges. (see photo 23)

Photo 21: Coating on Painter's Rails in Poor Condition with Active Corrosion

**RECOMMENDATIONS** – We recommend that the condition of the coating on the painter's rail and the hinges for the manway be monitored during each annual inspection. These fabrications are not structural components of the tank but do assist in accessing portions of the tank for maintenance purposes.

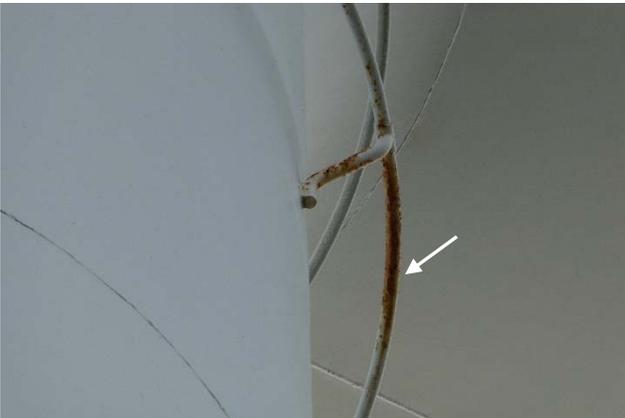
Photo 22: Coating on Painter's Rails in Poor Condition with Active Corrosion Activity

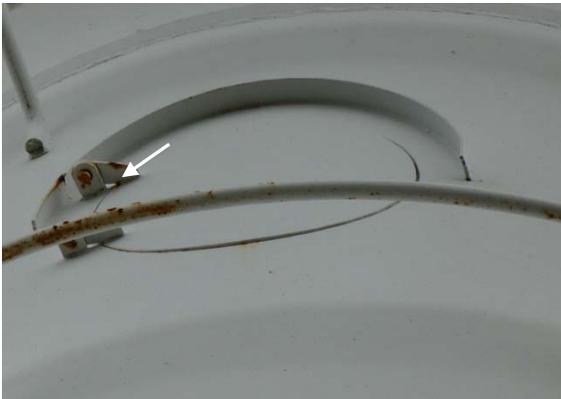
Photo 23: Start of Corrosion on Painter's Rail Manway Hinge Assemblies

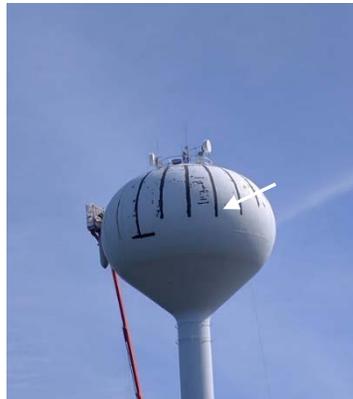
UPPER PORTION OF BOWL – The area of the upper portion of the bowl where coating delamination occurred was mainly on the radial welds and on some of the circumferential welds. (see photo 24) The coating system on the upper portion of the bowl now appears to be in good condition. (see photos 25 and 26) The color of the repair coatings appear to fairly well match that existing, but the gloss is different as the existing coating has faded. (see photo 27)

Photo 24: Coating Repairs Underway on Upper Bowl

**RECOMMENDATIONS** – We recommend that the condition of the coating on the bowl area be monitored during each annual inspection, especially the areas where the coating was repaired.

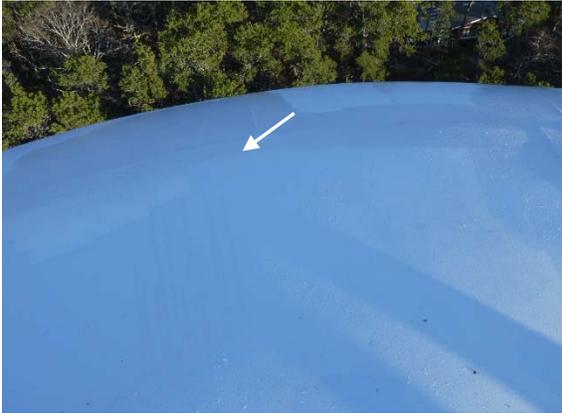
The coating repairs were completed on October of this year, and the repaired coatings appear to be in very good condition. Observations were made on the repair coatings applied and there did not appear to be any lifting at the joint transition, the repair coating appeared to satisfactorily over-lapped over existing and well adhered, and thickness measurements appear to indicate that the repair coatings were adequate in thickness, at least on the areas that could be accessed.

Photo 25: Coating on Upper Bowl appears to be in Good Condition after Repairs

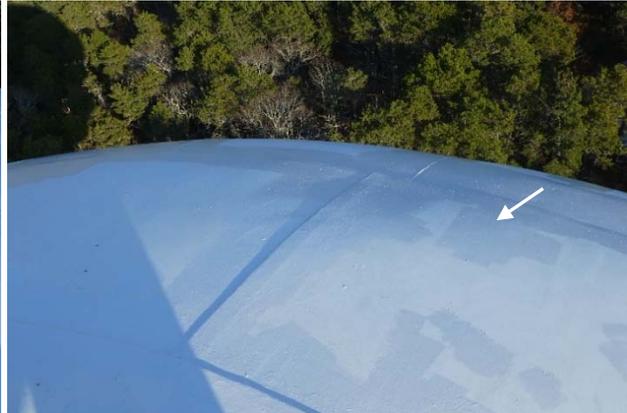
Photo 26: Coating on Upper Bowl appears to be in Good Condition after Repairs

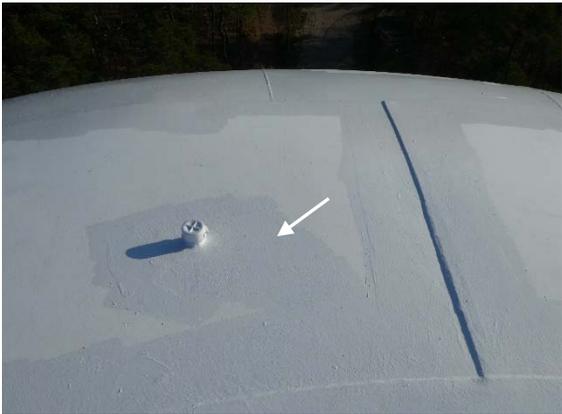
Photo 27: Repair Coating Difference in Gloss as Existing Coating has Faded

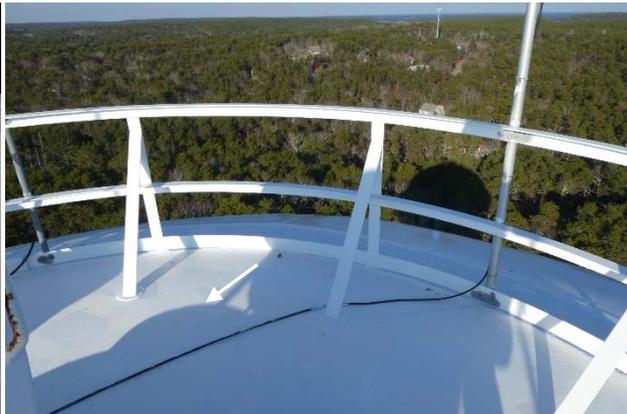
CENTER ROOF PLATE AREA – The coating on the center of the roof within the circumferential handrail system appears to be in very good condition. (see photo 28) These were only a very few areas that indicated repairs had been performed. There was some corrosion staining at the magnetic mounts for the communication cables. (see photo 29)

Photo 28: Coating on Center of Roof in Very Good Condition

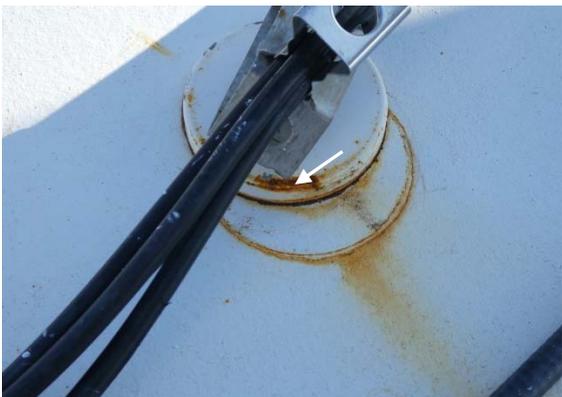
Photo 29: Corrosion Staining in Areas Where Magnetic Mountings Used

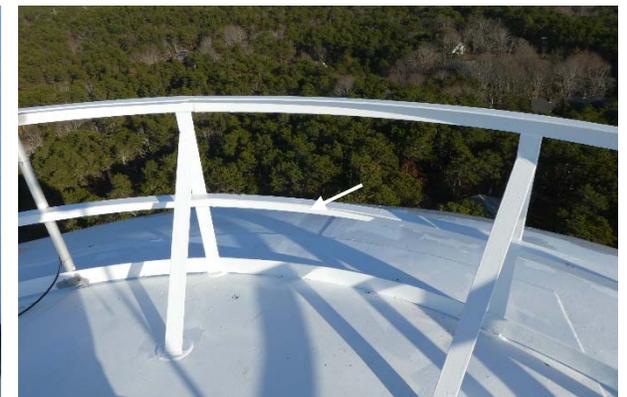
**CENTER ROOF ACCESSORIES** – The coating condition on the roof accessories appeared to be good in most cases. The handrail system coating appeared to be in good condition with only a very small number of spots with the start of corrosion activity. (see photo 30) There was corrosion bleed through on a small section of the hand rail kick plate. (see photo 31)

Photo 30: Coating on the Roof Handrail Generally in Good Condition.

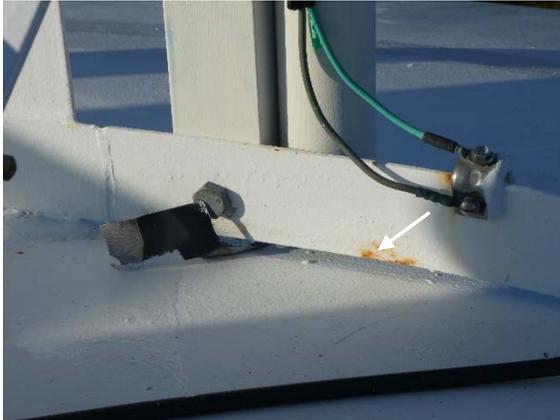
Photo 31: Very Start of Corrosion Break Through on Roof Handrail Kick Plate

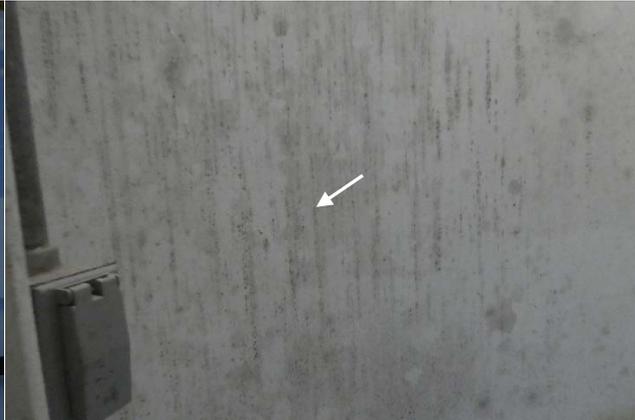
**INTERIOR ACCESS TUBE AND COLUMN**– The coating on the interior of the column and access tube is in good condition, with spot mildew activity in many areas. (see photos 32 and 33)

Photo 32: Interior Coating on Column in Good Condition, Spot Mildew Activity Present

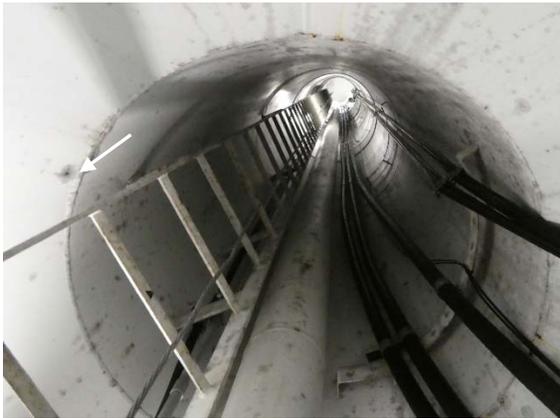
Photo 33: Interior Coating on Access Tube in Good Condition, some Spot Mildew

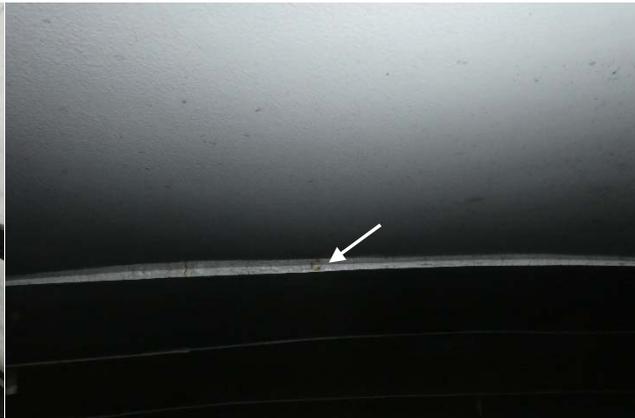
**TOP BOWL INTERIOR SURFACES** – The roof hatch was opened and the underside of the roof and a portion of the upper bowl was observed. The coating condition on those areas observed was good with the very start of minor spot corrosion. (see photos 34 and 35)

Photo 34: Coating on Interior Roof in Good Condition, Start of Spot Corrosion

**RECOMMENDATIONS** – We recommend that the condition of the coating on the interior roof and upper bowl be monitored during each annual inspection.

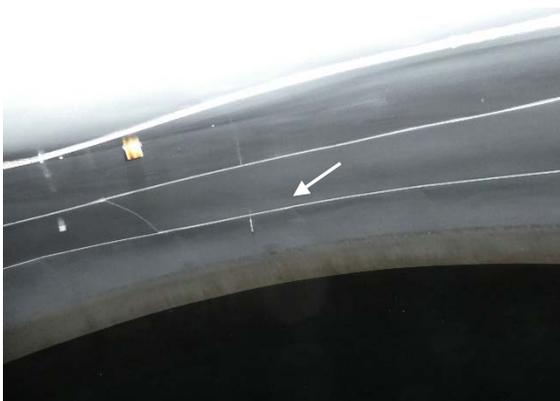
Photo 35: Coating on Interior Upper Bowl in Good Condition, Minor Corrosion
