***INSPECTION AND CLEANING (SEDIMENT REMOVAL) OF THE  
LAWRENCE ROAD 500,000-GALLON HYDROSPHERE WELDED  
STEEL SPHEROID WATER STORAGE TANK LOCATED  
IN WELLFLEET, MASSACHUSETTS***

***WHITEWATER INC. - WELLFLEET  
AUBURN, MASSACHUSETTS***

***JULY 23, 2015***

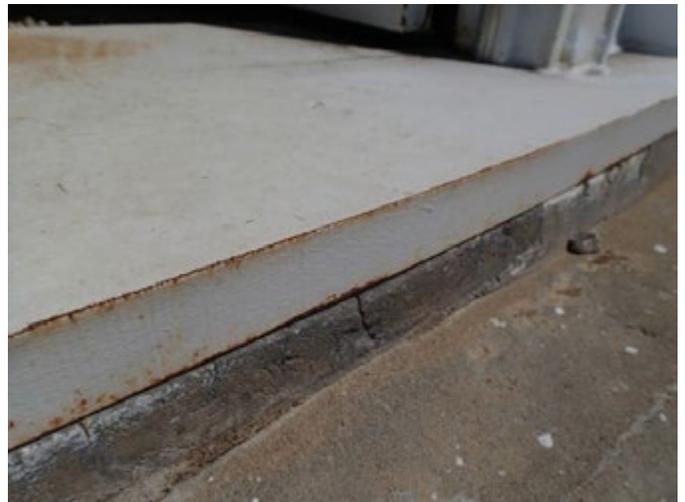
Mild coating fatigue and minimal steel exposure was observed throughout less than 5% of the corner edges on both the interior and exterior surfaces of this steel base plate. Although very mild surface corrosion was evident within these areas showing minimal steel exposure, no obvious fatigue or deterioration of these steel surfaces was evident.

24 *Steel Base Plate With Coating Fatigue, Exposed Steel And Mild Surface Corrosion*

It is our recommendation to spot grind and re-coat these areas showing coating fatigue and steel exposure in an effort to halt corrosion and prevent fatigue of this steel base plate.

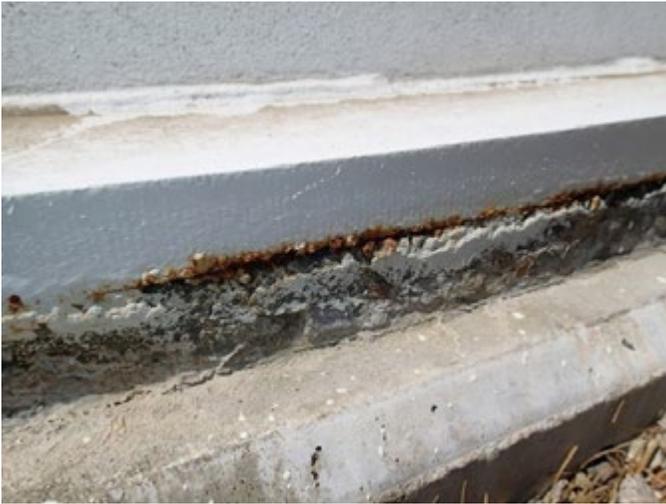
25 *Steel Base Plate With Coating Fatigue, Exposed Steel And Mild Surface Corrosion*

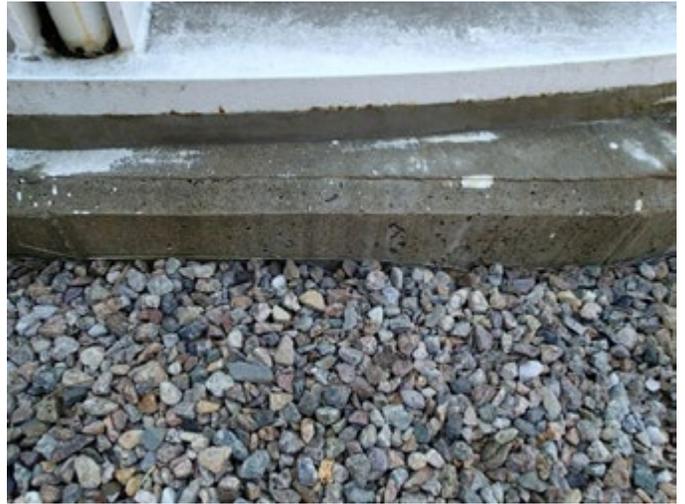
26 *Steel Base Plate With Coating Fatigue, Exposed Steel And Mild Surface Corrosion*

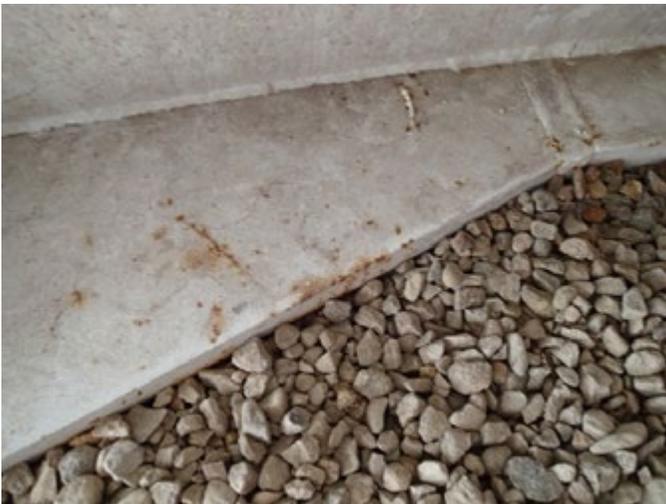
27 *Steel Base Plate With Coating Fatigue, Exposed Steel And Mild Surface Corrosion*

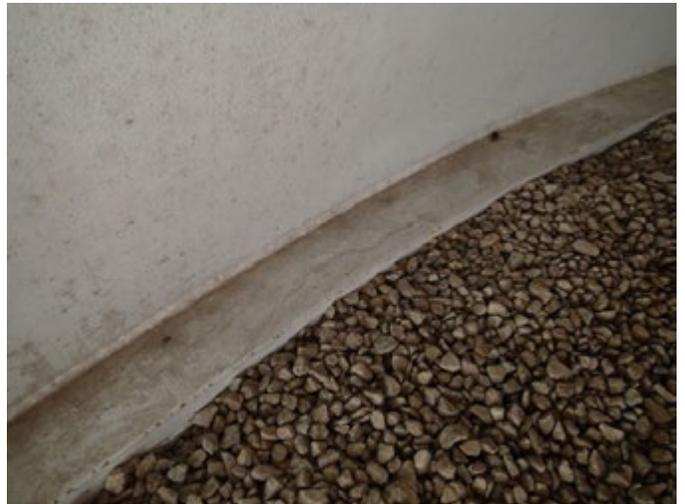
28 *Steel Base Plate With Coating Fatigue, Exposed Steel And Mild Surface Corrosion*

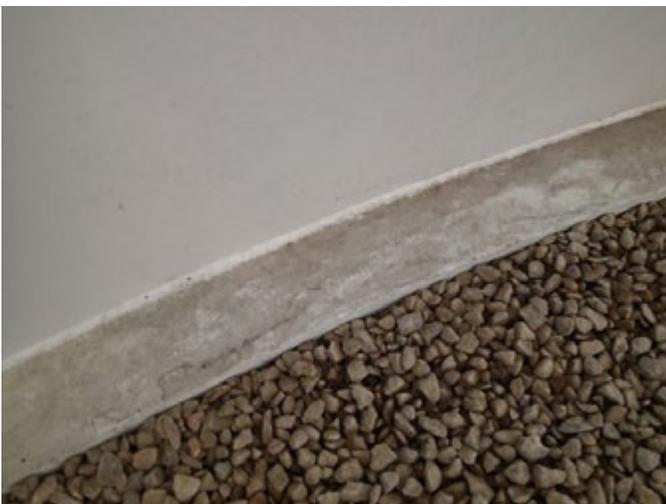
29 *Steel Base Plate With Coating Fatigue, Exposed Steel And Mild Surface Corrosion*

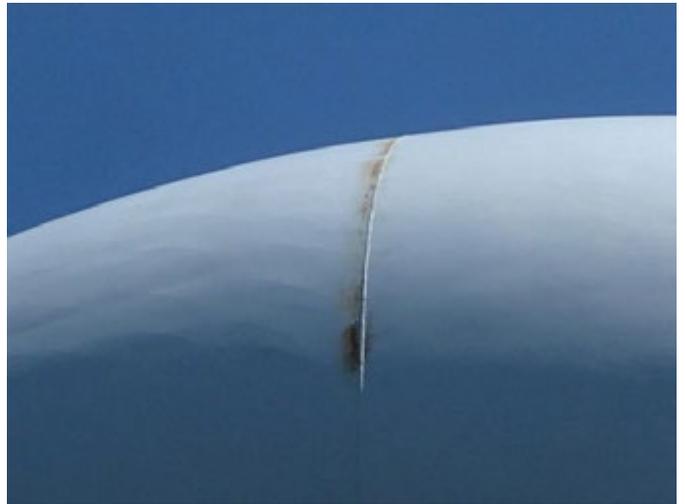
Cracking and lifting of the protective coating was observed throughout approximately 50% to 75% of the length of the vertical welds between the side wall panels, while cracking and lifting of the protective coating was observed throughout the side wall panels for a distance of 3” to 6” to each side of these vertical welds, resulting in exposure of the underlying steel.

Although surface corrosion exists within these areas showing coating fatigue and steel exposure, no obvious fatigue of the steel panels or the vertical welds between these panels was evident at this time.

34 *Exterior Bowl With Coating Cracking/Lifting, Exposed Underlying Steel And Surface Corrosion*

It is also our recommendation to spot grind and re-coat the areas showing coating fatigue and steel exposure throughout the vertical welds and wall panels in an effort to halt corrosion, prevent steel fatigue and provide good protection for the steel, while improving the overall aesthetics.

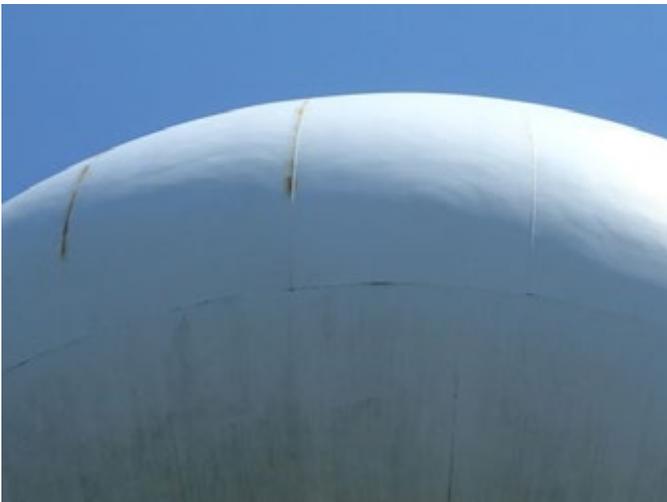
35 *Exterior Bowl With Coating Cracking/Lifting, Exposed Underlying Steel And Surface Corrosion*

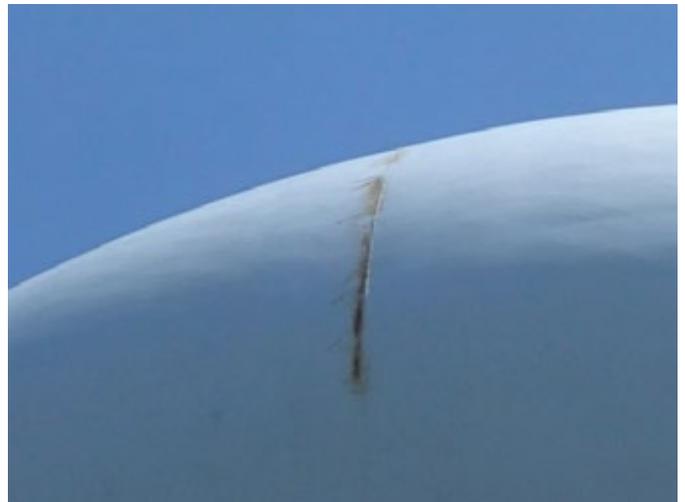
36 *Exterior Bowl With Coating Cracking/Lifting, Exposed Underlying Steel And Surface Corrosion*

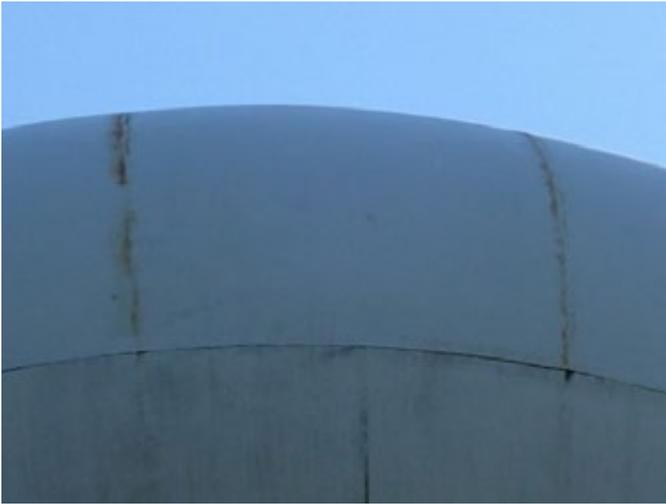
37 *Exterior Bowl With Coating Cracking/Lifting,  
Exposed Underlying Steel And Surface Corrosion*

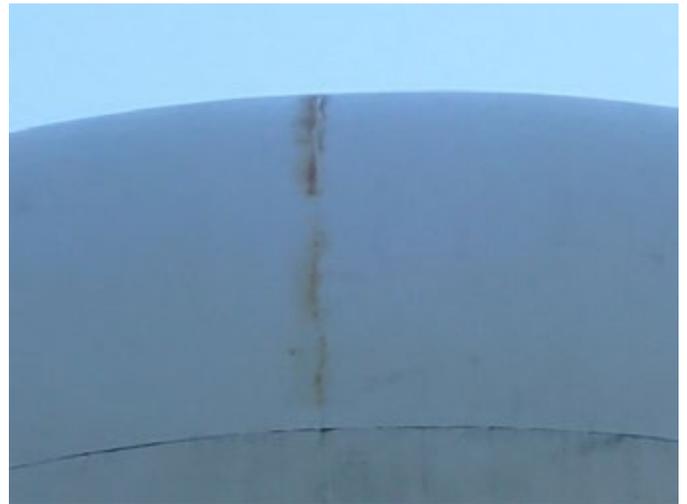
38 *Exterior Bowl With Coating Cracking/Lifting,  
Exposed Underlying Steel And Surface Corrosion*

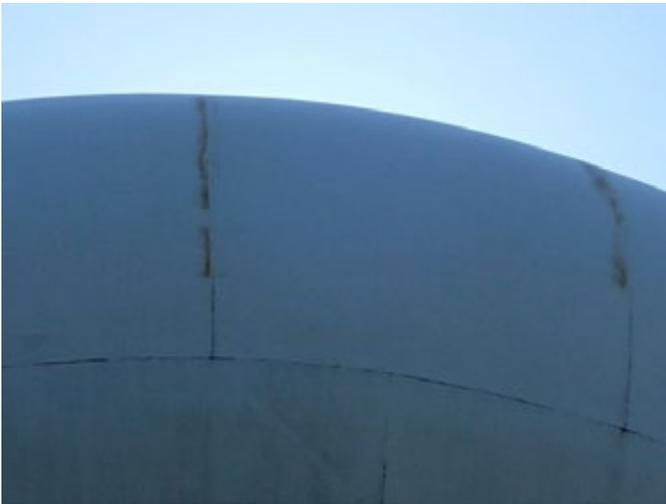
39 *Exterior Bowl With Coating Cracking/Lifting,  
Exposed Underlying Steel And Surface Corrosion*

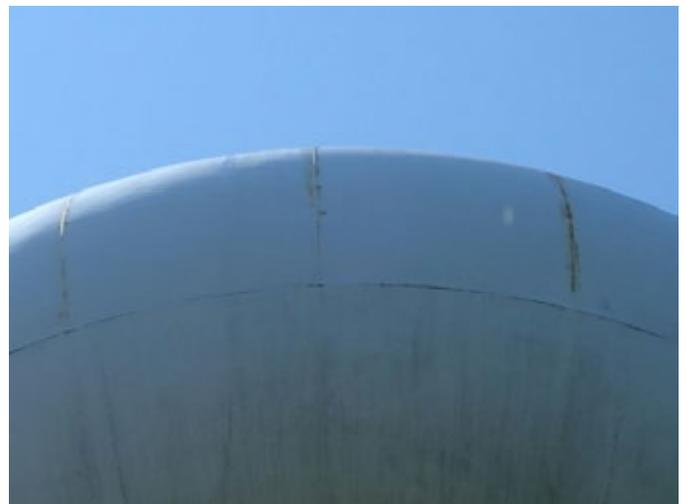
40 *Exterior Bowl With Coating Cracking/Lifting,  
Exposed Underlying Steel And Surface Corrosion*

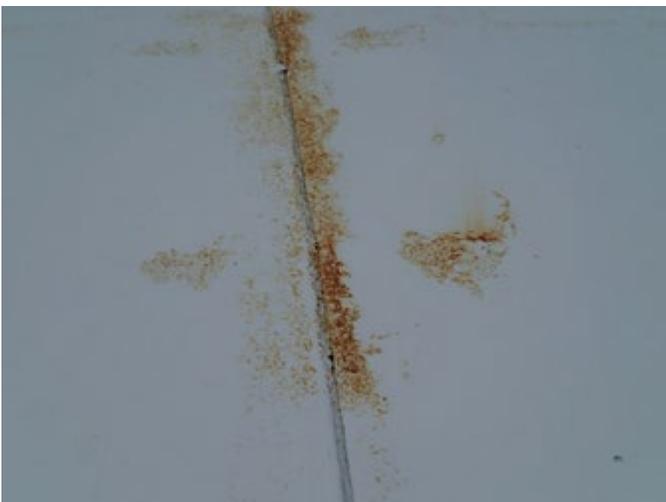
41 *Exterior Bowl With Coating Cracking/Lifting,  
Exposed Underlying Steel And Surface Corrosion*

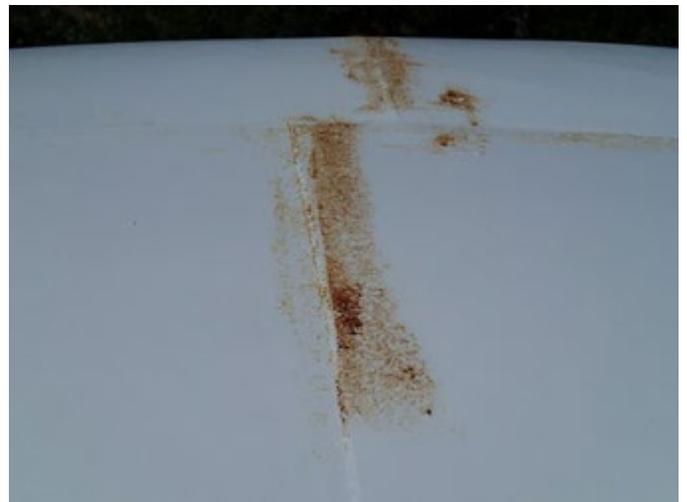
42 *Exterior Bowl With Coating Cracking/Lifting,  
Exposed Underlying Steel And Surface Corrosion*

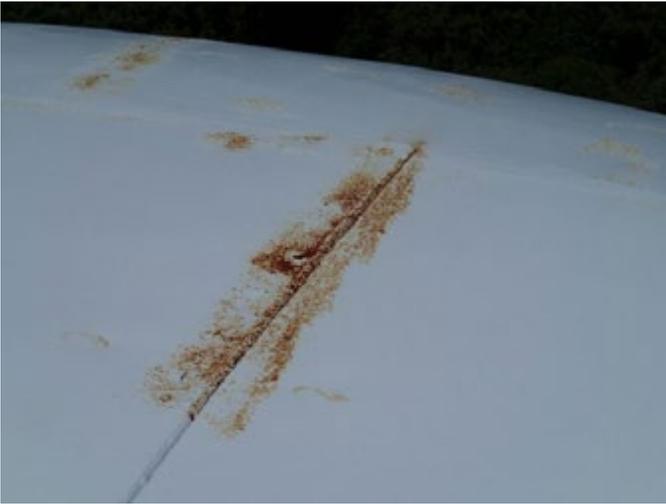
43 *Exterior Bowl With Coating Cracking/Lifting, Exposed Underlying Steel And Surface Corrosion*

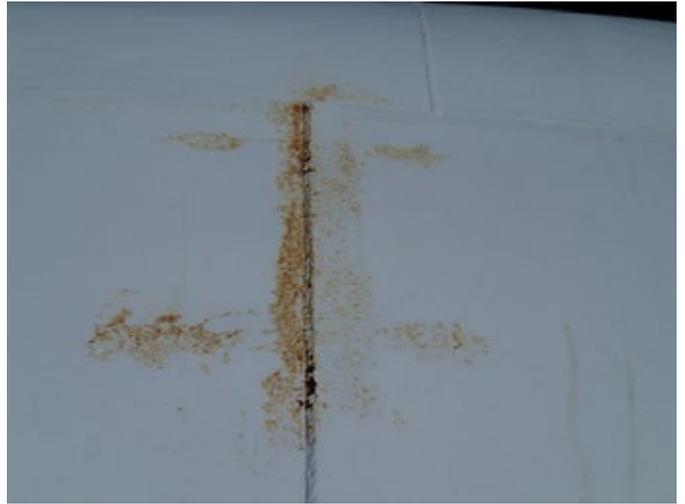
44 *Exterior Bowl With Coating Cracking/Lifting, Exposed Underlying Steel And Surface Corrosion*

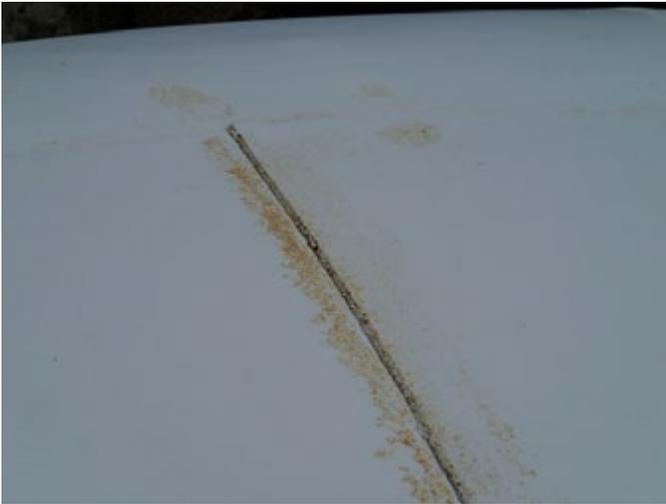
45 *Exterior Bowl With Coating Cracking/Lifting, Exposed Underlying Steel And Surface Corrosion*

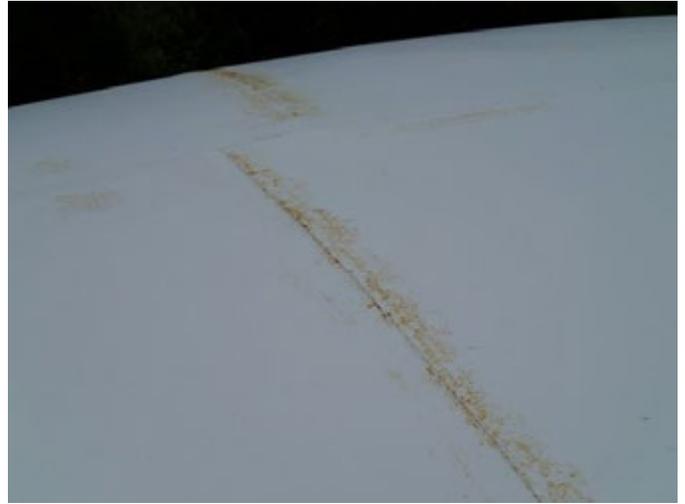
46 *Exterior Bowl With Coating Cracking/Lifting, Exposed Underlying Steel And Surface Corrosion*

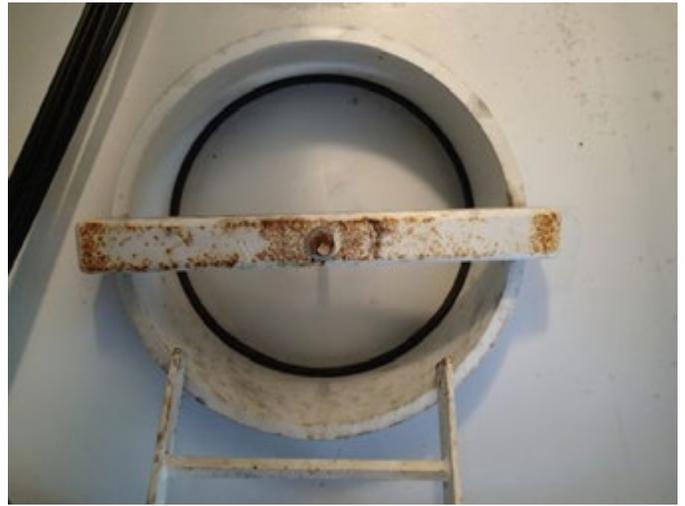
The protective coating applied to the surfaces of the steel lid was found having good adhesion value, and with an average dry film thickness of 11.2 mils, while blotch rusting exists on the securing hardware due to a decline in coating film thickness.

74 *Manway With Blotch Rusting Of Hardware*

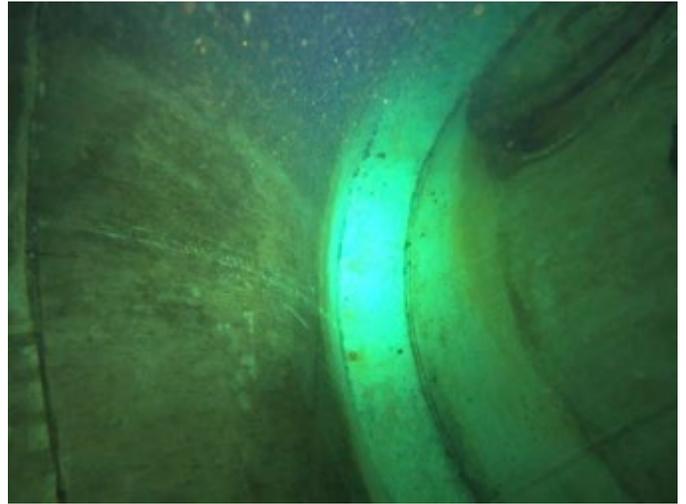
Mild staining exists throughout the entire floor due to the accumulation of precipitate.

86 *Floor With Mild Staining*

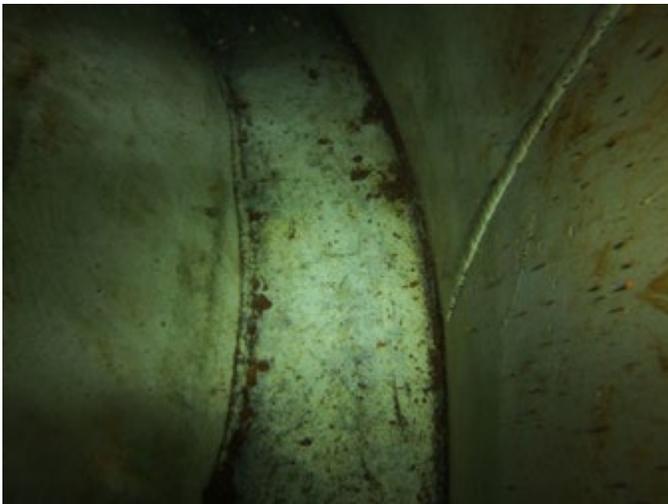
87 *Floor With Mild Staining*

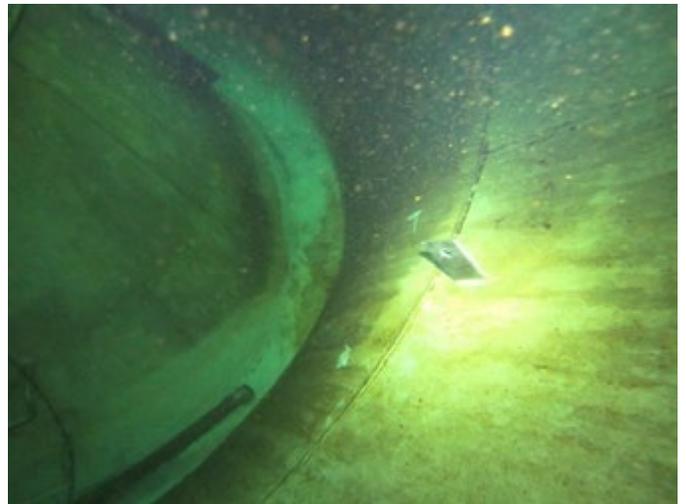
88 *Floor With Mild Staining*

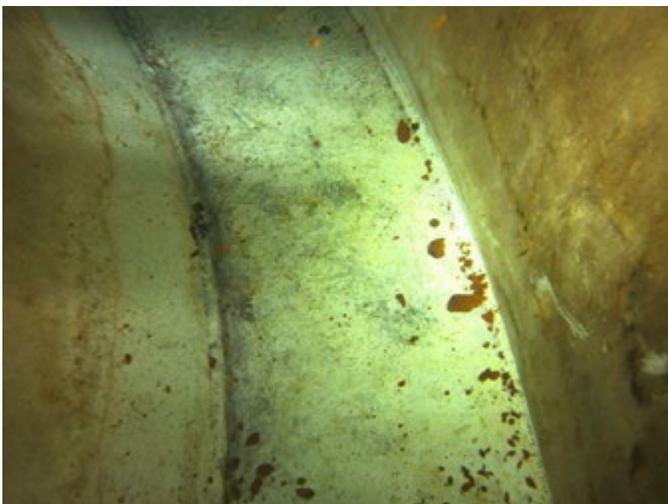
89 *Floor With Mild Staining*

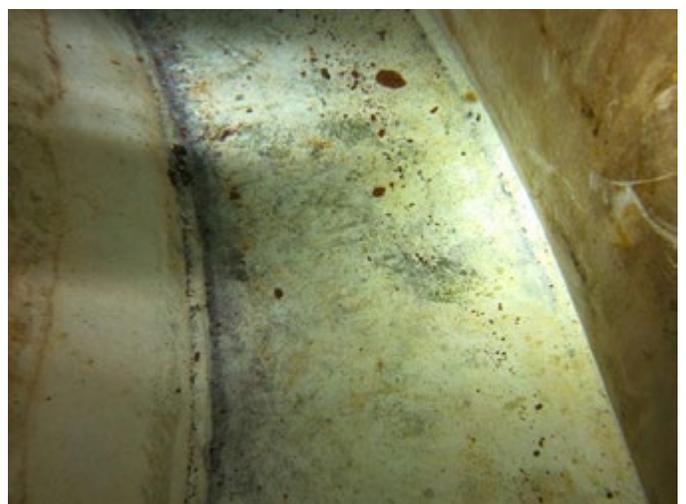
90 *Floor With Mild Staining*

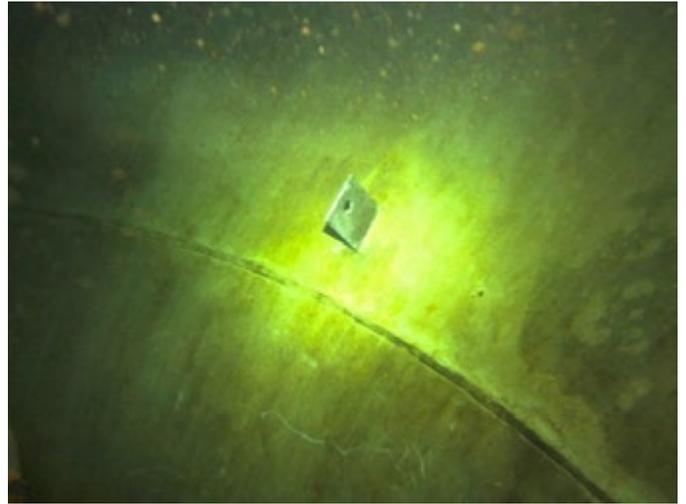
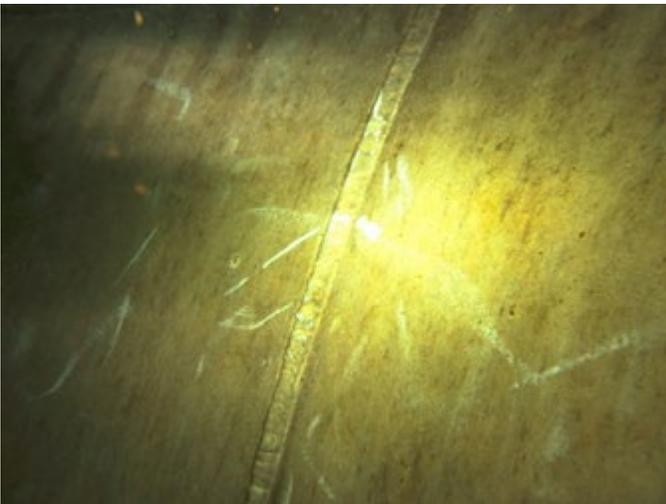
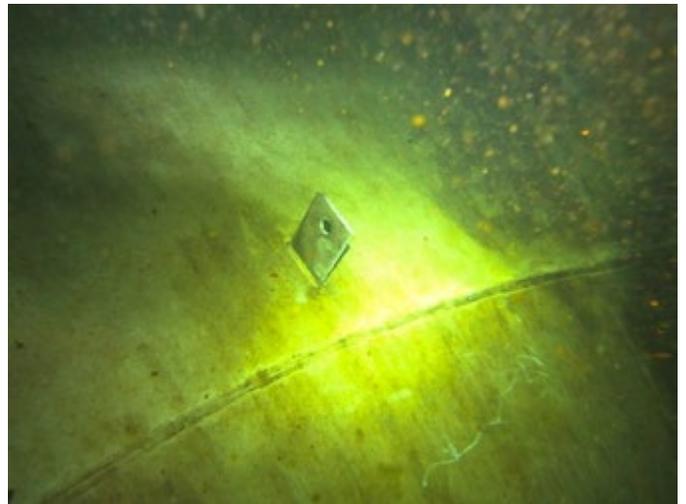
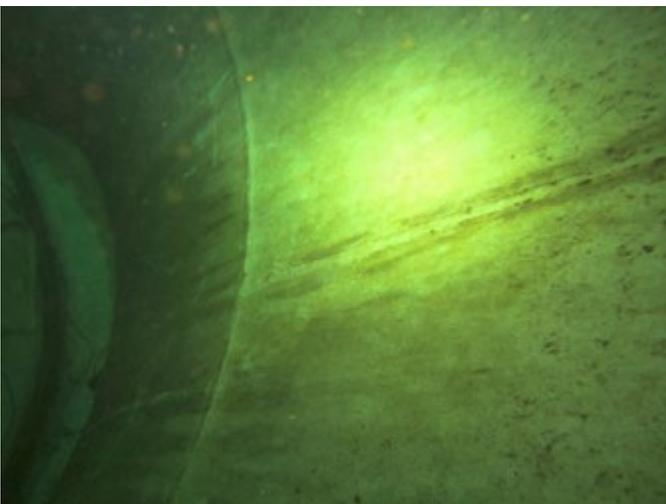
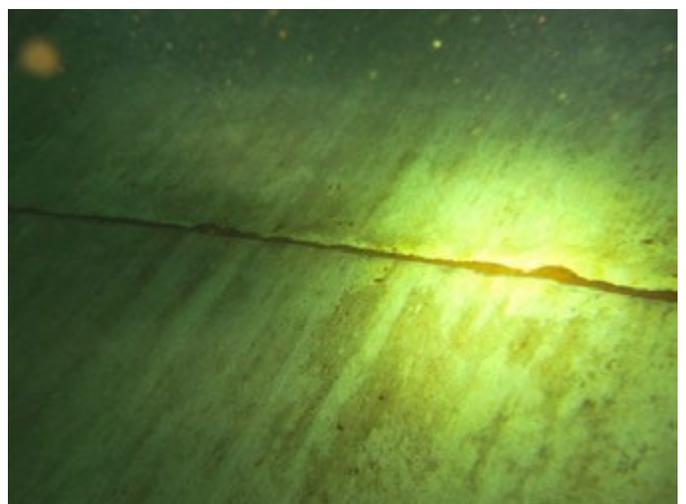
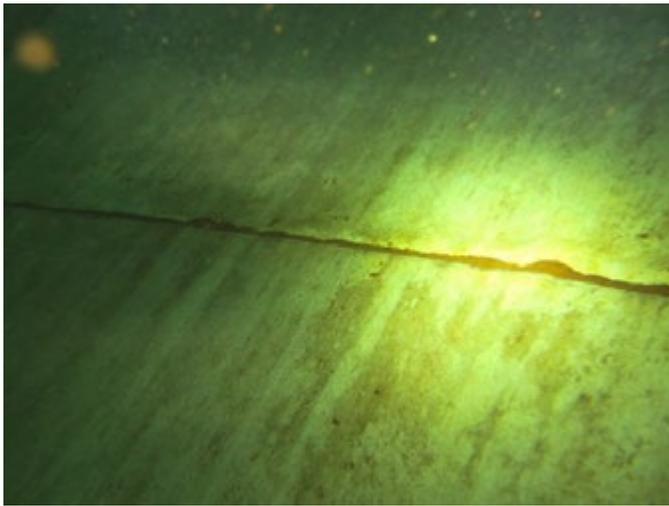
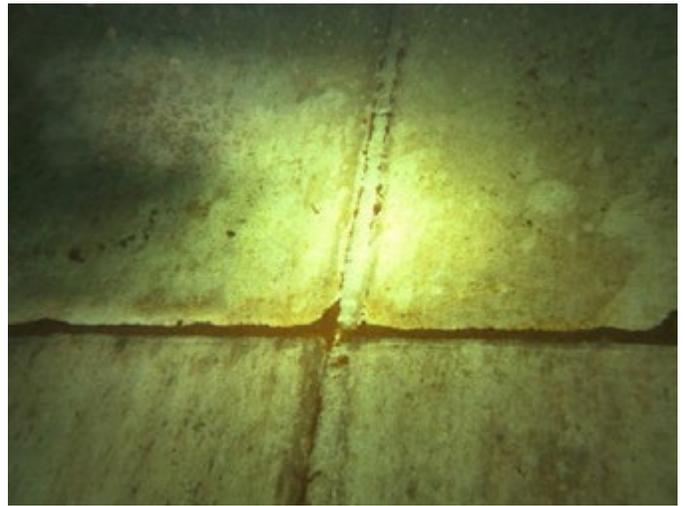
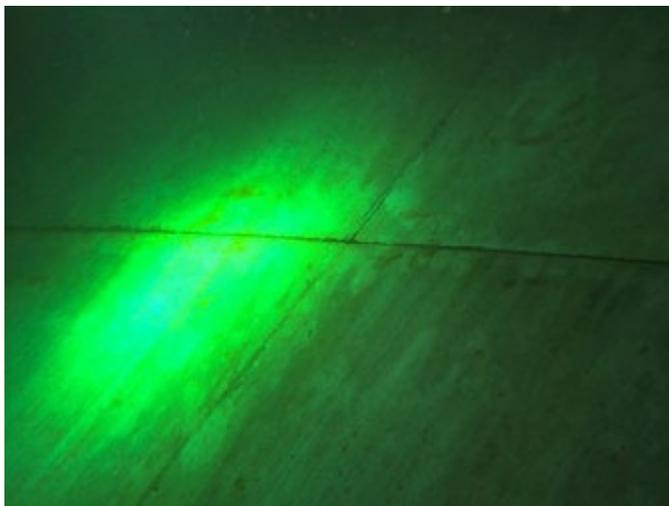
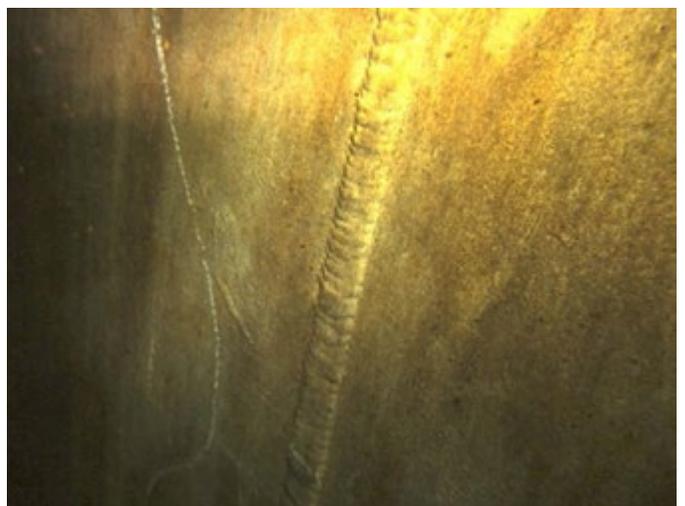
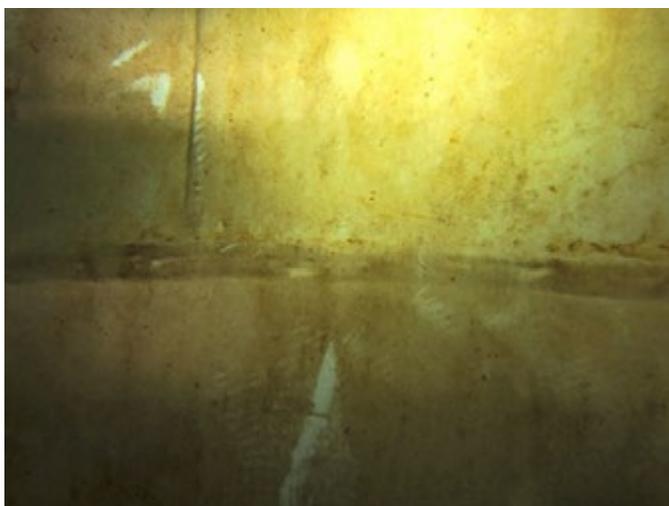
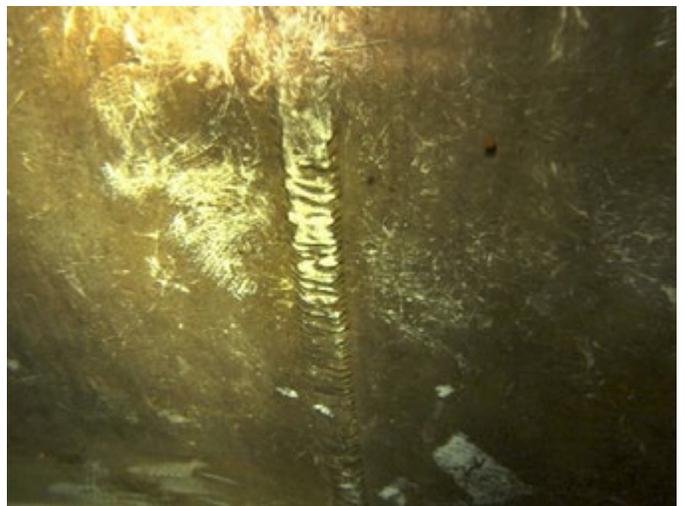
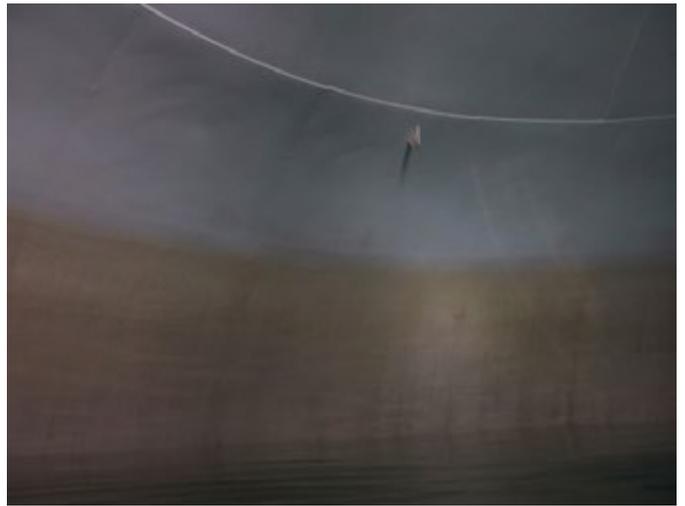
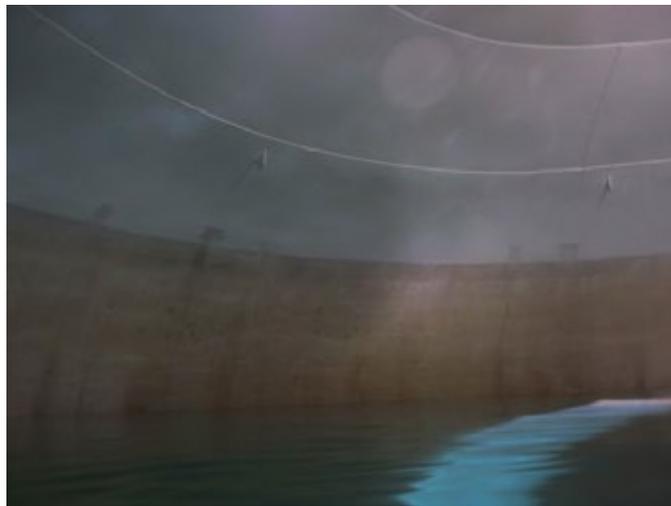
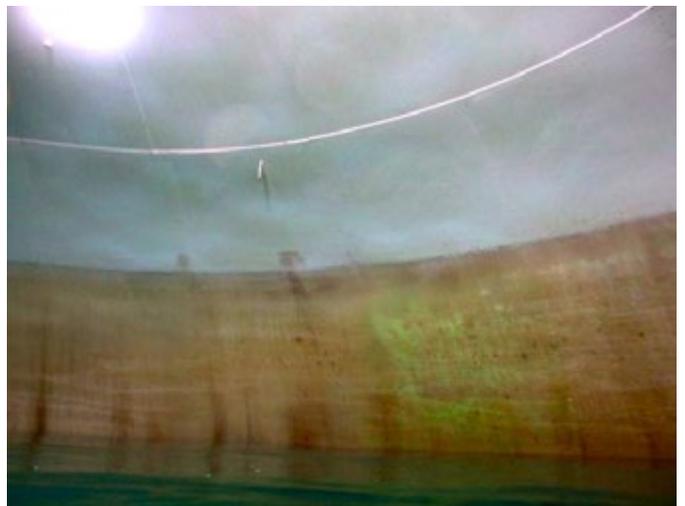
Mild staining exists throughout the interior walls, extending from approximately 12" below overflow level down to the floor.

104 *Interior Wall With Mild Staining*
