September 6, 2012

Project No. C17764.00

**Re: The Wellfleet Public Library
Task 1 Report: System Review, Evaluation, and Schematic Design**

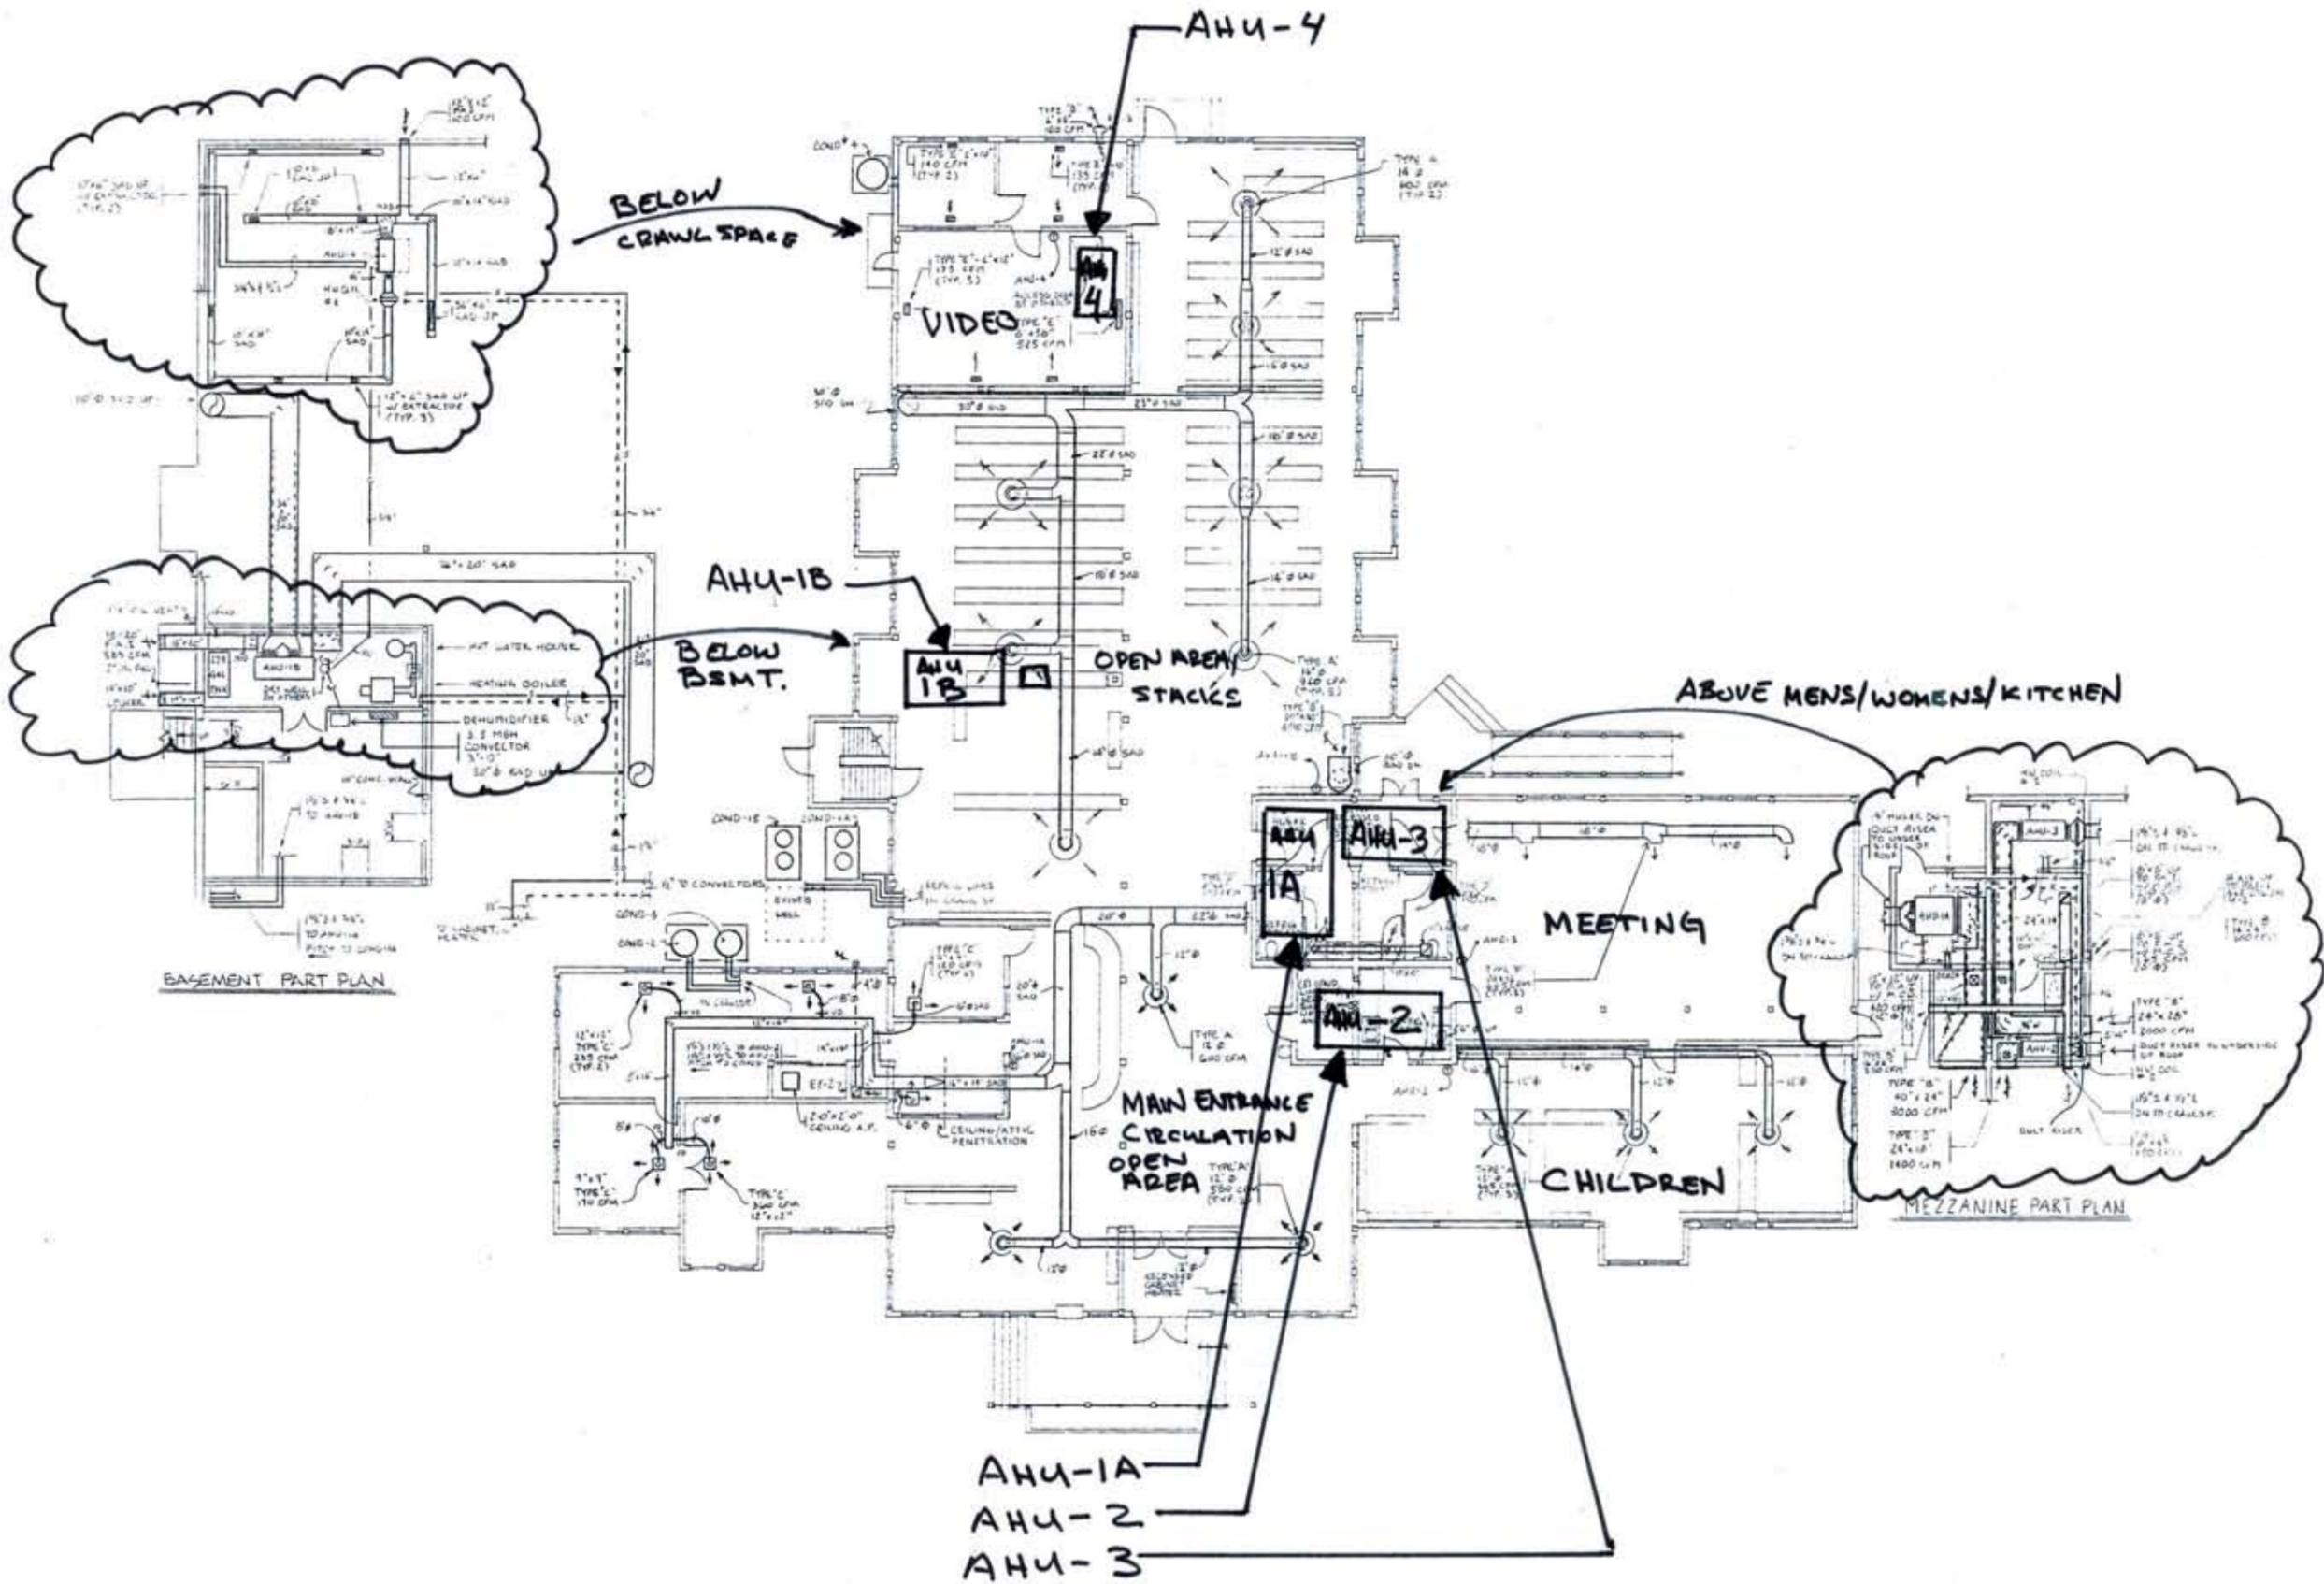
H-1

The existing HVAC system consists of five (5) ducted split system units with a direct expansion (DX) cooling coil and a hot water heating coil. Ridged copper piping is used as the conduit for the discontinued "ozone depleting" R-22 refrigerant piping between the outdoor Air Cooled Condenser Units (ACCU's) and the indoor ducted Air Handler Units (AHU's). Copper piping is used as the conduit for the hot water piping between the boiler and the 3-way control valves of the hot water heating coil. Below is a list of the five (5) existing systems, the areas they serve and location of the indoor units (see attached 1987 existing HVAC floor plan for reference to the existing unit locations):

AHU-1A & ACCU-1A Main Entrance/Circulation/Open Area, (AHU-1A located above Women's Room)
AHU-1B & ACCU-1B Open Area/Stacks, (AHU-1B located in Basement)
AHU-2 & ACCU-2 Children's area, (AHU-2 located above Staff Kitchen)
AHU-3 & ACCU-3 Meeting Room, (AHU-3 located above Men's Room)
AHU-4 & ACCU-4 Video Area/Back Offices, (AHU-4 located in Video Area crawl space)
