WELLFLEET MARINA BUILDING NEEDS STUDY

Wellfleet, MA

DRAFT SEPTEMBER 29, 2014

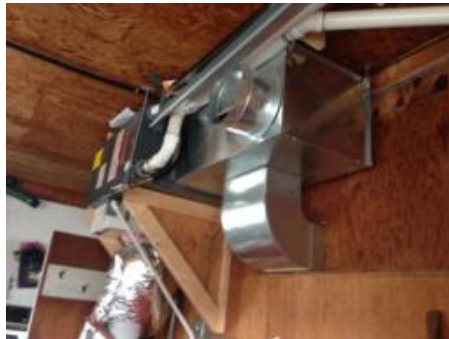
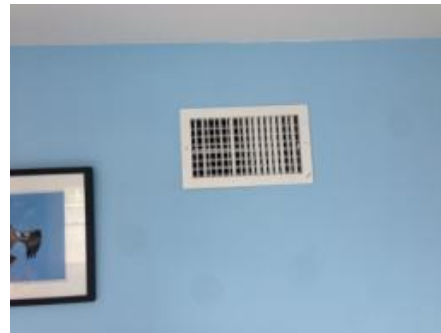
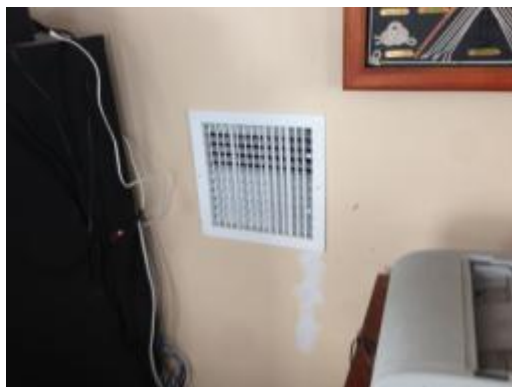
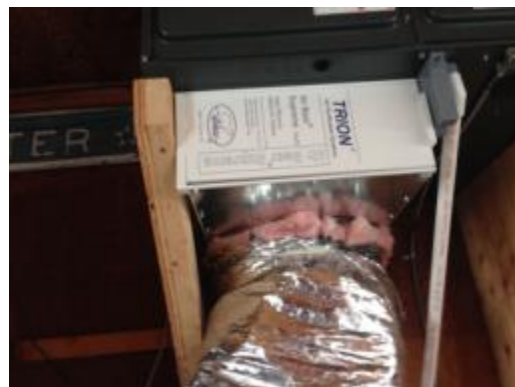
The building is presently served with one hot air furnace. The system is on a single zone. The furnace BTU output is approximately 80,000 and fueled by propane. The equipment is in good condition and was recently installed.

The combustion venting is direct vent to the exterior.

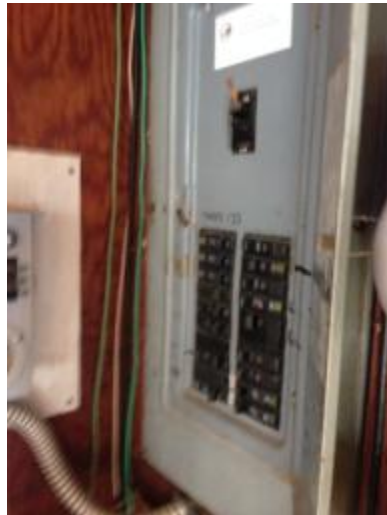
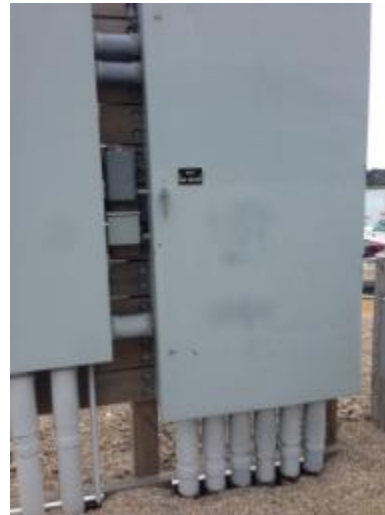
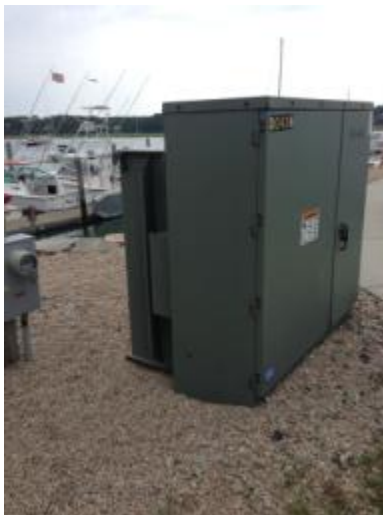
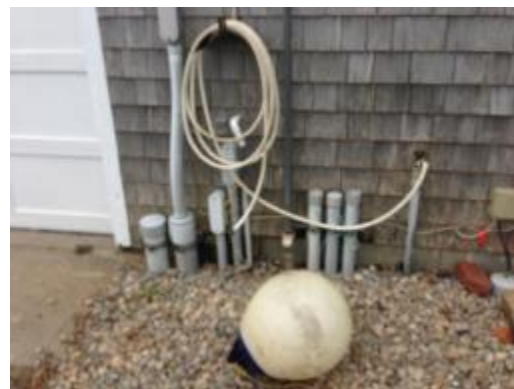
Presently, the Electrical Systems serving the Harbormaster Building are feed from underground wiring from exterior distribution equipment installed approximately six years ago. The service is rated at 200A, 120/208volt, single phase.

There is a portable generator at isolated panel with plug for generator.

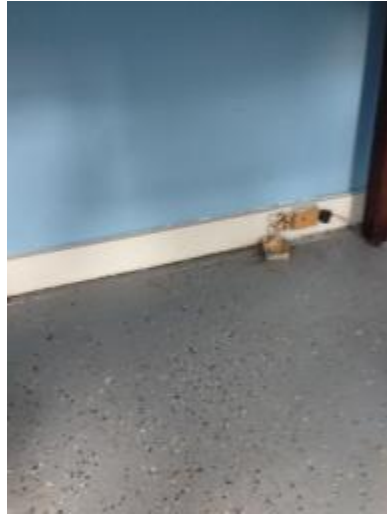
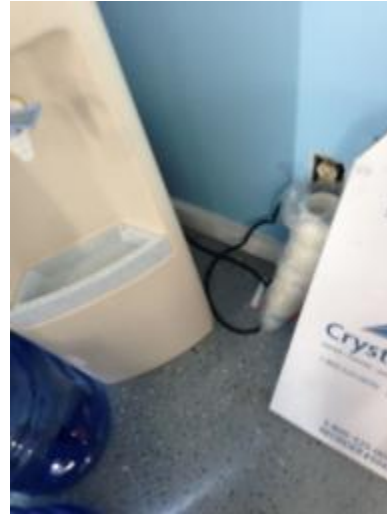
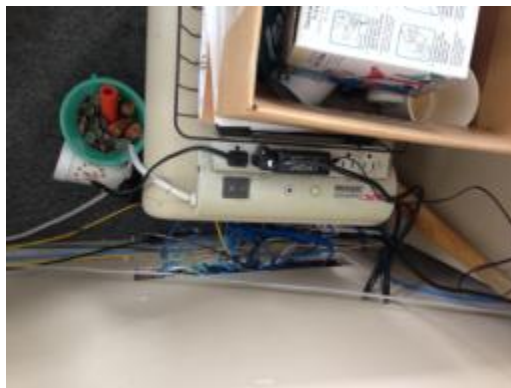
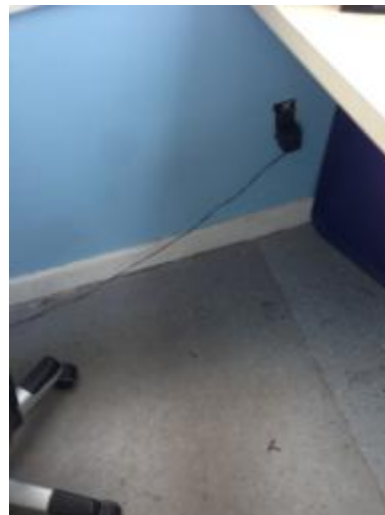
The existing wiring in the building is Romex similar to residential construction.

Receptacles generally are residential wall type.

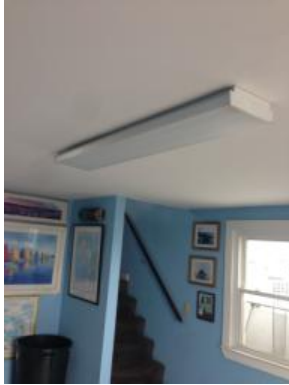
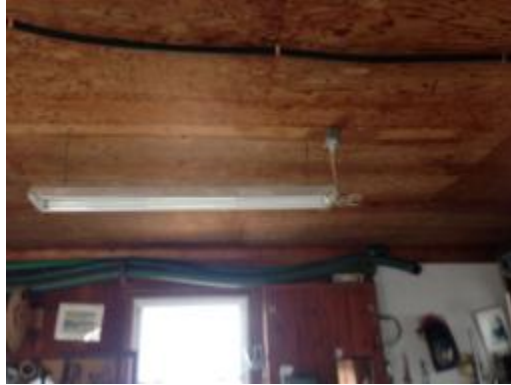
Lighting fixtures generally are wraparound fluorescent. These are in fair condition.

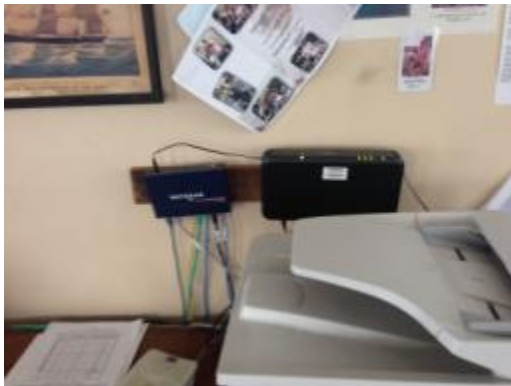
The incoming underground Telephone service is underground. There is a Comcast cable modem and network switch present.

The data wiring is run loosely on the second floor.

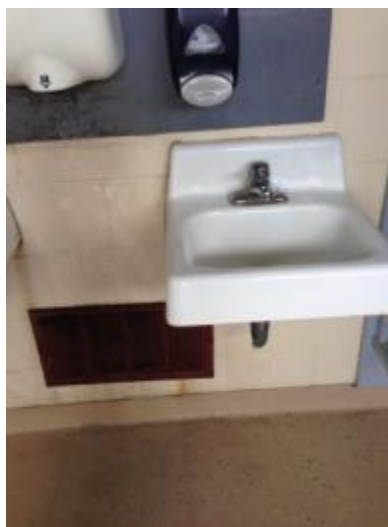
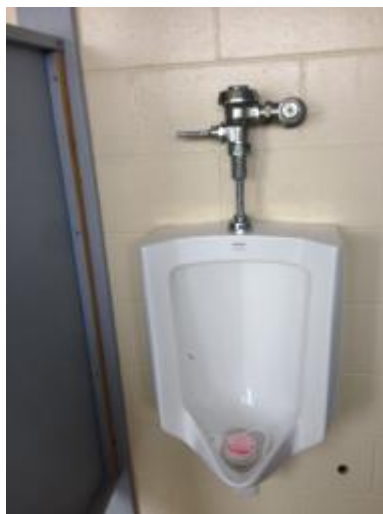
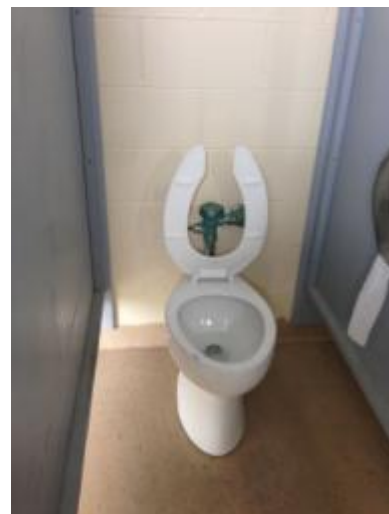
The water closets are floor mounted with flusho-meter vitreous china. Urinals are wall hung vitreous china with manually operated flush valves. Lavatories wall hung vitreous china or countertop mounted vitreous china. Faucets are generally center-set faucets.

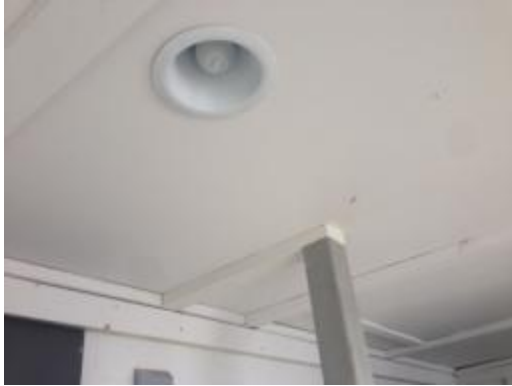
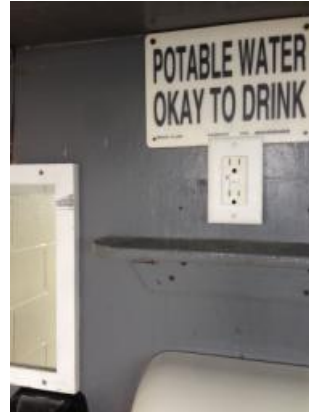
The lighting consists of recessed down lights. The fixtures appear to have retrofit LED lamps. Fixtures are in fair condition. There is a single GFCI outlet adjacent to sink and mounted at approximately 5 ft. above floor. The maximum height for receptacles used for convenience is 48" above finished floor.

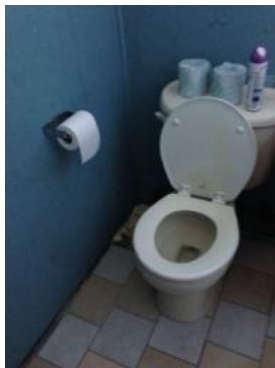
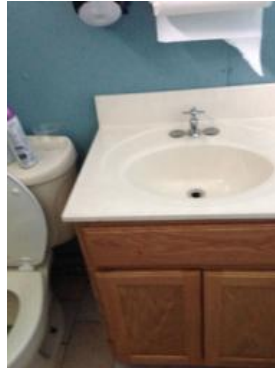
There is a single toilet room with floor mounted tank type water closet and a vanity type sink. The fixtures are of residential style and grade and are not code compliant.

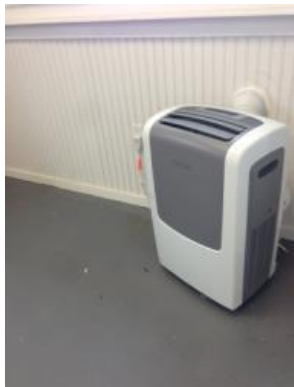
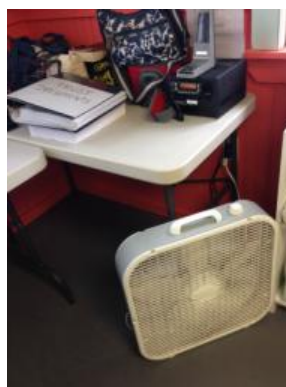
The building does not have HVAC. There is a portable floor mounted air conditioning that in corner office. Local fans are used for circulating air.

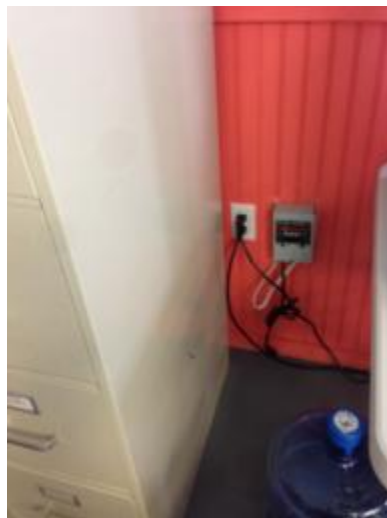
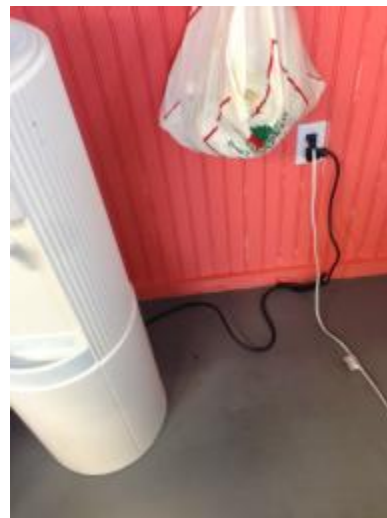
The existing wiring in the building is Romex similar to residential construction.

Receptacles generally are residential wall type. Extension cords are being used throughout.

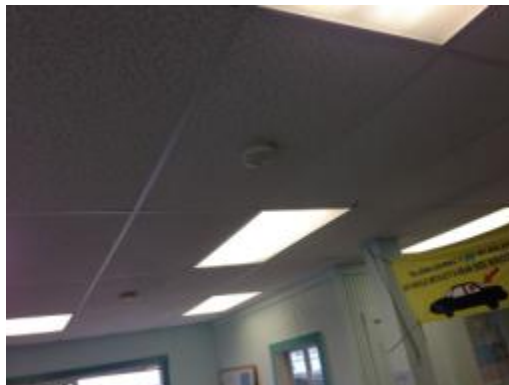
Lighting fixtures generally are recessed fluorescent. The fixtures are in fair condition.

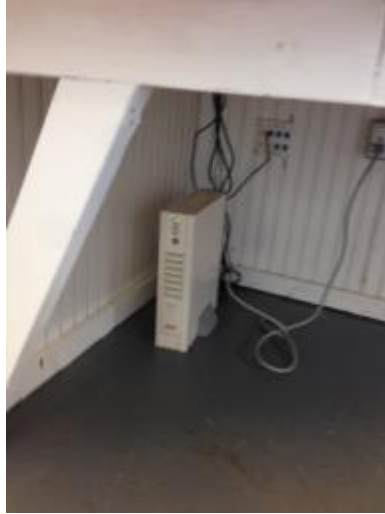
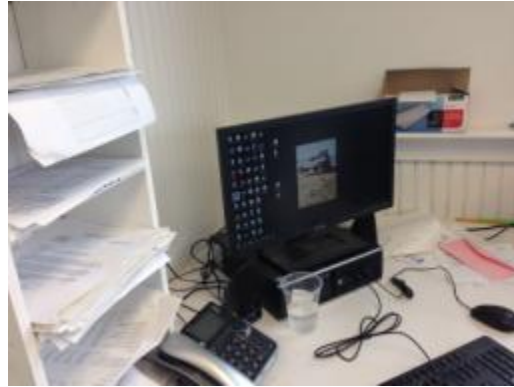
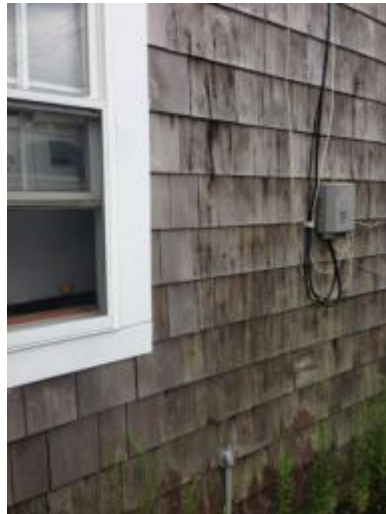
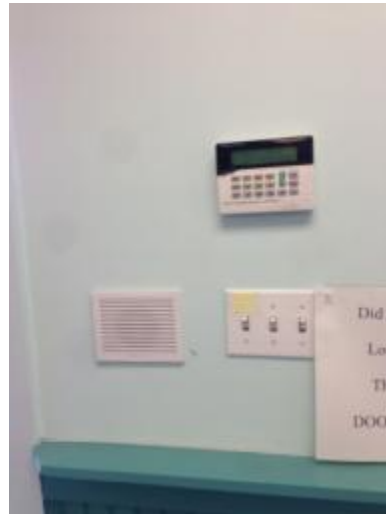
There is incoming overhead Telephone service.

The data wiring is not run to patch panels. There is a security system present manufactured by Napco. Motion sensors are present in open space.

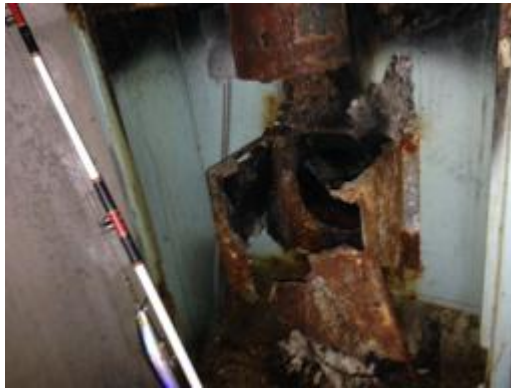
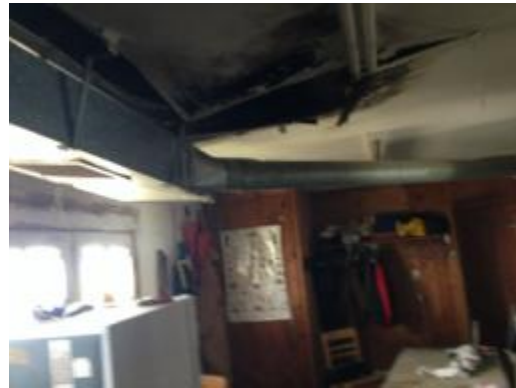
The building is presently served with one hot air furnace. The system is on a single zone. The furnace is not operational and beyond repair

The combustion venting is to the exterior. The ductwork is in poor condition.

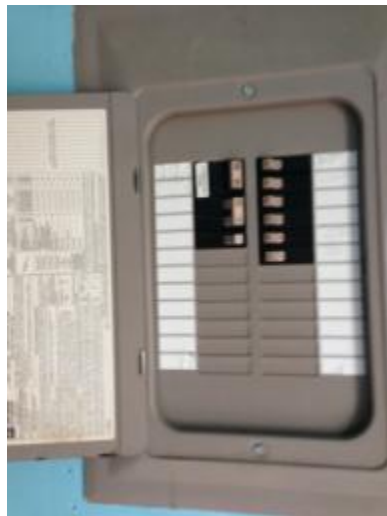
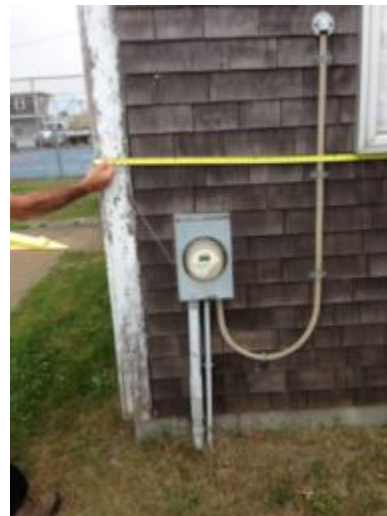
The electrical serving the Shellfish Building is underground. The service is rated at 100A the equipment is in fair condition.

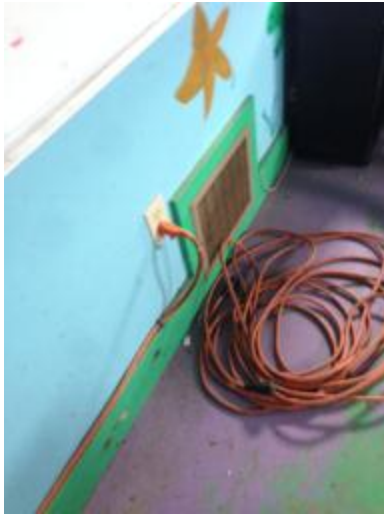
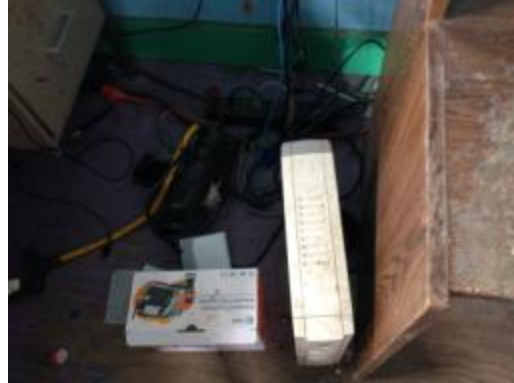
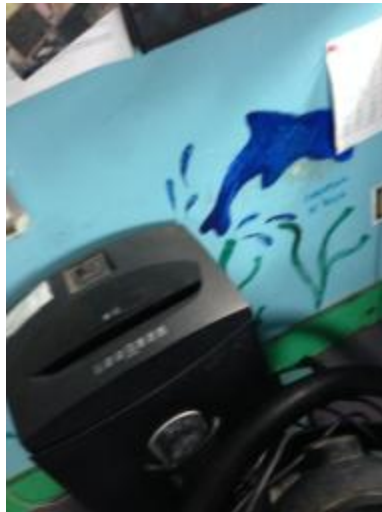
The existing wiring in the building is Romex similar to residential construction.

Receptacles generally are residential wall type. Extension cords have been used in past.

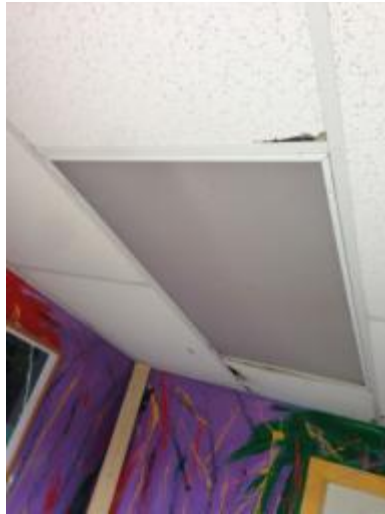
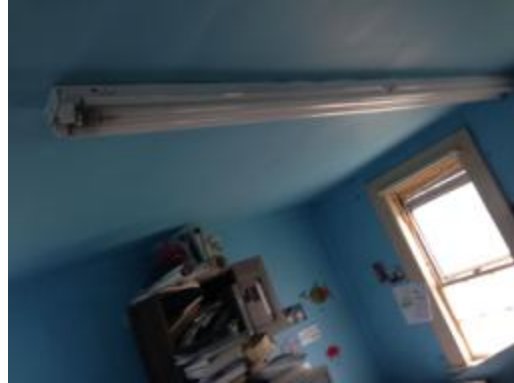
Lighting fixtures generally are recessed fluorescent in the office area and fluorescent strips in storage area. Lighting fixtures are in poor condition.

Remove the building from service/demolish. Incorporate the functions of the structure into a combined waterfront services building.
