This analysis reviews the existing Police Station in Wellfleet, MA, with regard to the Massachusetts State Building Codes (“Code”) for new construction. The 8<sup>th</sup> Edition consists, in part, of the 2009 International Building Code (IBC) and the 2009 International Existing Building Code (IEBC) with Massachusetts Amendments to these codes.

**STRUCTURAL EXISTING CONDITIONS ASSESSMENT**

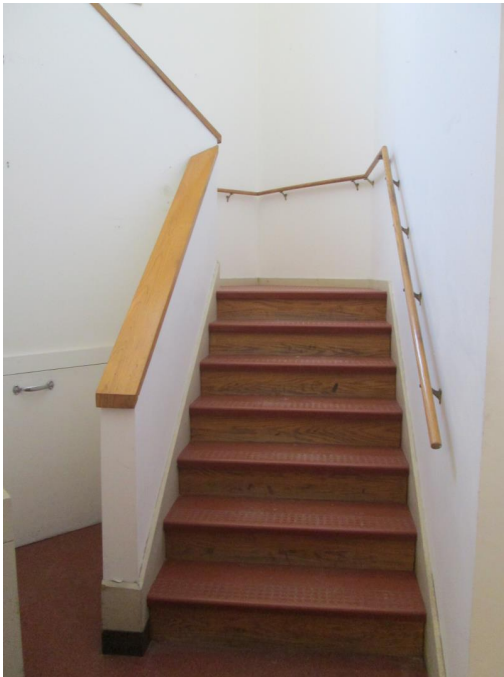
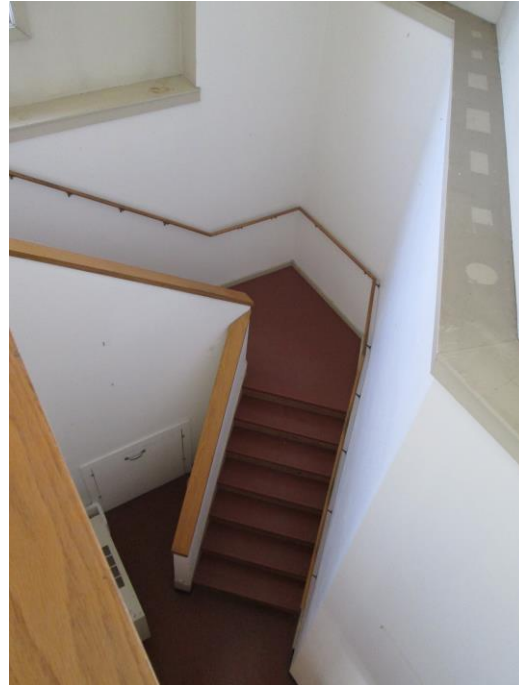
- Existing egress stairs in the building are not enclosed in required fire rated construction, do not have risers and treads of required dimensions, do not have railings and guards with required height and spacing, do not have required rail extensions, and do not have fire rated doors which comply. All stair conditions must be corrected in accordance with current egress requirements as part of any renovation project.

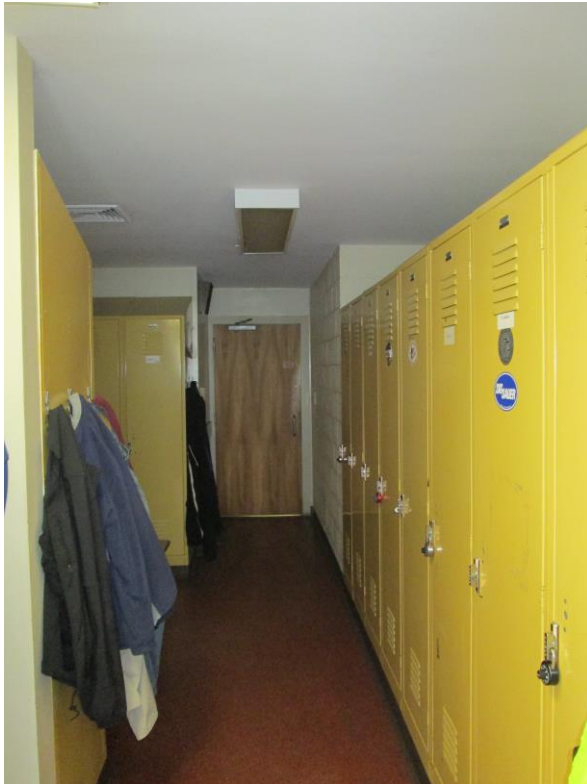
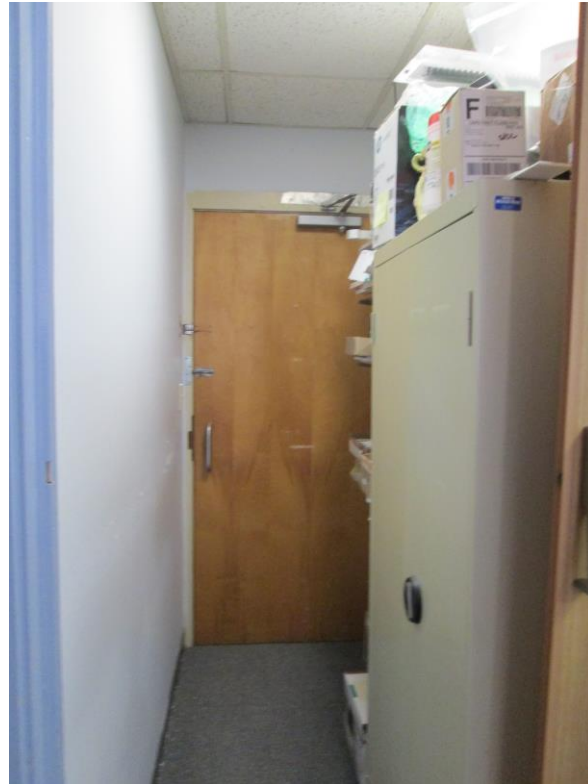
Some doors in the building do not provide required pull and push clearances for accessible doors. In public areas or areas accessed by civilian staff, modify these doorways to provide accessible clearances.

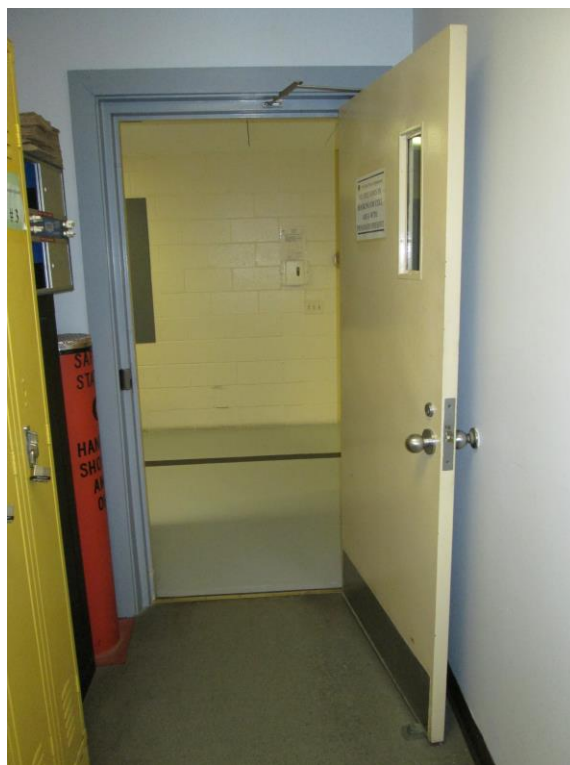
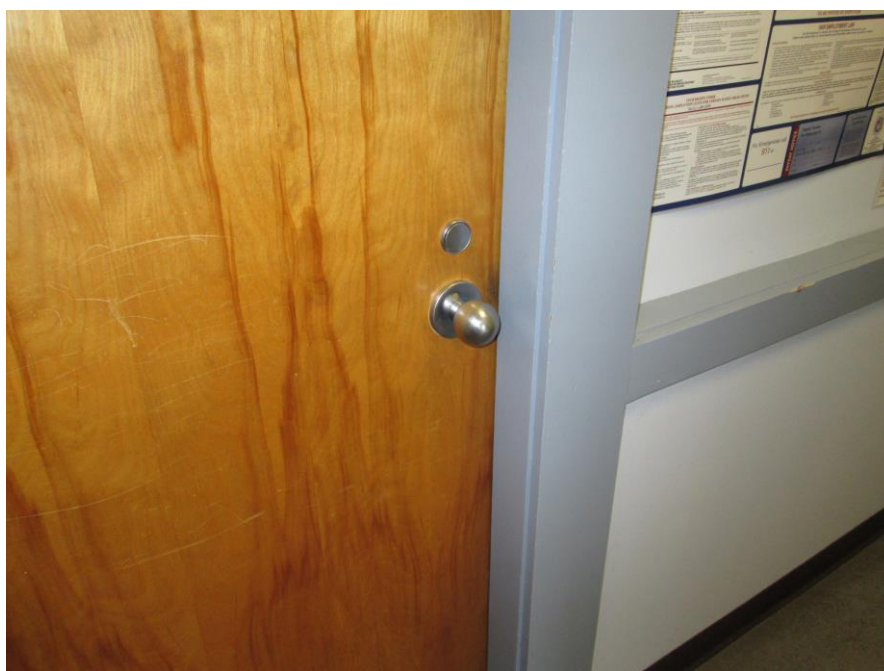
Existing hardware throughout building is not compliant and replacement with lever-type hardware at all doors is recommended .

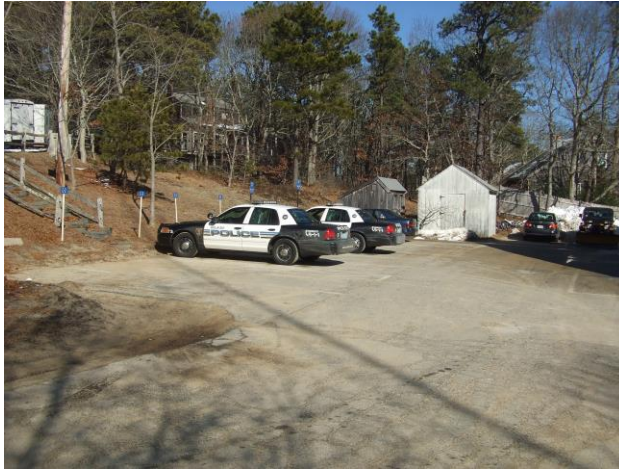
*Police Cruiser Parking and asphalt condition*

The condition of the asphalt is fair, with the only curbing being asphalt, located on the building side of the Police lot. Underground drainage on the site is minimal. There are several locations on the north side of the building where drainage is directed against the foundation. The south side of the building has positive drainage away from the building to Lawrence Road, where some ponding was noted.

- Improve drainage with new leaching pits and CB's
- Replace asphalt and curbing (granite curbing preferable)
- Provide ADA accessible entrances, new signage and improved and compliant striping
- Improve exterior connections between levels on the site. New stairs and railings to upper lot and to lower lot.
- Repair all split rail fencing.
- Provide improved signage for visitor parking, cruiser parking (straighten signs).
- Improve flat areas that appear to be used for parking. Gravel base or install impediments to prevent their use as parking spaces.

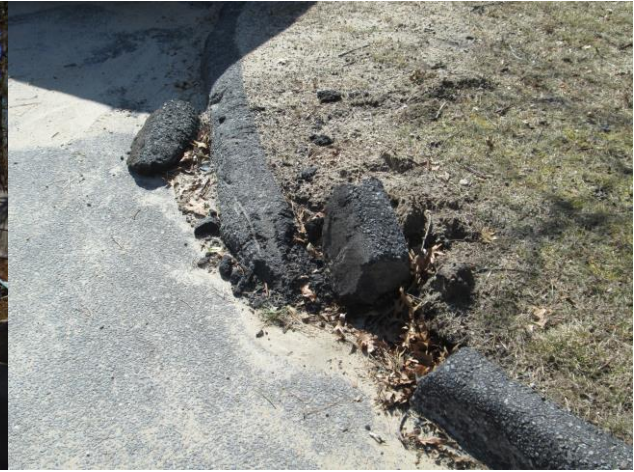
Damaged asphalt curb

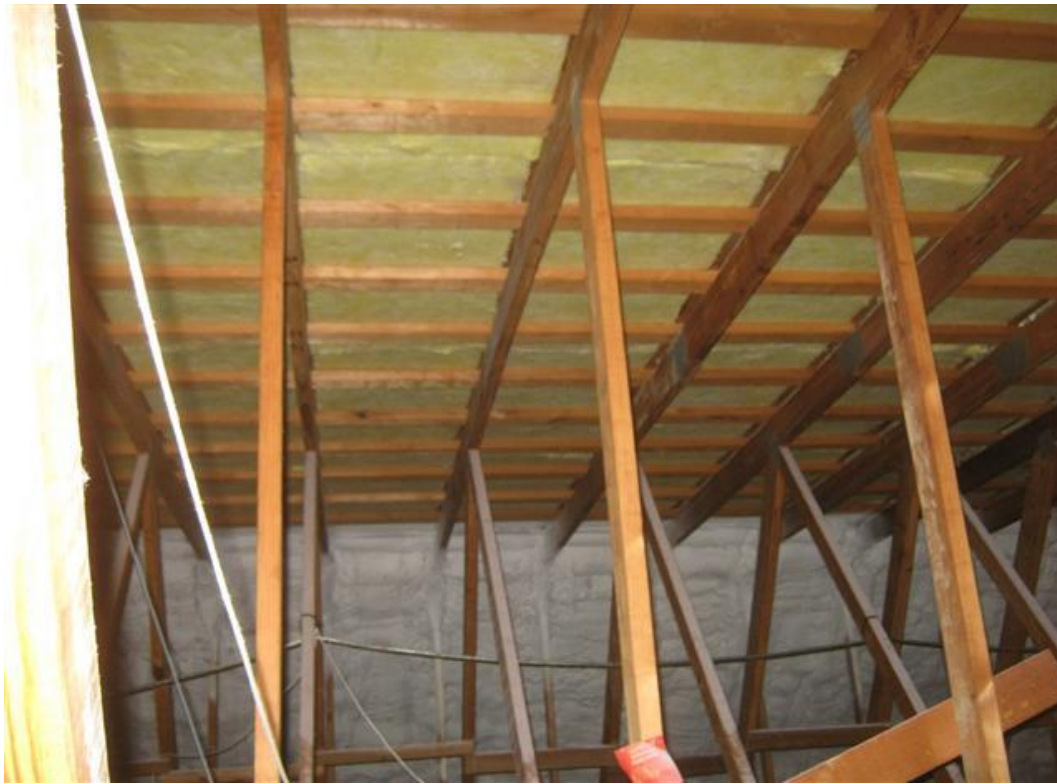
- The only area that was concealed from view was the underside of the plywood roof deck especially above the main trusses. Sprayed on insulation that has adhered to the underside of the plywood decking that was attached to the main trusses covered the surface of the plywood so that the condition of the plywood could not be observed. The condition of the plywood roof deck that is attached to the piggyback trusses was completely obscured do to insulation boards that were secured to the wood blocking that is located on top of the main trusses. Therefore, the roof deck was not evaluated for possible structural damage.

**Insulation board on top chord and sprayed on insulation in the background**

- Remove portions of the insulation in the attic to allow for access to the view the exposed roof deck. Any damage observed will be documented and evaluated for the extent of damage as well as repair recommendations.
- Remove portions of the damaged trim to expose the exterior sheathing for evaluation of possible damage and deterioration of the sheathing. Similar investigation of the condition of sheathing in the vicinity of the overflowing and failing gutters.
- Install gauges on two walls with cracks and movement to record any further movement.

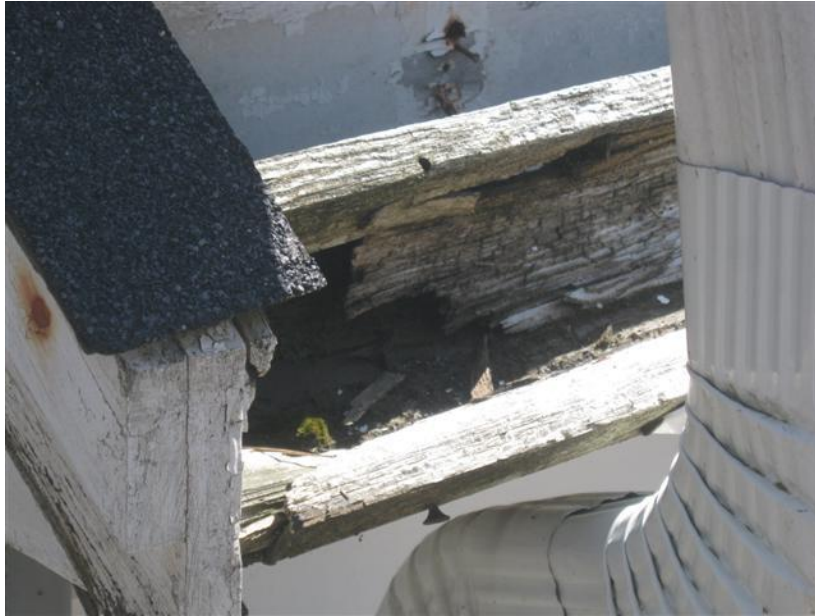
- The first item involves a failing gutter system which is discussed in the “Roofing Evaluation Report” allows what to enter into the exterior walls where the gutter is failing. The water infiltration can allow deterioration to exterior walls including possible mold growth.

**Deteriorated wood gutter allows infiltration of water into building**

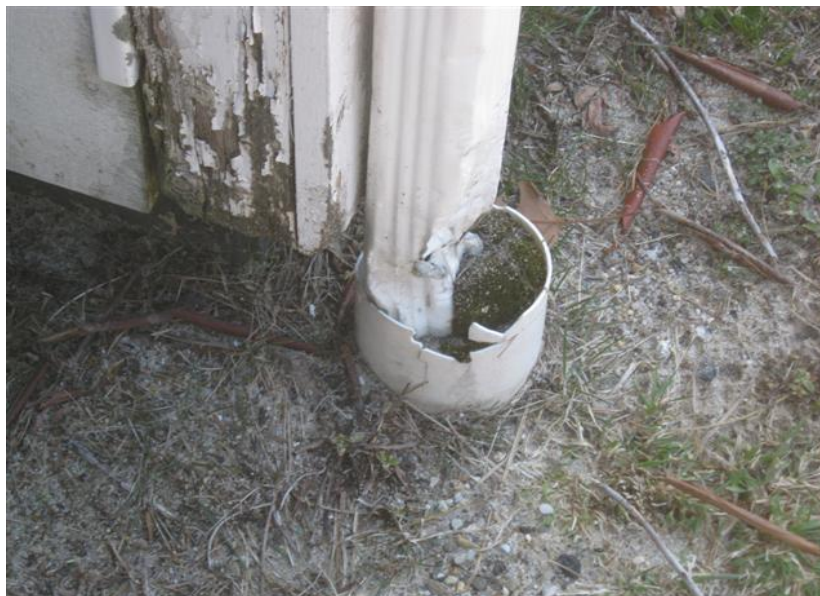
- Similarly, several areas of severely deteriorating wood trim where the wetting and drying cycles are causing dry rot to be observed. Where the rotting is such that opening have formed do to complete deterioration rain water and snow melt are seeping behind the exterior siding causing possible rotting to occur to the plywood sheathing.

**Voids in the rotting wood trim boards allows water to seep behind siding and be absorbed by sheathing**

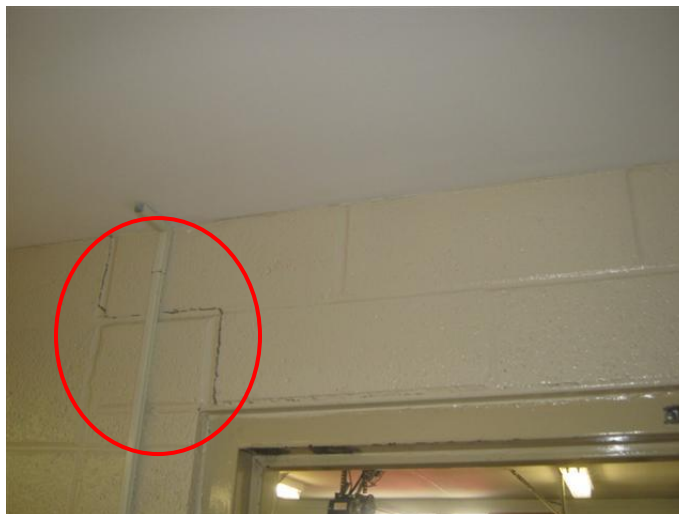
Possible settlement have caused horizontal and vertical cracks in the mortar joints in the concrete block walls of the chimney and adjoining wall.

**Cracks in concrete block wall adjacent to door opening**

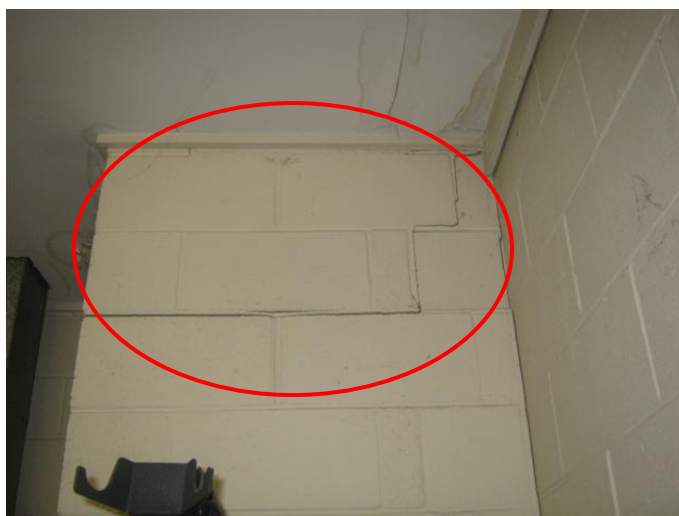
**Horizontal and step crack at chimney wall**

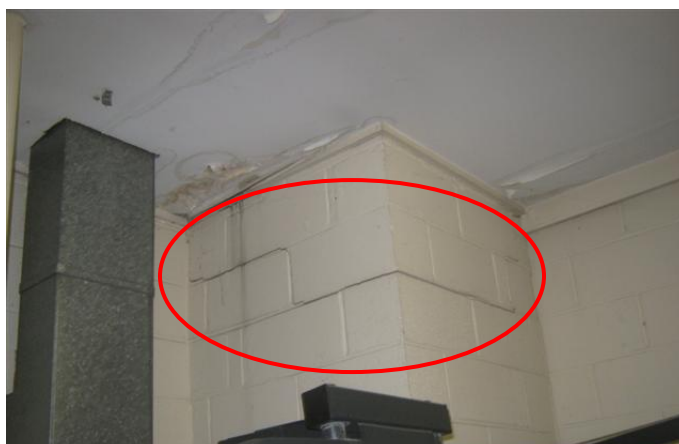
**Horizontal and step cracks in concrete block walls of chimney**

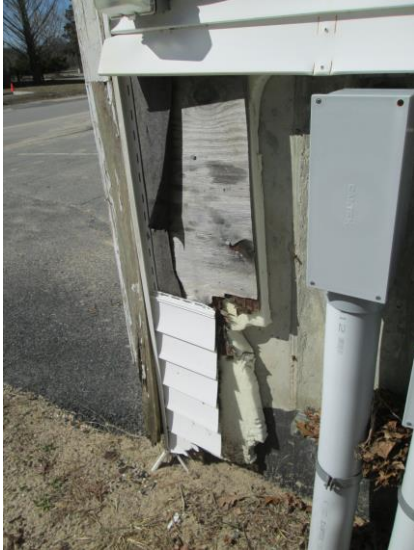
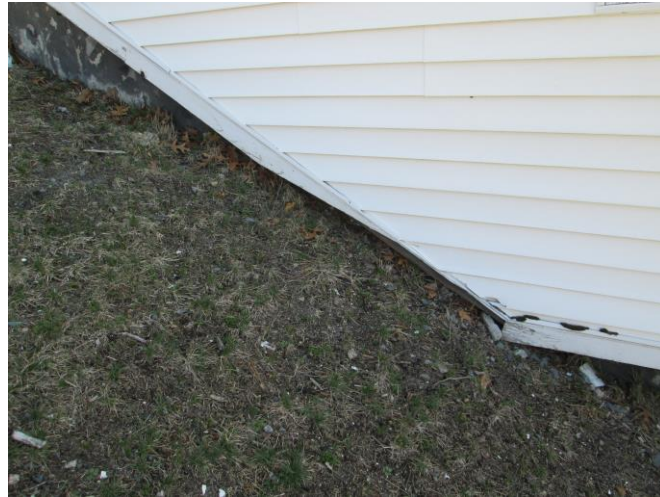
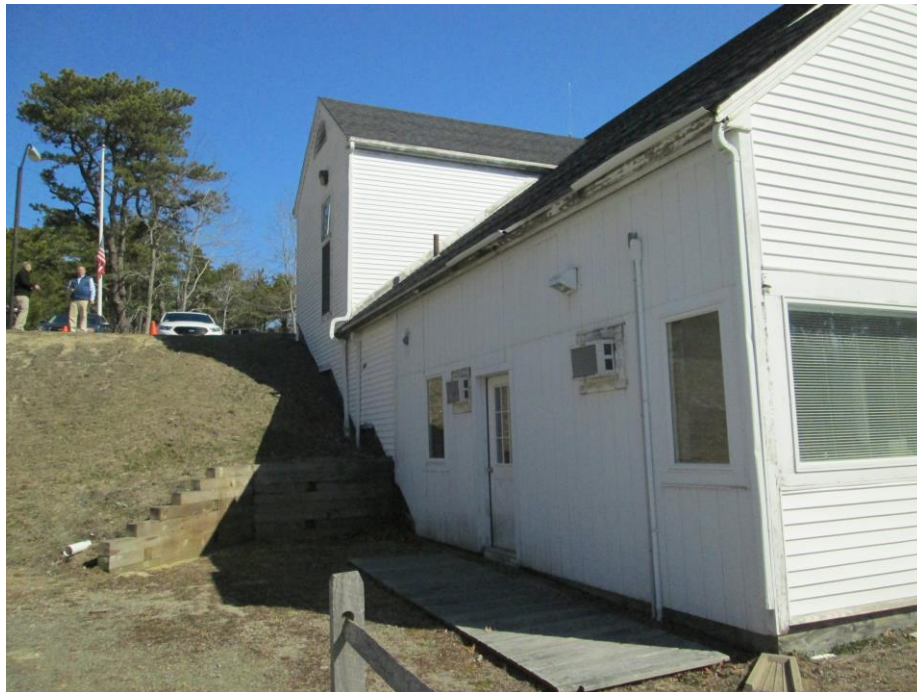
Exterior walls of the building are constructed of wood framing with vinyl siding and wood trim. Except for a small area of wall on the Garage Level, there are no building permits on file indicate that this siding has been replaced and it is assumed that the siding and trim are original construction. As investigative demolition was not performed, the condition of any existing wood sheathing and wall construction beneath this vinyl siding is unknown. The siding has been damaged and is cracked at many locations around the building and in many areas is discolored from mold and deterioration. As the expected useful life of vinyl siding is 25 – 30 years, this siding has reached the end of its expected life and needs to be replaced.

1. Replace vinyl siding and wood trim with new durable and low maintenance siding, such as prefinished fiber-cement siding and solid PVC trim.
2. Regrade around building perimeter to provide six inches minimum clearance between the bottom of the exterior siding/trim and to direct water away and around the building.

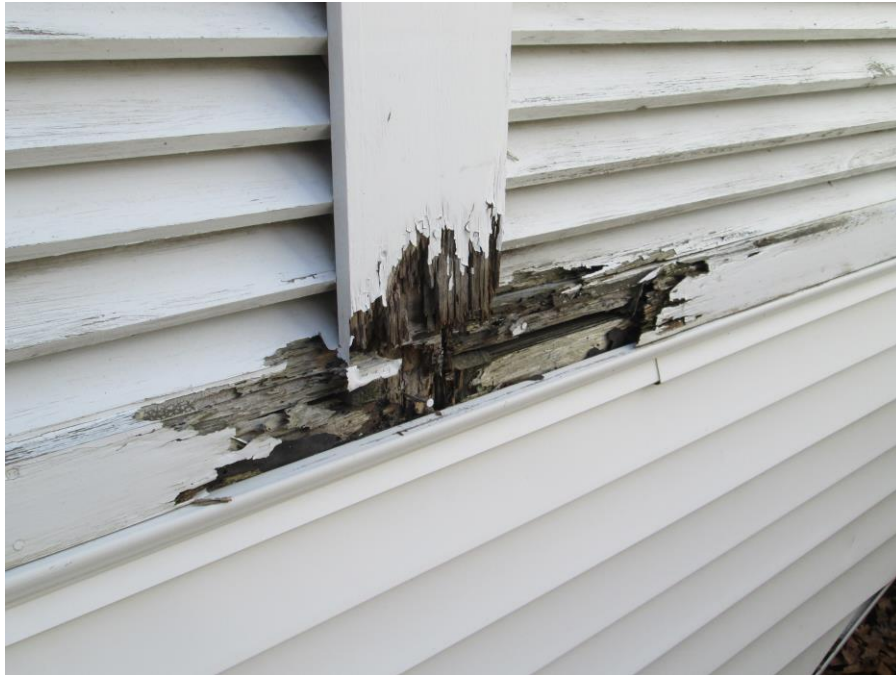
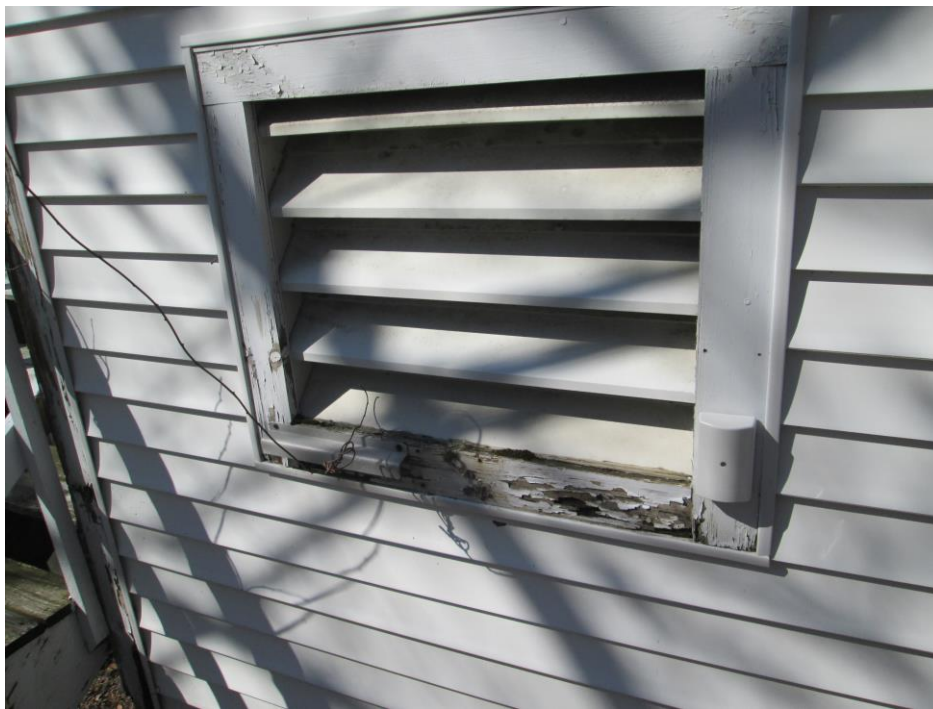
The wood trim is severely damaged and rotted in many areas. In many places, the trim at the base of the wall is in contact with the ground and has decayed and broken off. Water cascading from overflowing or missing gutters and downspouts has cause failure of the paint on wood trim surfaces throughout. Infestation by mice is reported by the Department and one possible source of infiltration is missing Trim around windows, louvers, doors, cornerboards, eaves, and roof rakes all show severe deterioration and rot and require replacement.

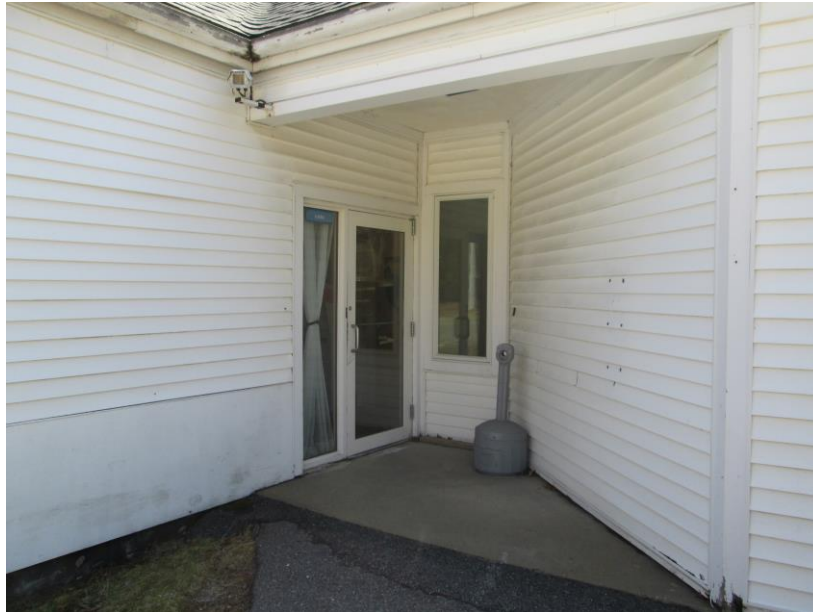
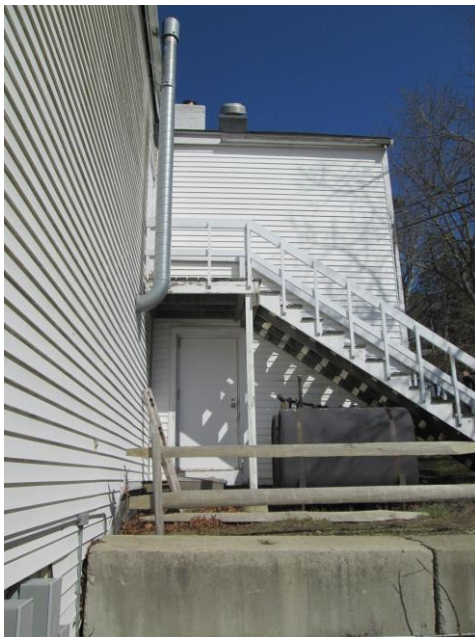
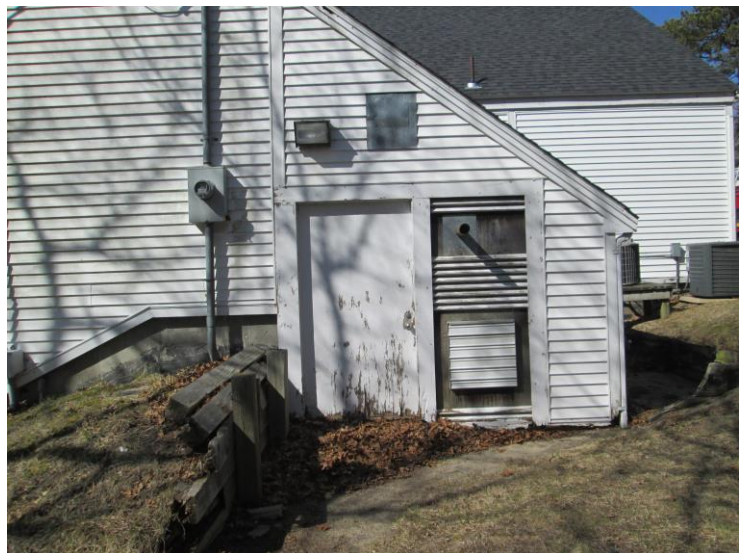
Other exterior mandoor are painted steel doors in steel frames and are in poor condition. For example, at the Boiler room which is accessed from an exterior mandoor, the door frame can be moved back and forth within the framed opening as if the connection between the door frame and wall is failing. In the Generator addition, the exterior door is wood and is severely damaged from moisture collecting at the base of the door.

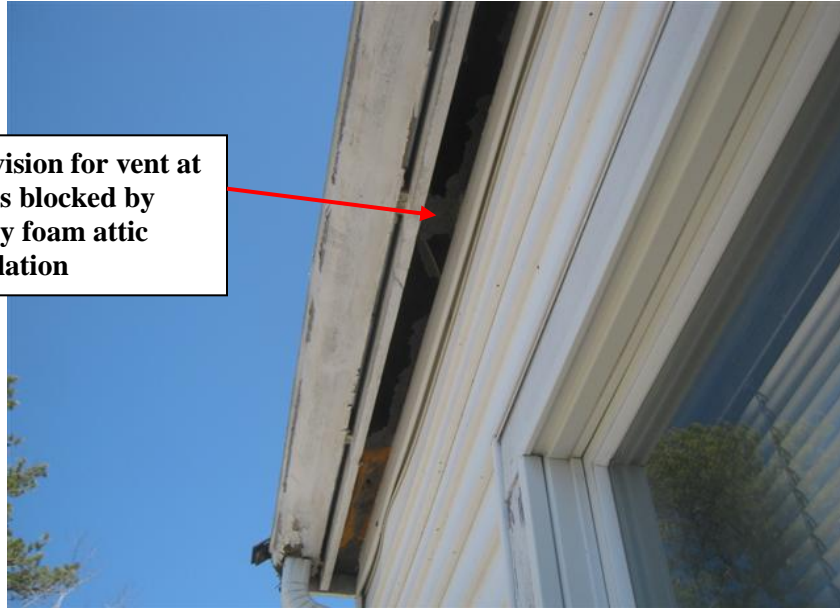
The existing construction does provide a detail for ventilation at the eaves with a gap behind the fascia board. This gap is protected by an insect screen but this has been damaged over time and this gap is now mostly unprotected from infiltration by insects or vermin. Spray foam attic insulation installed in 2010 completely infills the space between the roof rafters from eave to ridge, effectively covering the eave and ridge vents and eliminating the possibility of free air flow. (Refer to structural report)

Provision for vent at  
eaves blocked by  
spray foam attic  
insulation

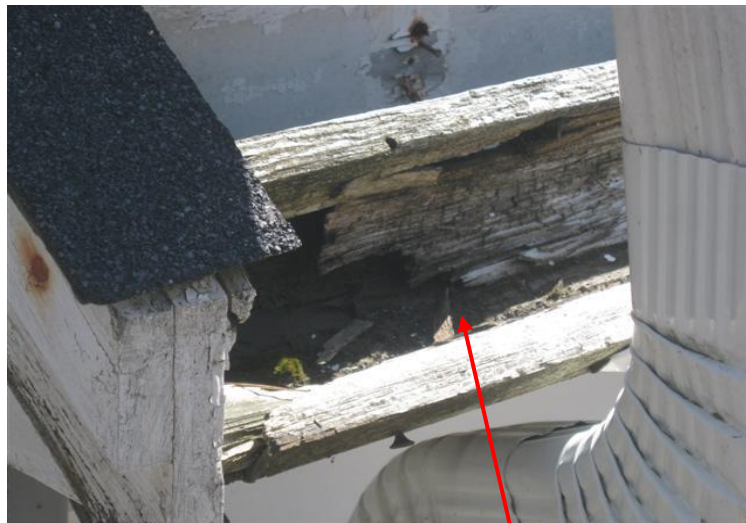
Although the re-covered shingle material on the roofs are relatively new and in good condition, the original wood gutters are in extremely poor condition. The wood is rotted and in disrepair, sections have separated from the fascia boards which also show signs of rot.

Rotted gutters

12. Install new aluminum gutters and downspouts with adequate capacity to provide continuous free flow of water to grade. Snake and clean underground storm drain system and replace all the existing wood trim with low maintenance composite white PVC trim.

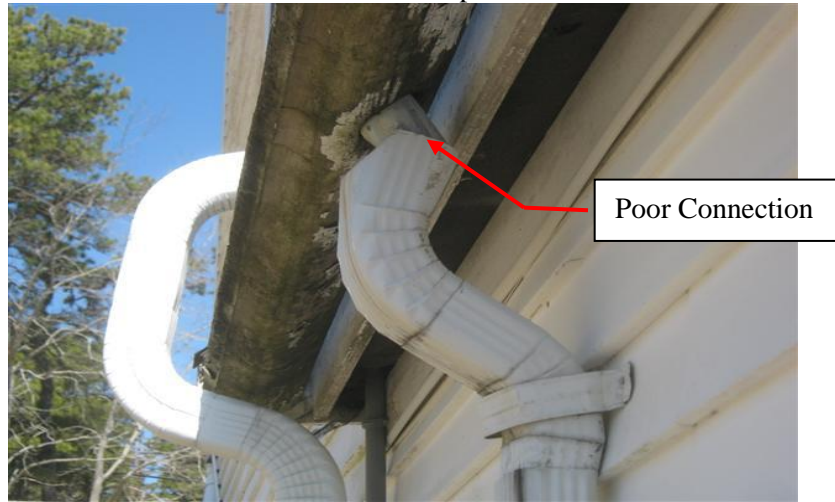
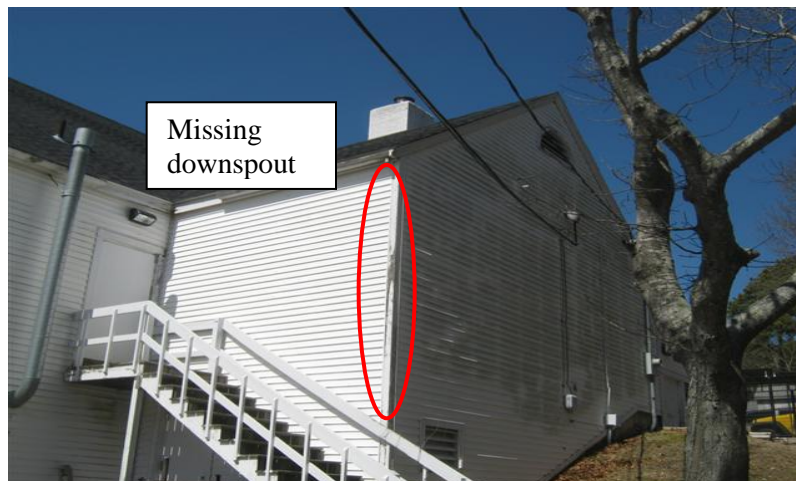
Roofs are drained through perimeter aluminum downspouts that are not connected properly to the gutters or are missing completely allowing water to flow freely to the ground level creating slippery conditions during the winter. Water flow from inadequately sized gutters and open downspouts sprays on the building face and has cause severe deterioration of the painted wood trim.

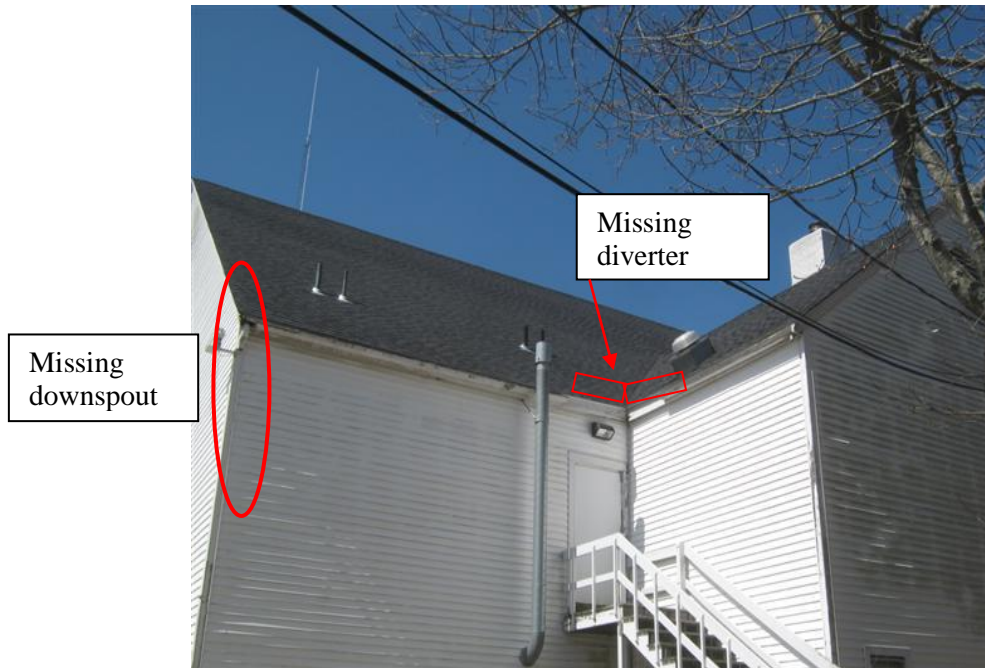
At one location at the top of a stair there is no diverter at the bottom of a valley directly above a door to protect people from cascading water when entering or leaving the facility.

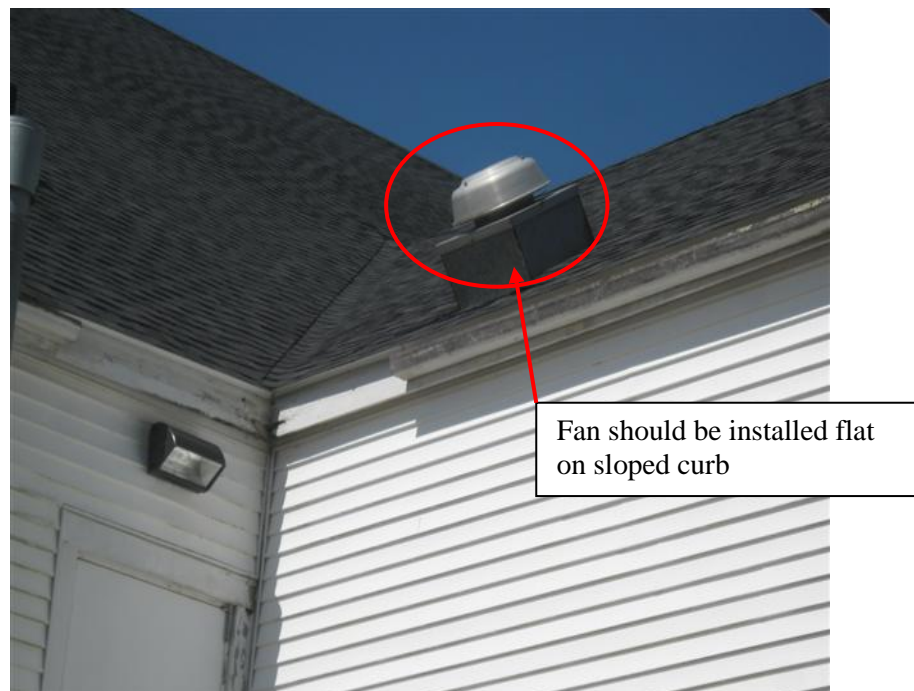
An exhaust fan was observed install on an angle because the curb follows the slope of the roof. For better efficiency and longer life expectancy the fan should be installed flat on a curb fabricated to the slope of the roof.

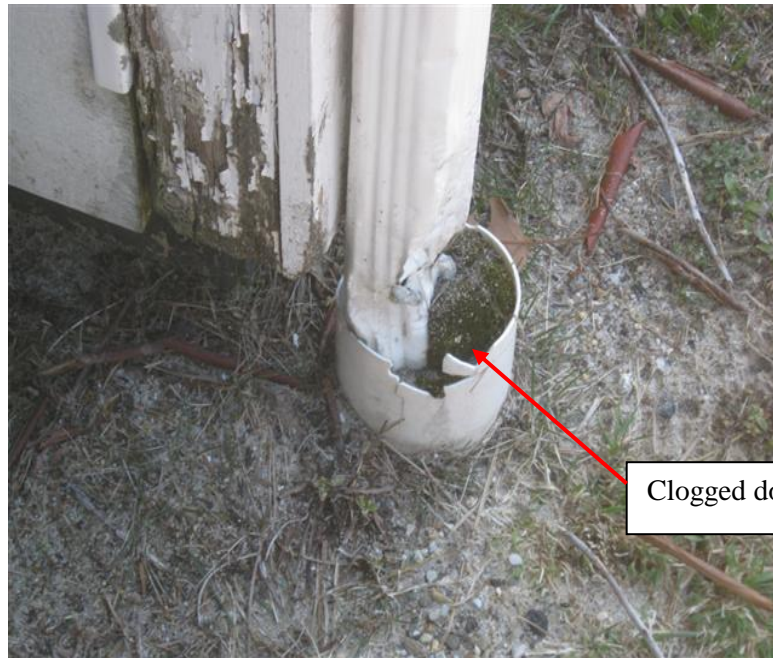
Numerous downspout connector boot at grade were filled solid with dirt and debris causing the gutters above to overflow. Water accumulates at grade causing the wood trim to rot.

Clogged downspout boot

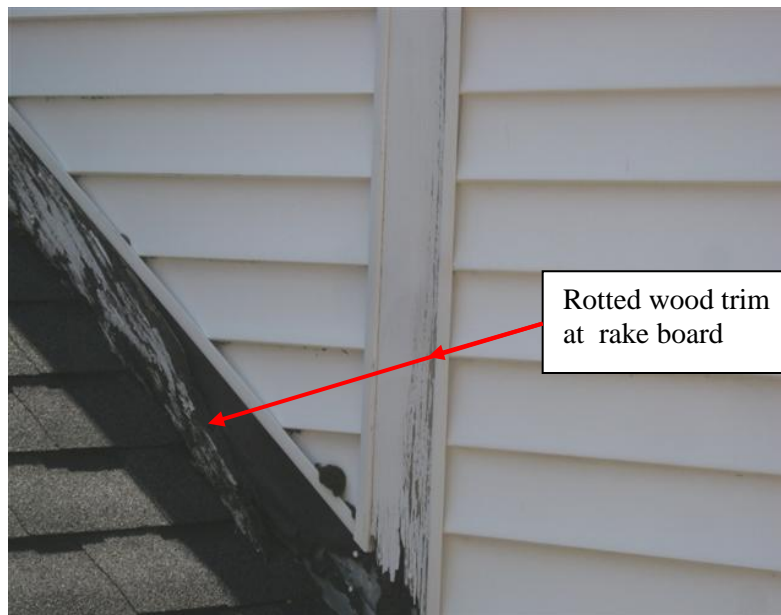
Wood trim at rakes and eaves on the roofs is rotted and in very poor condition.

Rotted wood trim  
at rake board

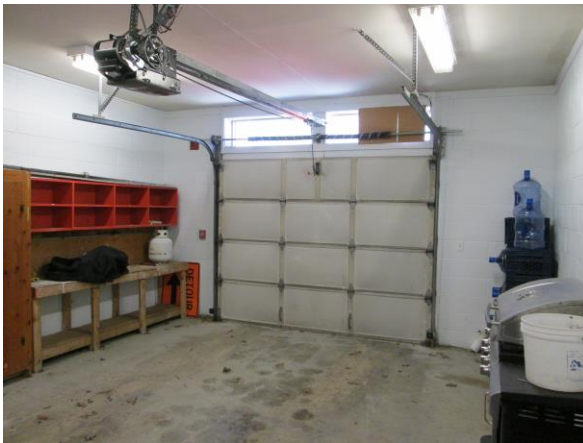
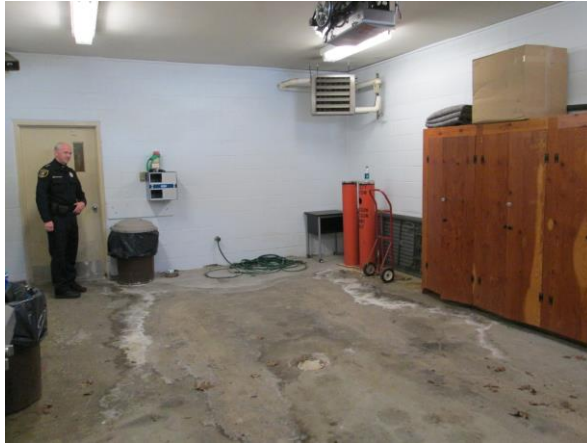
Due to a drainage issue cited by the Health Department in correspondence on file at the Building Department, the floor drains in the Sallyport and Apparatus Bay on the Garage Level were required to be sealed. As a result, the pitched slabs in these rooms pond with water when melting snow or rain runs off the police vehicles creating a slip hazard on the concrete floor slabs.

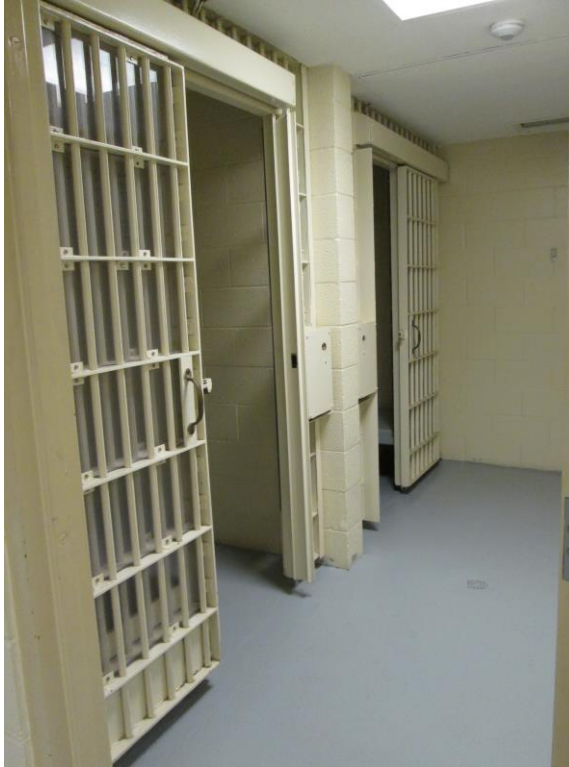
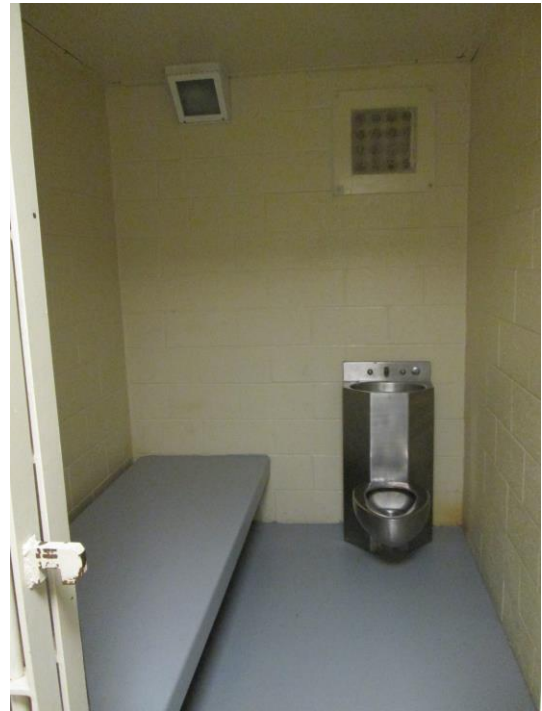
- Two other cells are located in a separate cellblock for male prisoners. These cells have electrically latching sliding doors, but these doors and the front cell wall are enclosed with bars. Although the bars have been retrofitted with lexan panels to attempt to prevent prisoner self-inflicted injury or suicide, these cell enclosures do not provide the smoke resistance and allow more open space than allowed by Code. All cells are observed and supervised by the detention staff through cameras. Diffusers for the mechanical systems are embedded in the ceilings of the cells and are perforated; the size of the perforations appears to be a violation of the State Health Code which limits the diameter of punched holes for diffuser grilles to minimize the risk for suicide attempts by prisoners.

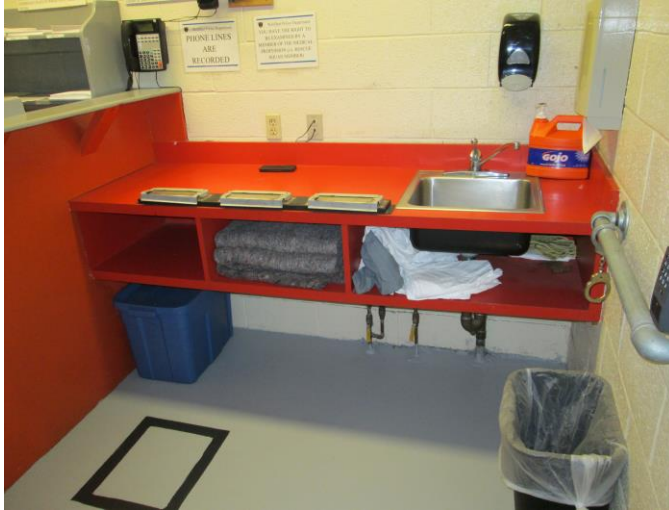
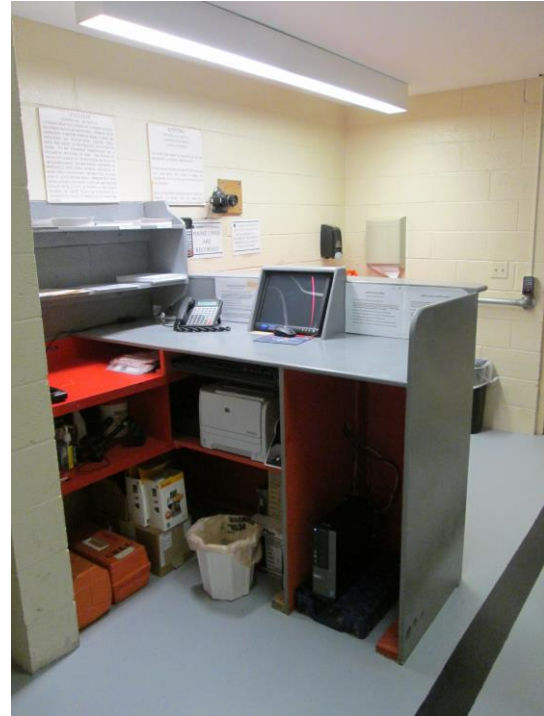
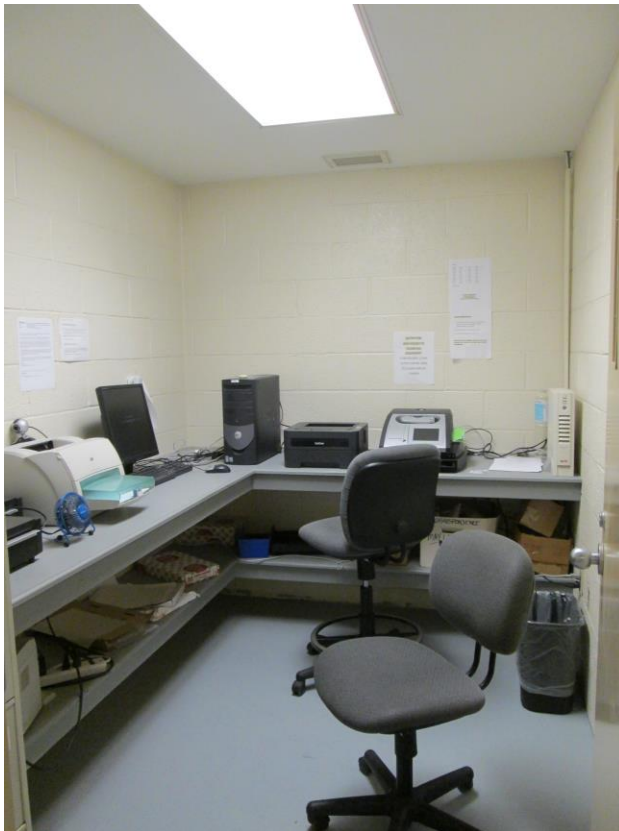
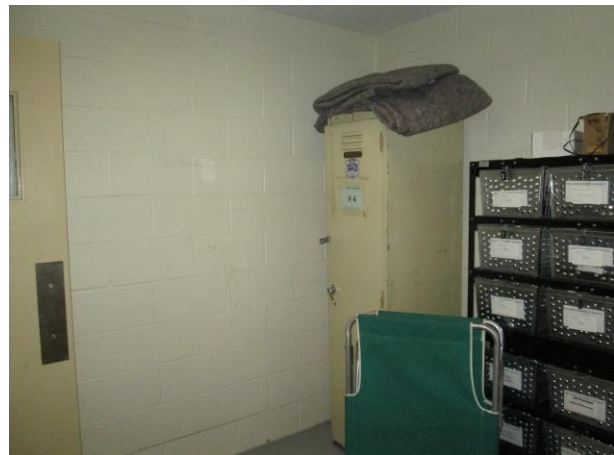
- A holding area is a handcuff rail on the wall adjacent to the Sallyport door but no bench for sitting is provided.
- Booking is processed by an officer at a casework booking station without any security-rated glass.
  - There is not a pass through to receive prisoner property; this must be collected and put into storage lockers in the Matron's room at the juvenile cell.
  - Also, handcuff bars or other restraints are not provided and should be provided to minimize the activity of the prisoner while being processed.
  - The booking station is not handicapped accessible.

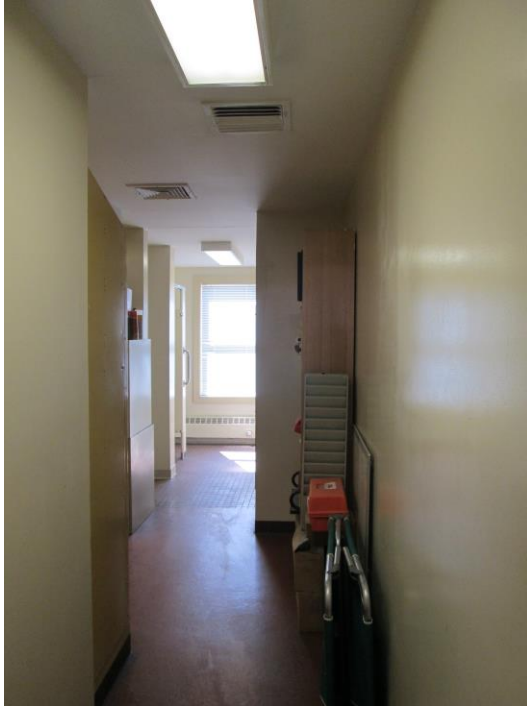
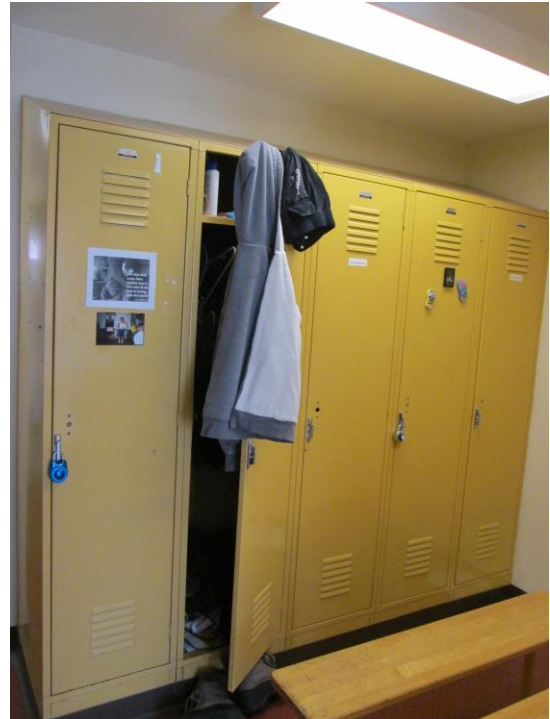
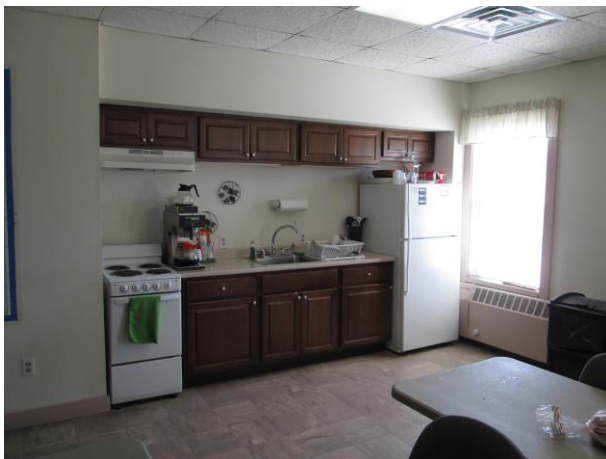
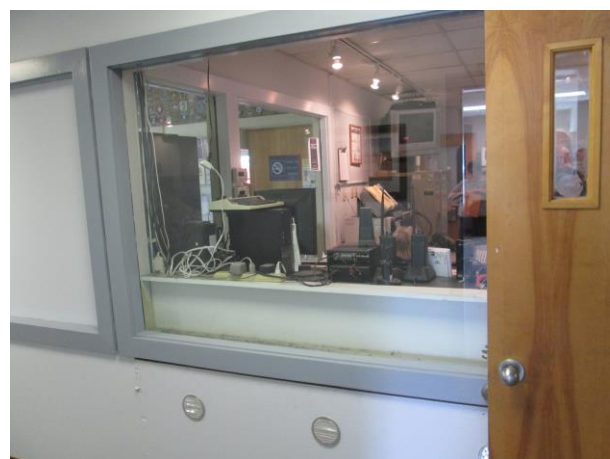
The interior of the locker rooms is visible from the corridor when the locker room door is opened and provides no privacy for staff and officers. A small toilet stall, sink, and shower are provided in each locker room but are not accessible.

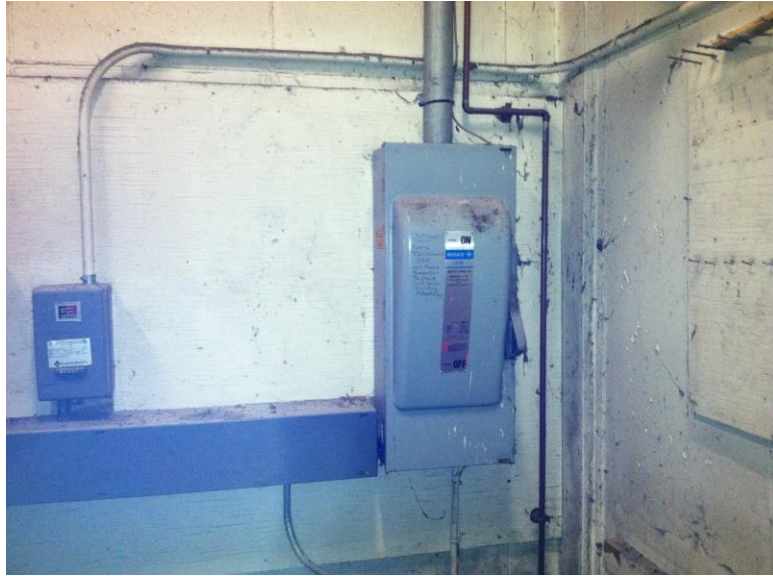
Code violation of water line directly over main disconnect switch.
