WELLFLEET MARINA BUILDING NEEDS STUDY

Wellfleet, MA

DRAFT SEPTEMBER 29, 2014

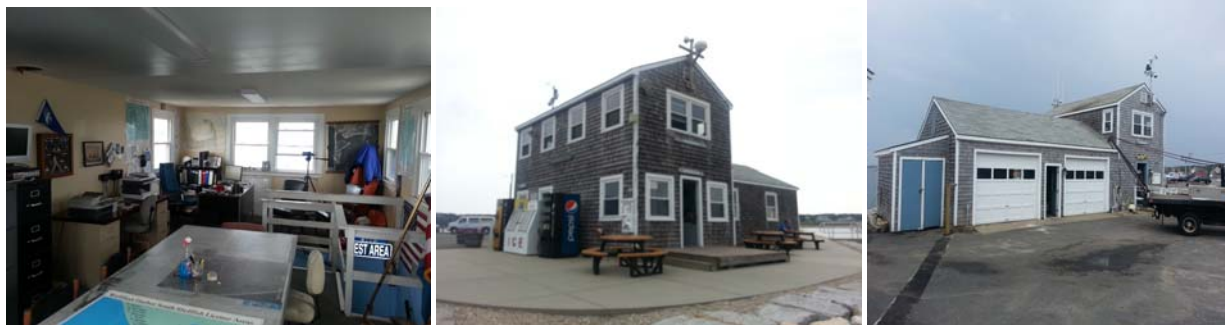
The building consists of a two story office space with a two stall attached garage. It is a wood framed structure with weathered white cedar shingle siding, painted wood trim and asphalt single roof. The two story portion of the building has approximately 390 square feet of area with eight feet ceiling height per floor. The garage portion of the building has approximately 400 square feet of area with nine feet ceiling height, and attached to the east end of the garage is a small storage shed approximately 90 square feet. The total building area is 1270 square feet. The ground floor is concrete slab on grade, and the foundation is CMU. There is an existing concrete ramp from grade to the first floor office main entrance door. The exterior doors are wood panel the windows are vinyl replacement double hung. The structure is not served by plumbing. The function of the Harbormaster appears to be met in this building.

The exterior envelope of the building requires replacement. Wood shingles are cupping worn and beginning to break due to age. The lack of gutters and down spouts is causing excessive wear at roof wall intersections and premature aging of wall and roof finishes. The roof shingles are past their useful life and should be replaced immediately. Stained ceiling plaster on the second floor above the stair is indicative of a roof leak and should be removed and replaced immediately to further prevent damage. The windows have recently been replaced with vinyl, however are set in the existing frames which are damaged and potentially allowing water to penetrate the system. The overhead garage doors appear to be in functional condition. The exterior access ramp does not comply with accessibility standards as the railing is not sufficiently anchored and the landing is too small. The slope of the ramp was not confirmed. The interior finishes appear to be serviceable.

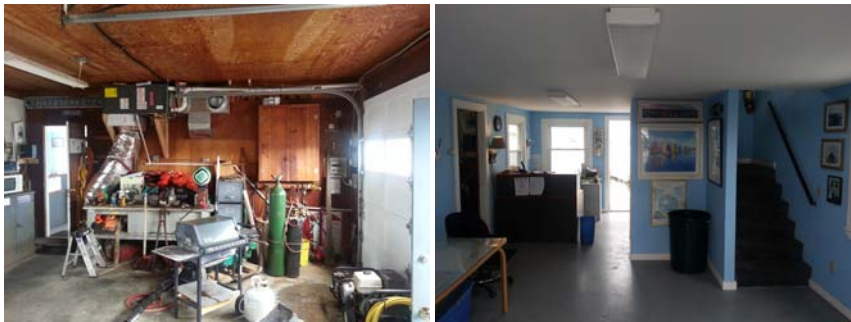
The building is a wood frame structure with conventional stick built walls and roof and a concrete slab on the ground floor. The roof structure in the office was not accessible, but judging from the rest of the building, presumed to be conventional wood frame construction. The foundation is CMU.

The building sets close to the grade, with less than two inches clearance to the adjacent grade in some areas. A concrete ramp leads up to the Harbormaster's reception area, which then steps down to the garage floor slab. The roof in the garage area is field built roof trusses spanning the short building directions. The roof rafters are not secured to the wall plate with hurricane straps or hardware required by current standards for buildings in coastal high wind areas. Framing augmentation will likely be required to meet current high wind load standards.

The exterior handicap ramp is in fair condition, however the railings are not well constructed or anchored to concrete base.

There are no major structural repairs required for this building at this time, however, the exterior handicap ramp rails needs to replace with new materials solidly attached to the structure. The garage roof structure should be augmented to secure field built truss connections.

Long term recommendation to improve the building's resistance to high wind forces includes installation of metal hurricane ties and anchors at roof framing members. In order to be effective, the hurricane ties need to be installed to anchor each roof rafter through the double plate and into the exterior stud wall framing. As this cannot be easily done from inside the roof attic, it is recommended that this be done when the exterior siding is replaced.

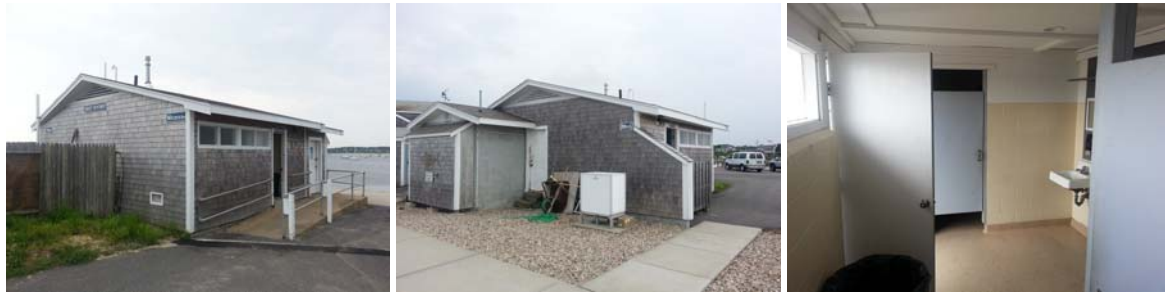
The building is one story. The floor area is approximately 490 square feet with separate men's and women's restroom facilities which are not handicapped accessible, and a unisex accessible restroom. The unisex accessible toilet room addition to the south of the main building was not inspected during this visit as the door was locked. Based on the exterior dimensions and previous study plans the room is not accessible. Further the ramp and landings are not accessible. The facility serves as the public and staff toilets for the marina based town departments.

Construction is wood strapped CMU exterior walls with weathered white cedar shingle siding, painted wood trim. The roof is wood framed with asphalt shingles. The floor is concrete slab on grade, and the foundation is CMU. There is an existing concrete ramp from grade to the unisex restroom. The exterior doors are metal and the windows are fixed wood sash.

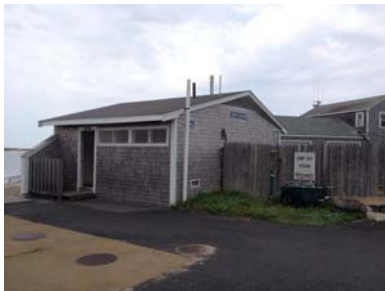
The existing building is a one story, public restroom building, approximately 490 sq ft, with separate men's and women's facilities on either side of the building. The building has concrete block walls and a wood frame roof; the ground floor is a slab on grade within a concrete masonry unit (CMU) foundation.

The roof structure was not fully accessible, however, from a small hole in the ceiling, it was determined that the structure was 2x wood frame. The exterior of the building is traditional white cedar shingles and pine trim on furring strips attached to the CMU wall structure. Exterior building roof lines appear plumb and true, and with except for a slight sag in the roof overhang, there was no apparent sign of excessive deflection or sagging in the roof structure. The existing roof structure should be adequate to sustain new roofing at the time of replacement, provided the old roofing materials are removed. The building sets close to the grade, with less than four inch clearance to the adjacent grade. A small platform landing that steps to the bathroom entrance door is in poor condition.

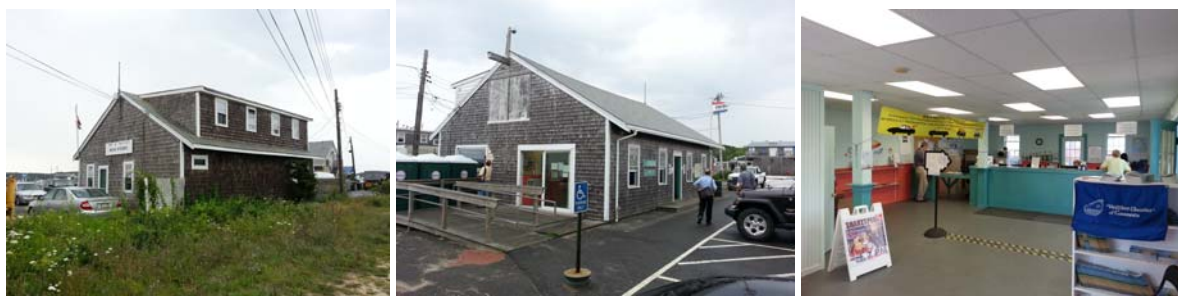
The building is one story wood framed structure with weathered white cedar shingle siding, painted wood trim and asphalt single roof. The ground floor has approximately 1,200 square feet of area with eight feet ceiling height. The main space on the ground floor is used for beach sticker sales and public information center, with a small private office currently used by shellfish operations. The remaining space is used for storage and a single user employee toilet area. There is an unfinished attic storage space with a full shed dormer spanning the entire ground floor accessible by a pull-down ladder in the storage area, and an exterior gable end door with a hoist beam. The ground floor is concrete slab on grade, and the foundation is CMU. There is an attached wood framed deck at existing floor level with a ramp at the south end of the building which provides handicapped access to the ground floor at the existing glass sliding door. The exterior doors are wood panel the windows are wood double hung and awnings. The structure appears to be in poor condition.

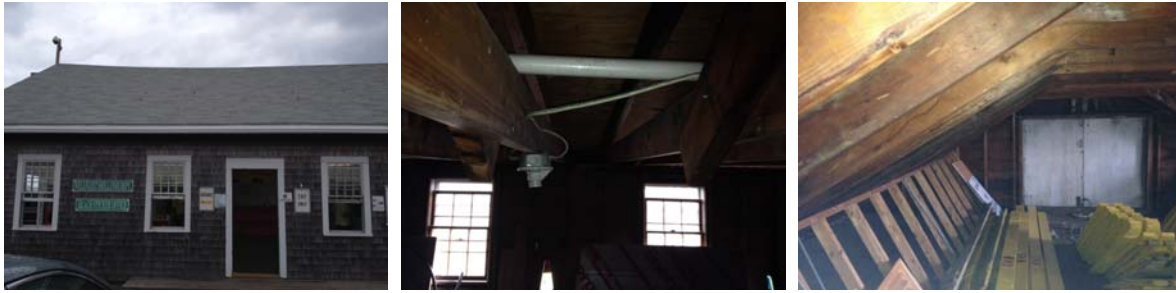
The building is a one story building, approximately 1,200 sq. ft. The structure is a wood frame structure with conventional stick built walls and roof, with a concrete slab on the ground floor. The foundation is CMU. The roof is a simple gable with a full dormer and continuous center ridge running the length of the building. Roof framing consists of 2x6 rafters and 2x6 ceiling joist spaced @ 16" on center on both sides of the sloped roof. The ceiling joists at the dormer section are cut into the interrupted rafter on the back side roof slope, forming a weak link in the framing. As a result, the roof ridge has a noticeable sag in the exterior roof line. Attempt has been made to remedy the situation as evident by a short 2x4 knee wall installed to prop up the front building sloping rafters. Roof rafters bear on a double plate in the exterior wall. It was noted that no hurricane ties were installed at any of the rafters. Ceiling joist above the main floor are supported on a continuous girder that bears on center bearing posts equally spaced at about thirteen foot centers inside the building.

As a result of the deficient framing described above, the exterior building lines appear uneven with obvious signs of deflection in the roofing. Walls are assumed to be 2x4 wall construction as evident by the generally shallow depth sills observed in the door and window frames. The exterior porch deck outside the living room is of marginal construction; the framing sits close to the ground with loose laid concrete block used to support the deck rail posts. The support posts are not anchored to the foundation and the ledger board supporting the deck joist is not properly connected to the building frame.

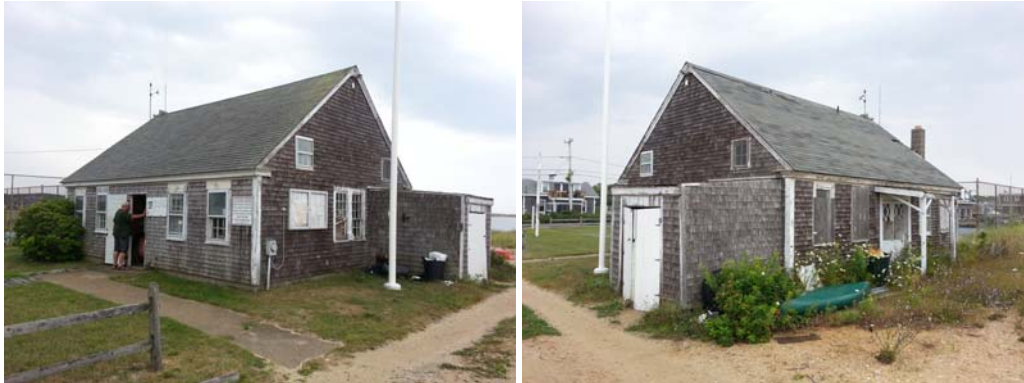
The building is one and a half story wood framed structure with weathered white cedar shingle siding and painted wood trim and asphalt single roof. The ground floor has approximately 730 square feet of area with eight feet ceiling height, and there is an unfinished attic space spanning the entire ground floor with usable floor space limited by the roof line. The ground floor is concrete slab on grade, and the foundation is CMU. There is an attached storage shed on the west side, and a wood framed awning over the rear door. The exterior doors are wood panel, and the windows are wood double hung. The building as a whole is in very poor condition and was recently condemned due to mold.
