This analysis reviews the existing Police Station in Wellfleet, MA, with regard to the Massachusetts State Building Codes (“Code”) for new construction. The 8<sup>th</sup> Edition consists, in part, of the 2009 International Building Code (IBC) and the 2009 International Existing Building Code (IEBC) with Massachusetts Amendments to these codes.

**STRUCTURAL EXISTING CONDITIONS ASSESSMENT**

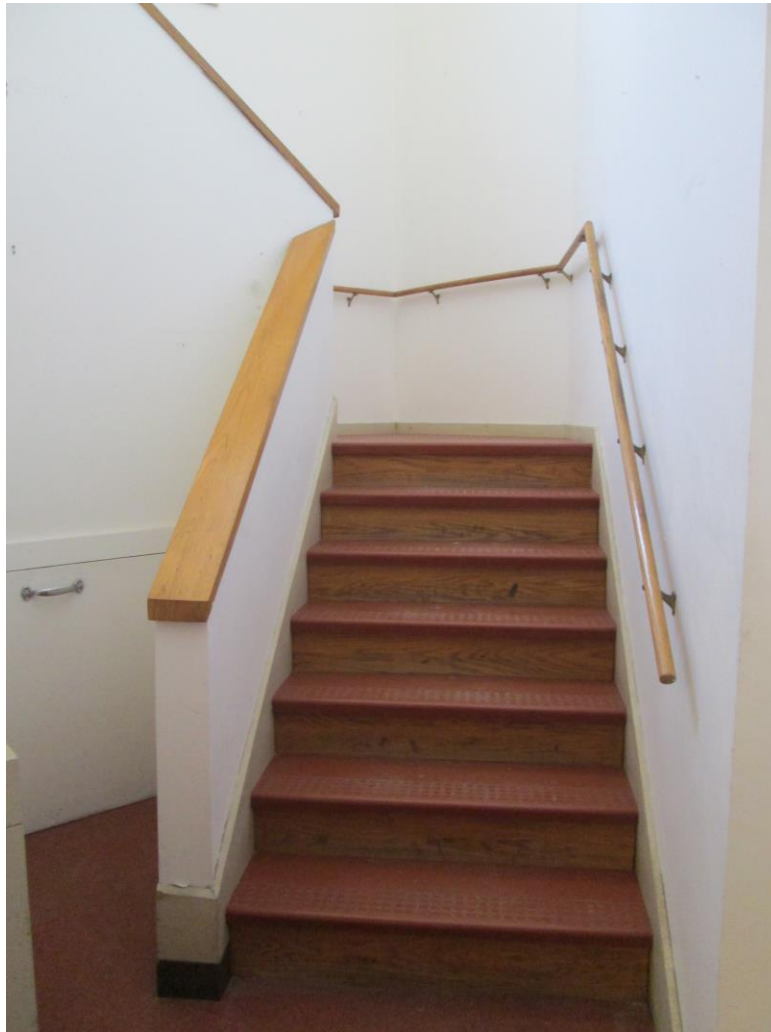
Stair nosings are required to be angled or radiused and not abrupt. Existing wood stair nosings at the connecting stair between the Garage Level and the First Floor have a protruding lip at each tread.

- The stair treads need to be modified to comply. Modification of the treads with tread covers is necessary to reduce the abrupt nosing.

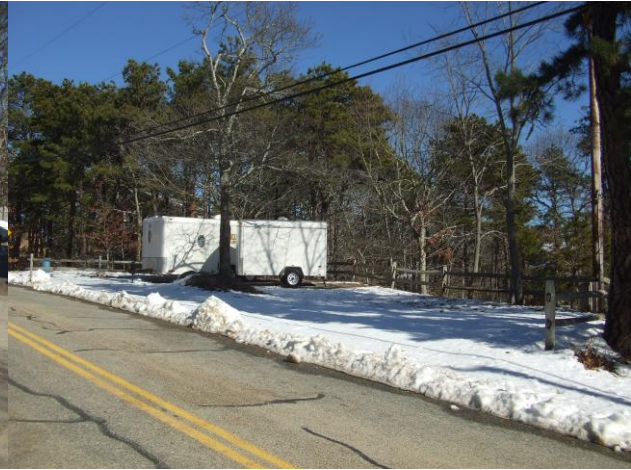
*Upper parking area and trailers*

At the time of the site visit, this upper parking lot had two trailers located there, one for emergency services.

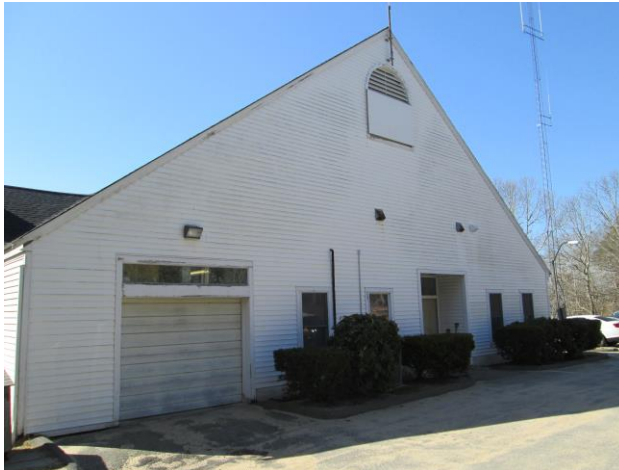
*Sally port and employee entrance*

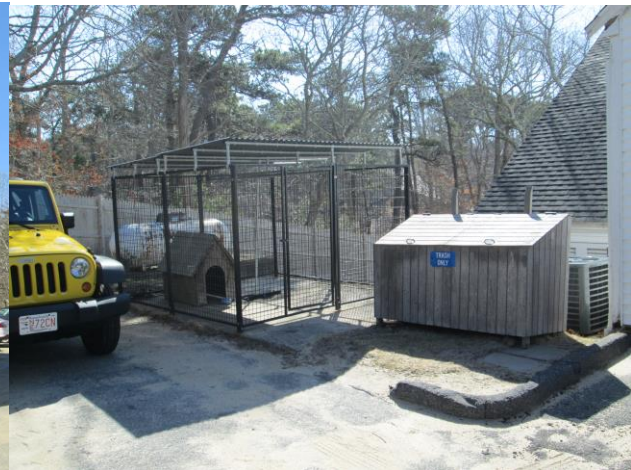
*Kennel and trash bin*

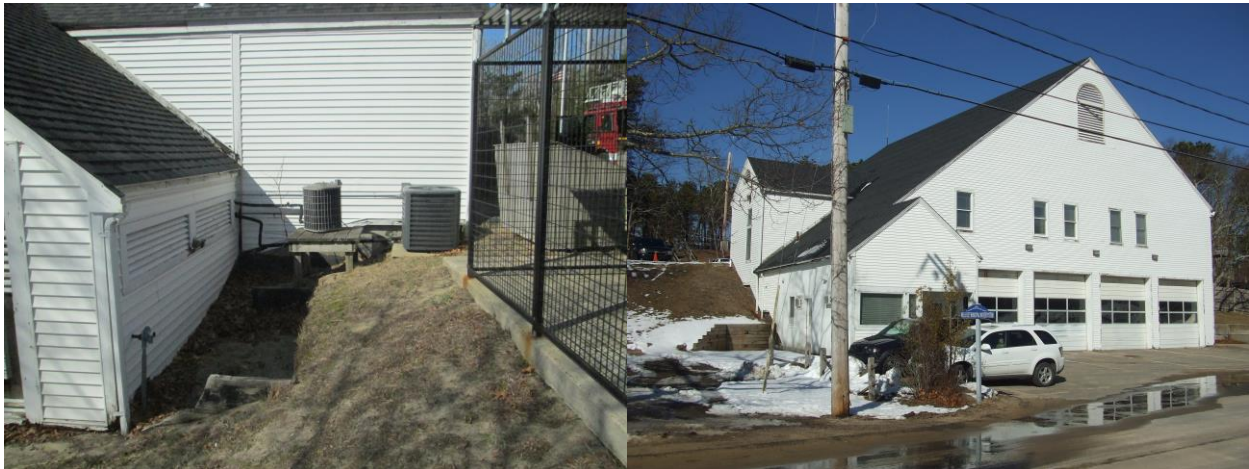
South side of building,

Drainage problem area

The condition of the asphalt is fair, with the only curbing being asphalt, located on the building side of the Police lot. Underground drainage on the site is minimal. There are several locations on the north side of the building where drainage is directed against the foundation. The south side of the building has positive drainage away from the building to Lawrence Road, where some ponding was noted.

- Improve drainage with new leaching pits and CB's
- Replace asphalt and curbing (granite curbing preferable)
- Provide ADA accessible entrances, new signage and improved and compliant striping
- Improve exterior connections between levels on the site. New stairs and railings to upper lot and to lower lot.
- Repair all split rail fencing.
- Provide improved signage for visitor parking, cruiser parking (straighten signs).
- Improve flat areas that appear to be used for parking. Gravel base or install impediments to prevent their use as parking spaces.

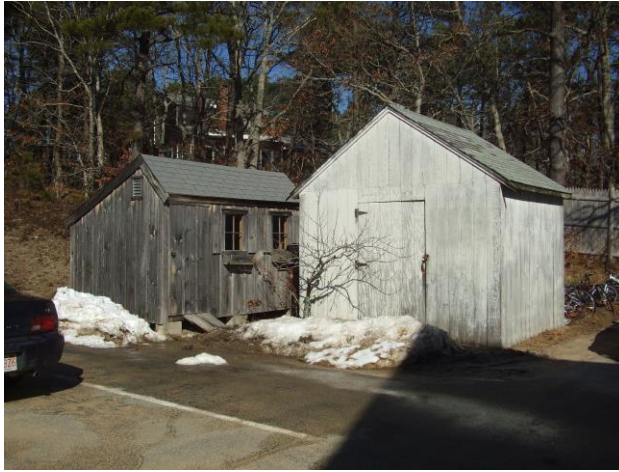
Storage space on the site consists of the two sheds (8 x 10 & 10 x 12). Lost and recuperated bicycles are simply piled outside of the sheds, exposed to the elements.

Storage Sheds

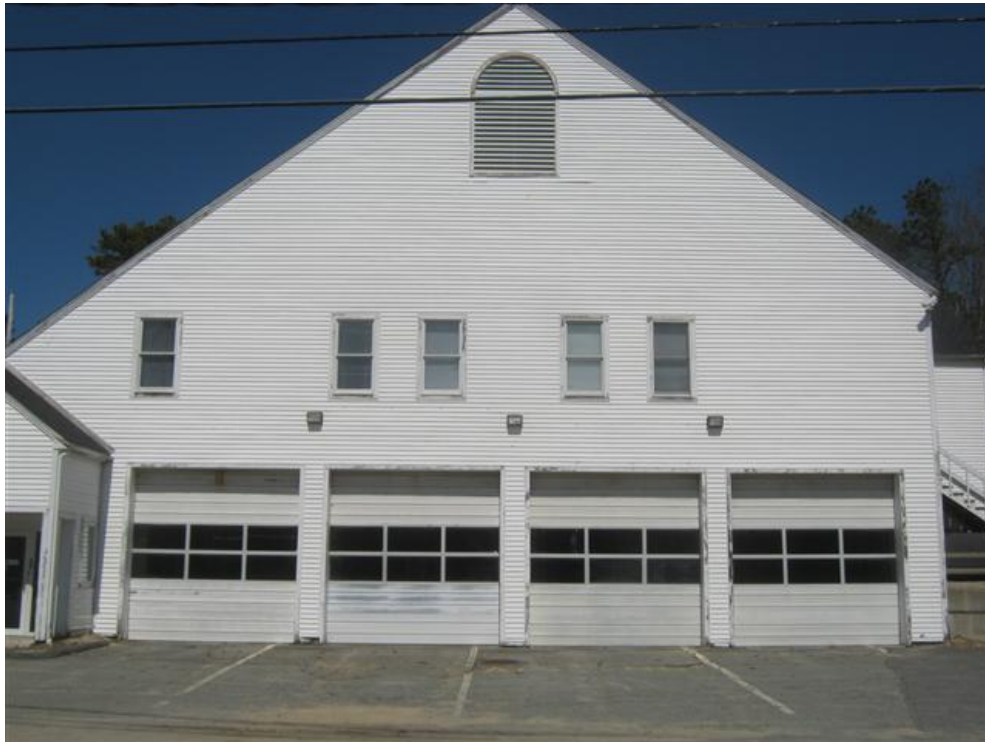
**South face of Police Facility including former Fire Department apparatus bays**

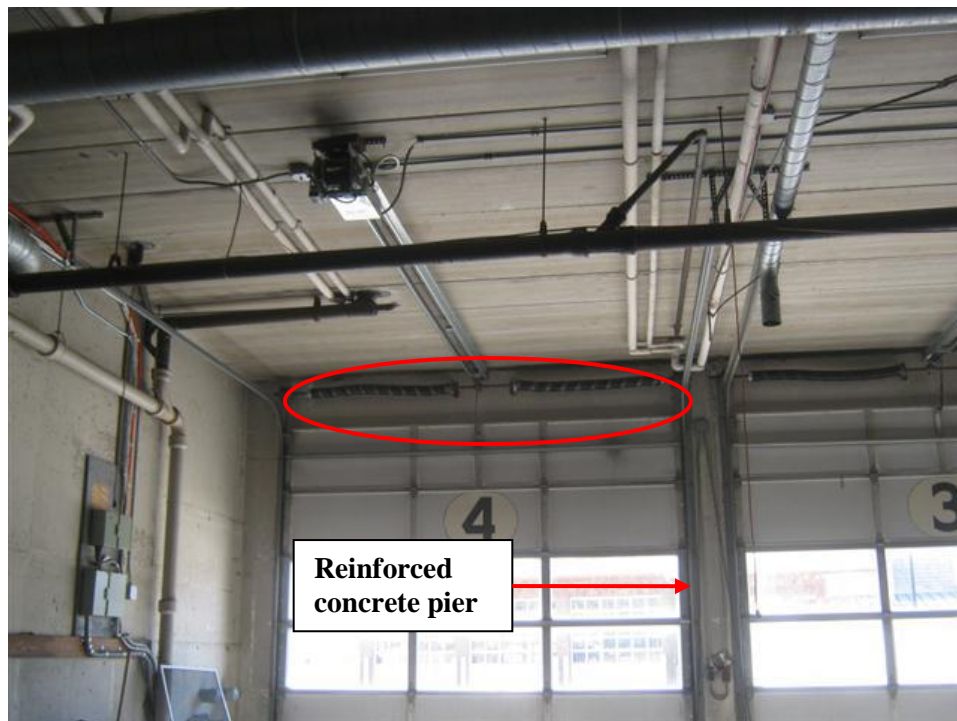
**Concrete beams spanning the overhead door openings**

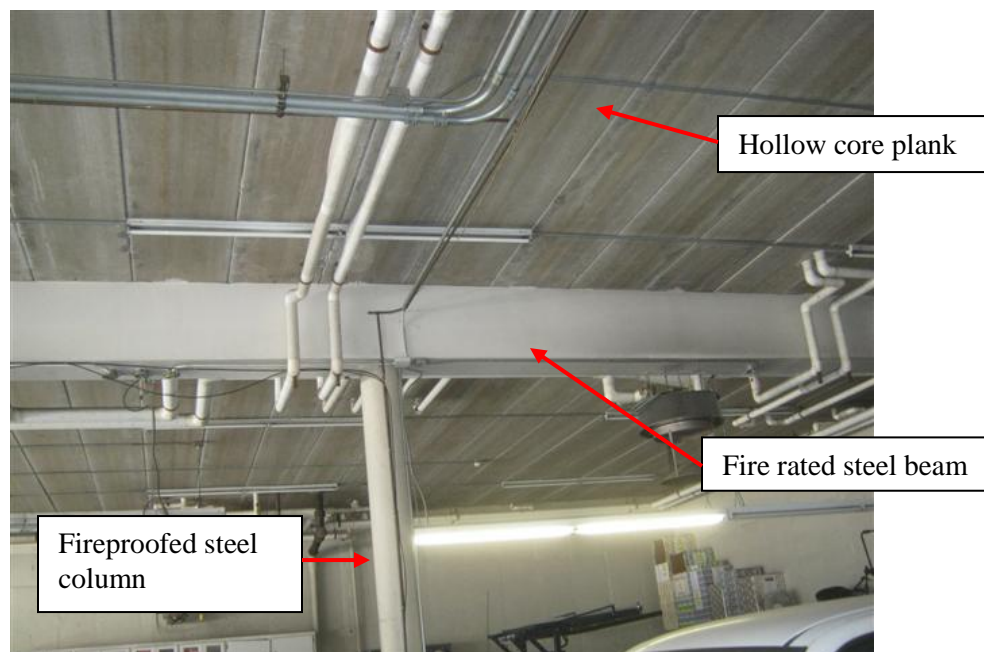
**Main floor structural framing as seen from the lower level**

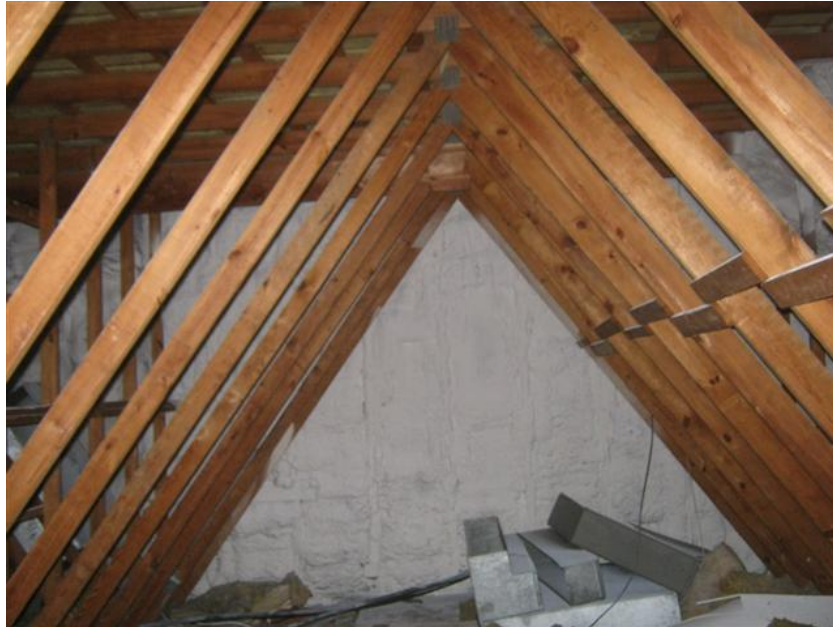
**Typical wood roof truss**

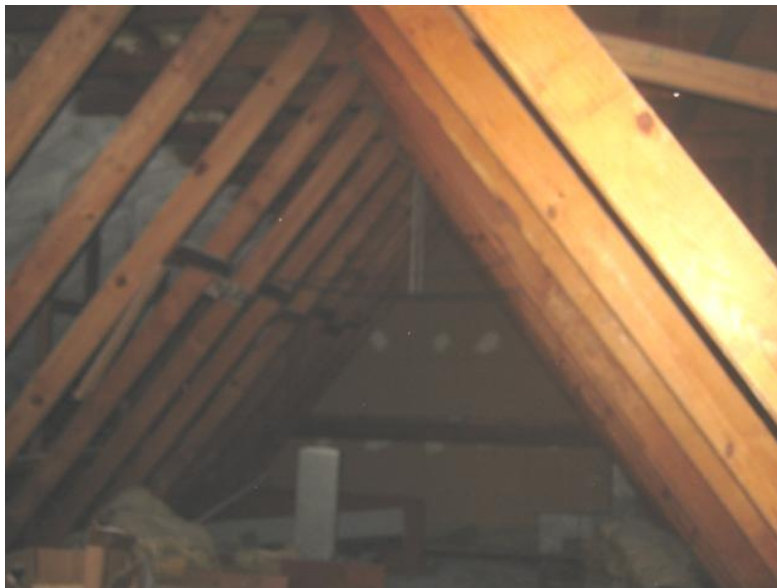
### **West gable roof trusses**

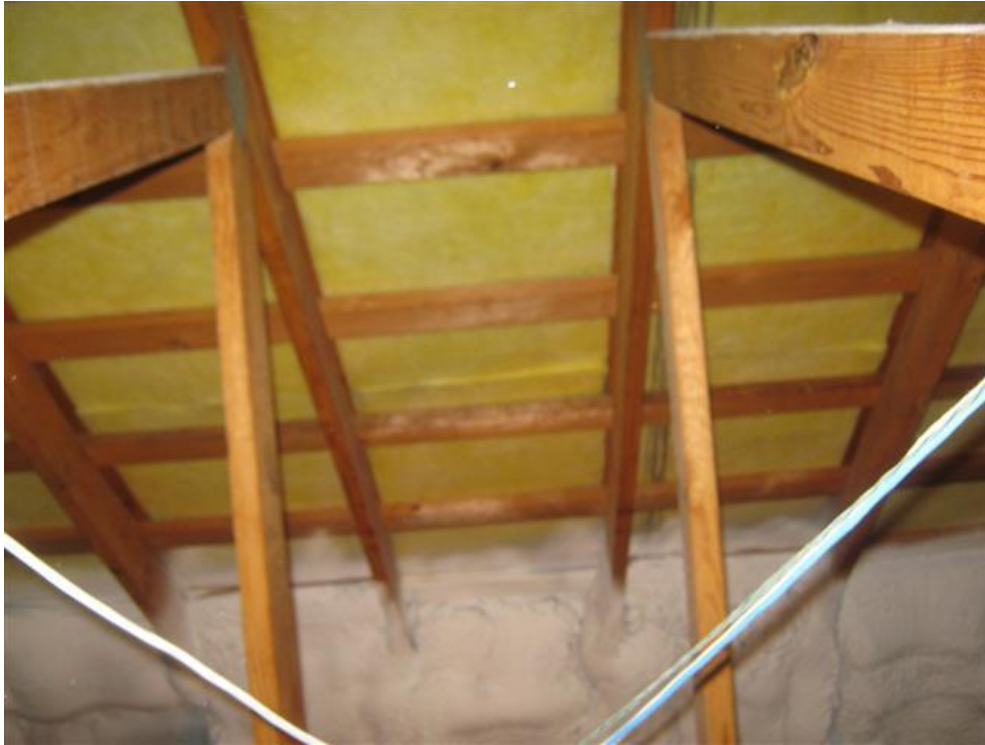
**Wood blocking at top chord of main trusses for support of piggyback trusses above**

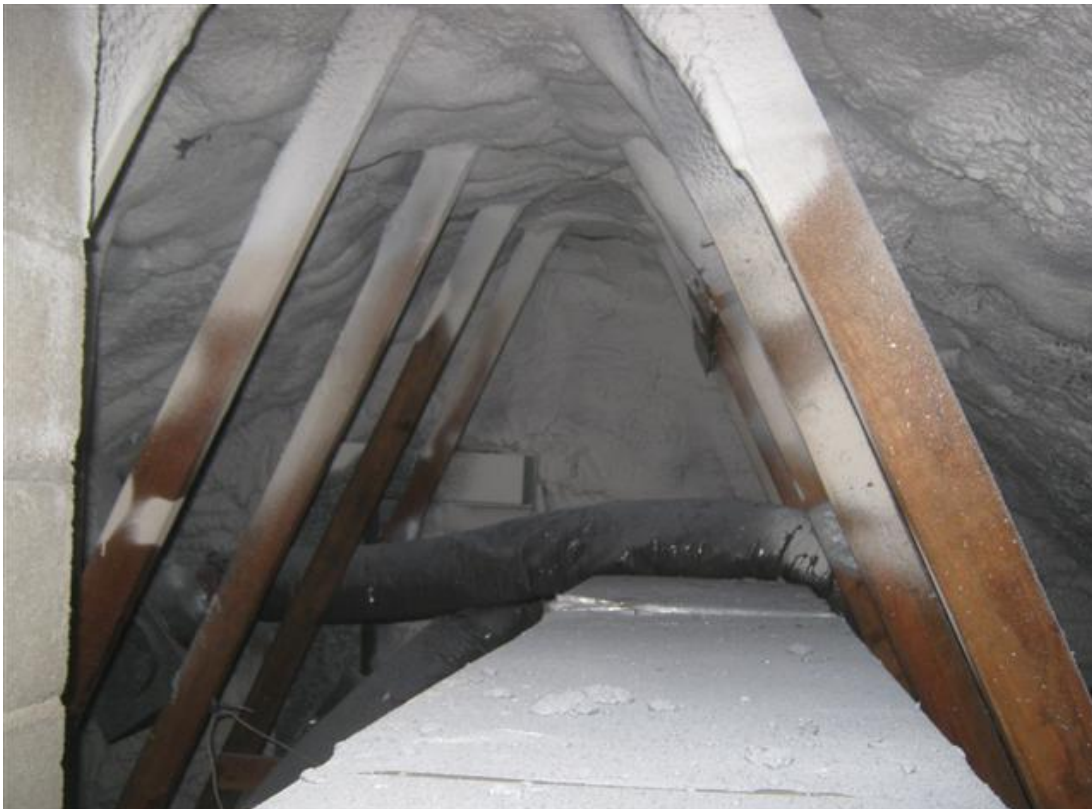
- The only area that was concealed from view was the underside of the plywood roof deck especially above the main trusses. Sprayed on insulation that has adhered to the underside of the plywood decking that was attached to the main trusses covered the surface of the plywood so that the condition of the plywood could not be observed. The condition of the plywood roof deck that is attached to the piggyback trusses was completely obscured do to insulation boards that were secured to the wood blocking that is located on top of the main trusses. Therefore, the roof deck was not evaluated for possible structural damage.

**Close up of sprayed on insulation which conceals underside of roof deck sheathing**

- Remove portions of the insulation in the attic to allow for access to the view the exposed roof deck. Any damage observed will be documented and evaluated for the extent of damage as well as repair recommendations.
- Remove portions of the damaged trim to expose the exterior sheathing for evaluation of possible damage and deterioration of the sheathing. Similar investigation of the condition of sheathing in the vicinity of the overflowing and failing gutters.
- Install gauges on two walls with cracks and movement to record any further movement.

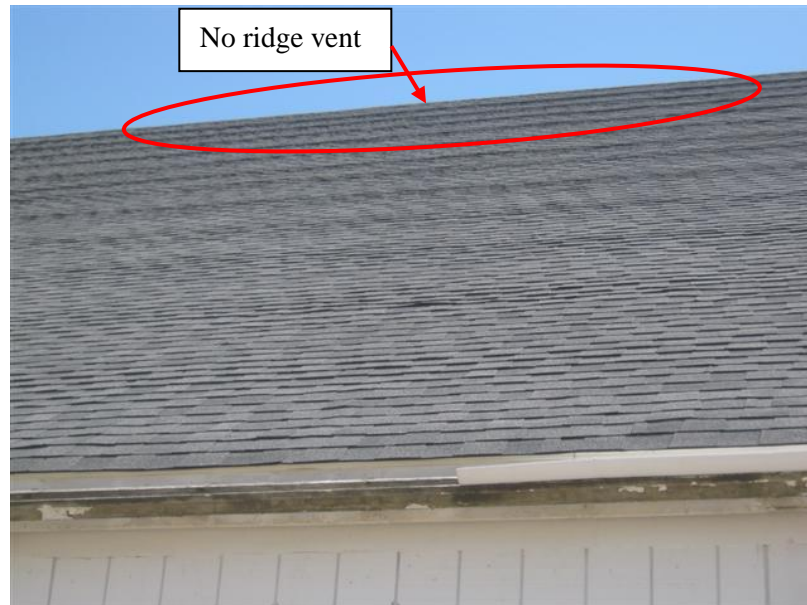
The existing construction does provide a detail for ventilation at the eaves with a gap behind the fascia board. This gap is protected by an insect screen but this has been damaged over time and this gap is now mostly unprotected from infiltration by insects or vermin. Spray foam attic insulation installed in 2010 completely infills the space between the roof rafters from eave to ridge, effectively covering the eave and ridge vents and eliminating the possibility of free air flow. (Refer to structural report)

Provision for vent at  
eaves blocked by  
spray foam attic  
insulation

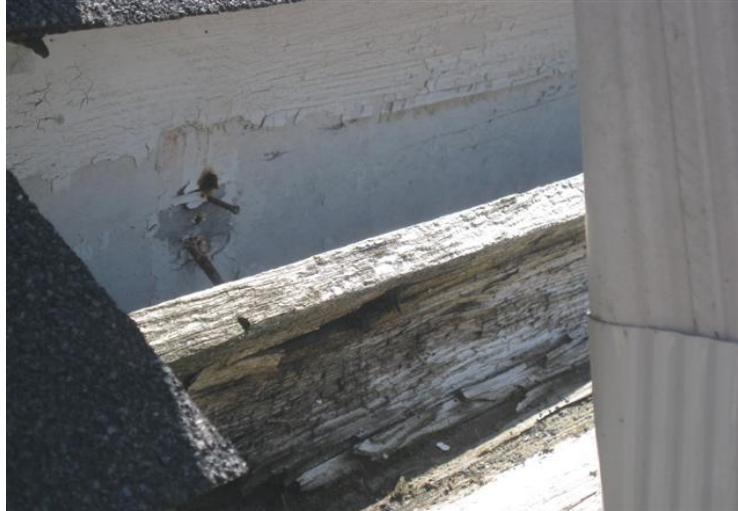
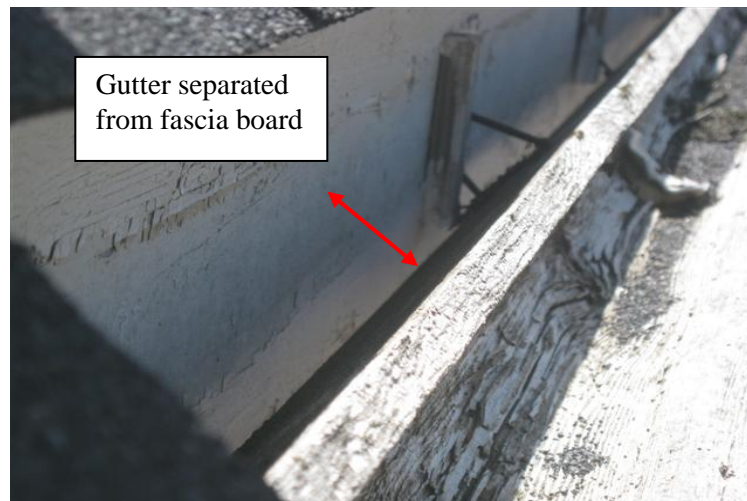
Although the re-covered shingle material on the roofs are relatively new and in good condition, the original wood gutters are in extremely poor condition. The wood is rotted and in disrepair, sections have separated from the fascia boards which also show signs of rot.

Rotted gutters

12. Install new aluminum gutters and downspouts with adequate capacity to provide continuous free flow of water to grade. Snake and clean underground storm drain system and replace all the existing wood trim with low maintenance composite white PVC trim.

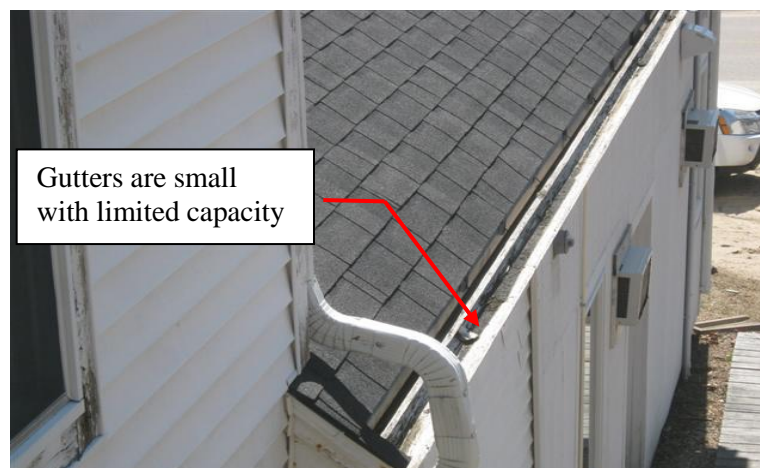
The capacity of the gutters is very limited considering the volume of water that sheds down the steep sloped roofs.

Roofs are drained through perimeter aluminum downspouts that are not connected properly to the gutters or are missing completely allowing water to flow freely to the ground level creating slippery conditions during the winter. Water flow from inadequately sized gutters and open downspouts sprays on the building face and has cause severe deterioration of the painted wood trim.

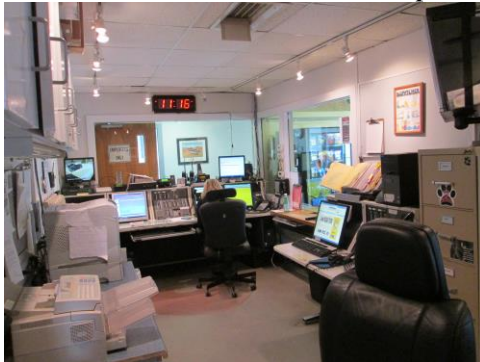
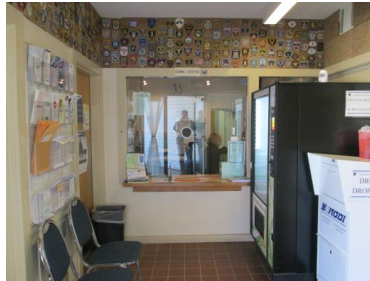
the desk that provides a view into the dispatch area from the lobby. A voice transfer grille is set into the glass, however, available documentation does not indicate if the desk or glass is bullet resistant. Also, it is unknown whether the walls or doors in the entrance lobby are bullet resistant. As the walls around the dispatch area are not fire rated or separated from the adjacent spaces, the Dispatch area does comply with the recommendations of NFPA 1221 for Emergency Centers. On the Department side of the entrance lobby, the design of the dispatch area leaves this area unsecured. Open access from the offices and corridors, sliding windows, and non-fire rated walls leave this area open and unsecure. The dispatch area is not separated from the Police Station with secure doors and fire-rated partitions and ceilings to protect the room and allow it to continue operation in an emergency situation.

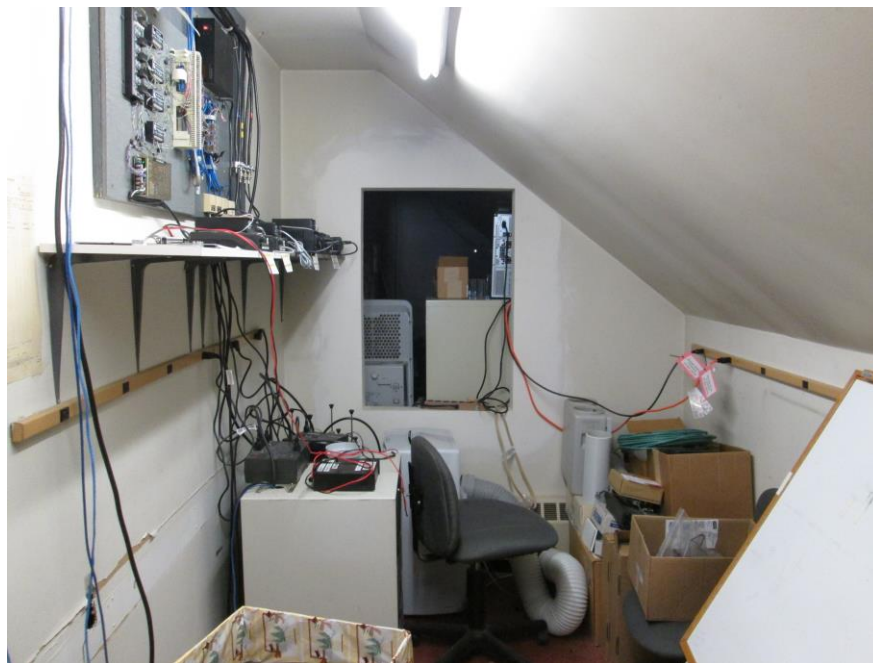
Data, recording, and 911 equipment are located in the Radio Room adjacent to the Roll Call. The enclosure around this room is not fire rated and, in the past, the roof above has leaked leaving this equipment and the dispatch capability of the town at risk. It is recommended that the data, radio, communication, and E911 be in a dedicated and secure fire-rated and cooled room. NFPA 1221 recommends that the dispatch/emergency communications center be protected with 2 hour fire-rated partitions and that the doors to this room or rooms should be fire-rated also. The recommendations stated in NFPA 1221 are intended to provide Emergency Control Centers with the optimum ability to perform in emergency situations. While doing this, these recommendations also provide guidelines for safe functioning of these centers throughout everyday operations.

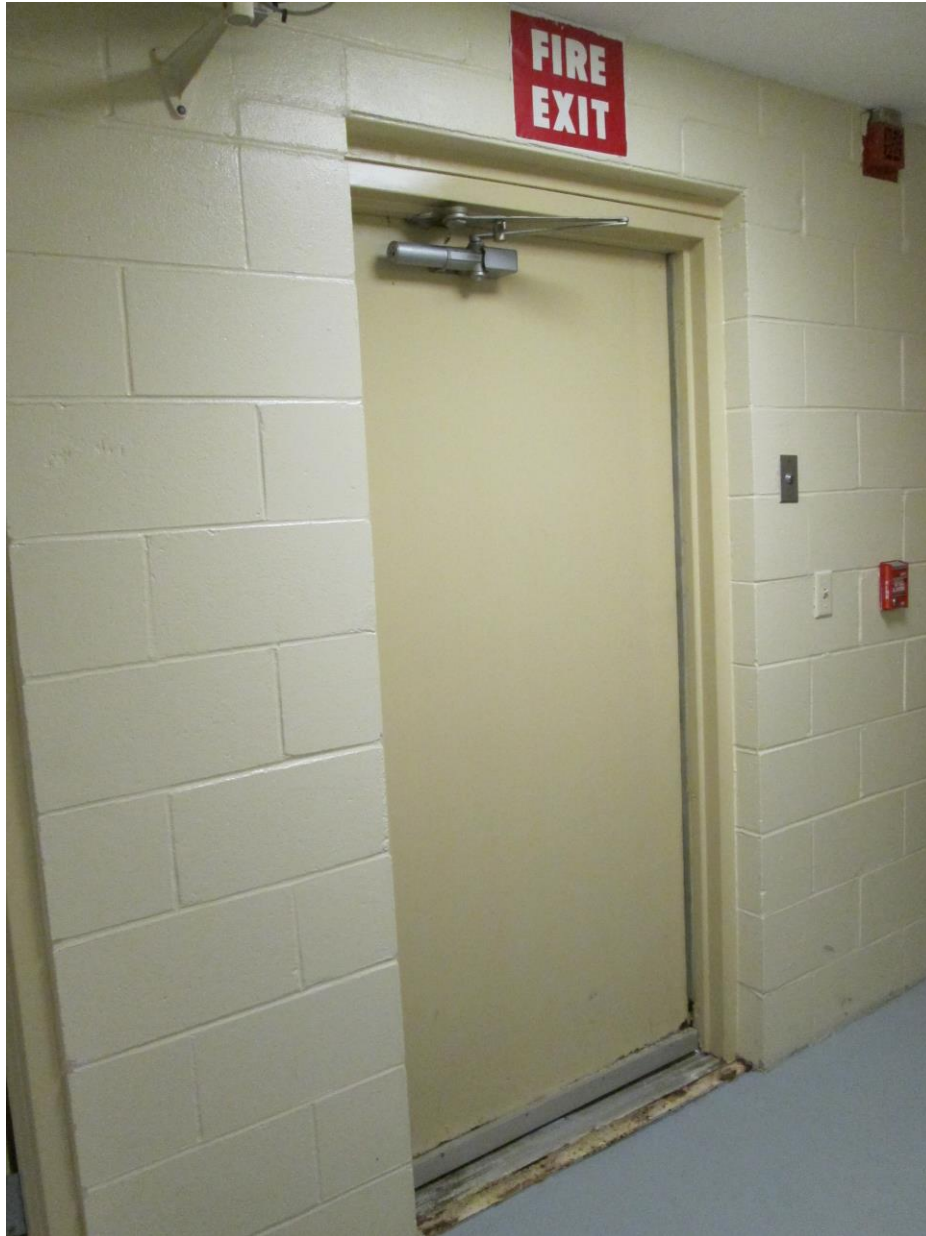
Prisoner processing and detention is accessed by a mandoor from the sallyport and from the main corridor from the entrance lobby. Egress is provided by the door to the main corridor and through an exterior door to an exterior wood stair to grade. This exterior door is noted on the original construction documents as being controlled by an electronic release and has no visible hardware, including key cylinders, on either the inside or exterior side of the door. Aside from the door not being operated with special knowledge, if the door is secure in a power outage it may not be operable in an emergency. As no mandoor exists to exit the sallyport, egress during an emergency is required to pass through the detention area. Mantraps are not provided at exit doors from the detention area.

Although all egress from the detention area is supervised, two means of egress from this area should be provided. All cell doors are electronically unlocking, the Building Code requires special egress procedures for occupied rooms in Use Group I-3 Occupancy Condition 4 (cells). Egress from cells to the exterior must be limited to passage through no more than 10 doors and must be accomplished with no more than 2 separate keys. As a worst case, all cells require exiting through 3 doors to the exterior; as access with a cell key is required, opening the remaining doors (to the cellblock, exterior stair, and main corridor) must require no more than 1 masterkey.

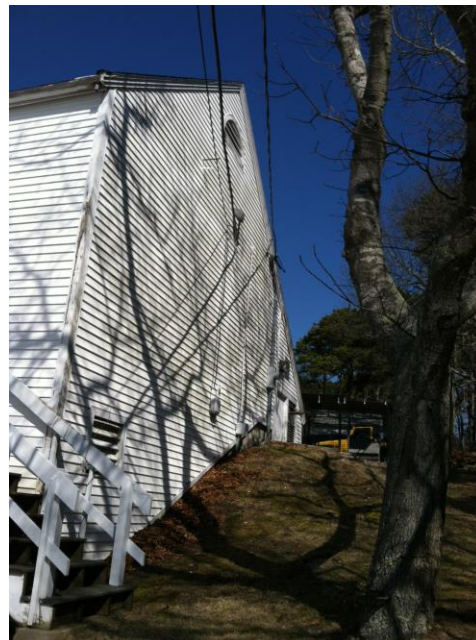
- c. Electrical
- 1) Power Distribution System:
    - a) The facility is served from three (3) 25 kVA pole mounted transformers on the garage side of the site. The service spans the pole line and drops to the building on the opposite side. The service drop is at the mid-point of the left side of the building. The service meter is located at the service drop.

Overhead service drop to building and meter socket.

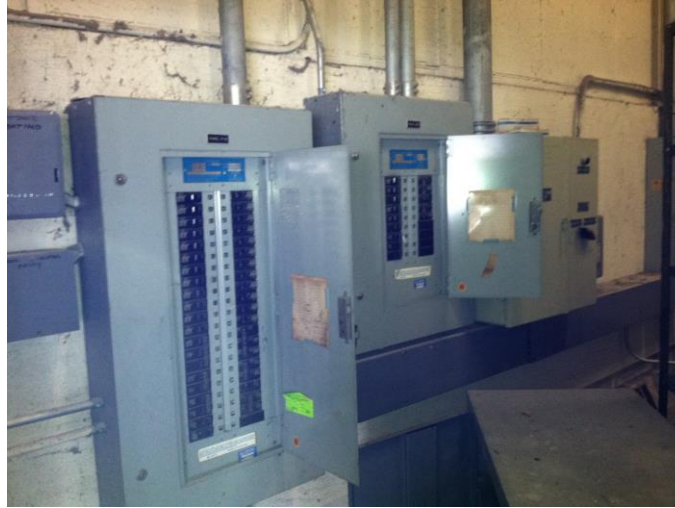
- b) The main electric service is rated 200 amps at 120/208 volts, 3 phase, 4 wire. This main switch is located in the basement utility room. It is assumed the main switch is fused at 200 amps. The main distribution panel is located in this room. The “MDP” serves panels P-1, P-1A, P-B and the Plymovent System. The original automatic transfer switch is located in this room. It appears the entire building is supported by the emergency generator.

Main Electric Service

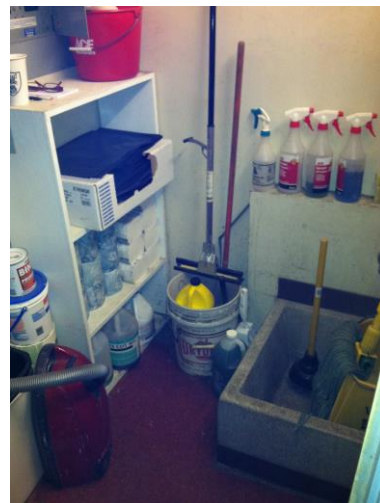
- c) Panel P-B is located in the main utility room and serves the basement electrical loads. Panels P-1, 1A are located in the janitor’s closet on the main level. It appears the Code required work space clearance is not met. The janitor mop sink encroaches on the equipment space; these panels serve all electrical loads on the main level. All electrical panels are ITE equipment, installed in 1982. Panels are in fair conditions. There are limited spaces and spares available within these panels. It was noted that there is a cold water line installed directly about the main disconnect switch. This is a Code violation.

Code required work space violation  
in front of Panels P-1, P1-A.

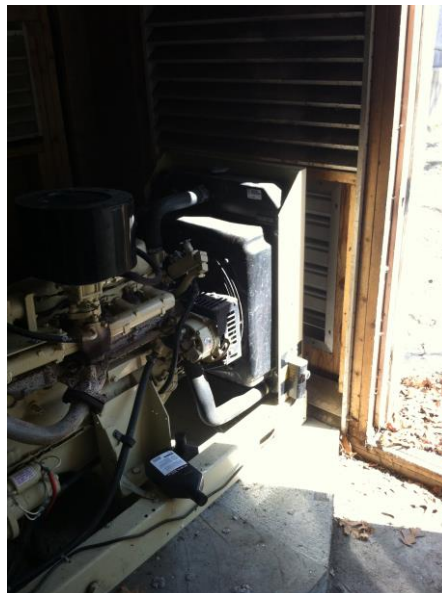
- a) The facility has 100% backup power capability via a 43 kW/54 kVA 0.8 pf Kohler generator. This unit is propane fired. The propane tank is located outside the building on the hill. The generator is located in a dedicated closet, on the left side of the building, accessed from the exterior. This generator was installed June 25, 1997 and is serviced by South Shore Generator.

Kohler Generator

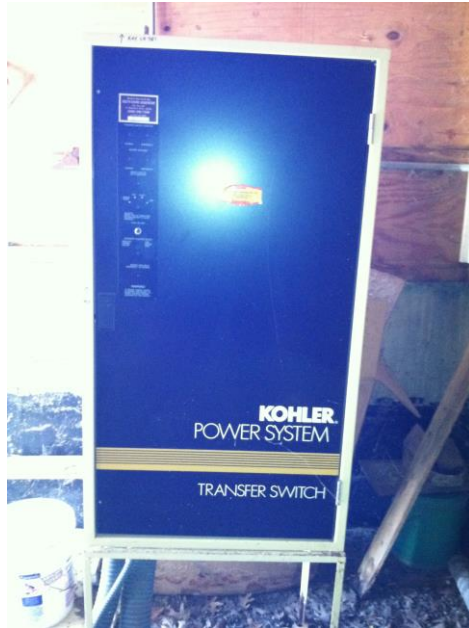
- b) The generator has a 225 amp output breaker.
- c) There is a Kohler main transfer switch located in the generator room. Unable to confirm use of two (2) ATS' in line with each other.

Kohler Main Transfer Switch

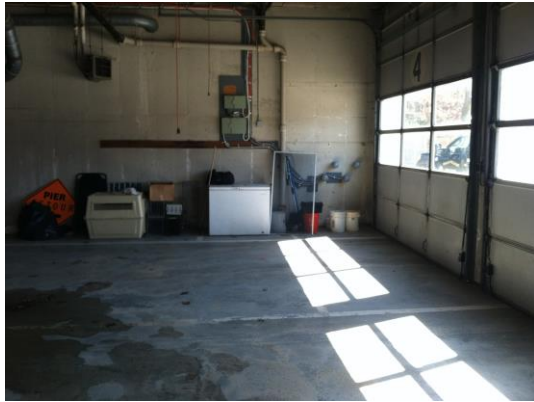
Telephone & Communication Services.  
Entrance at garage level.

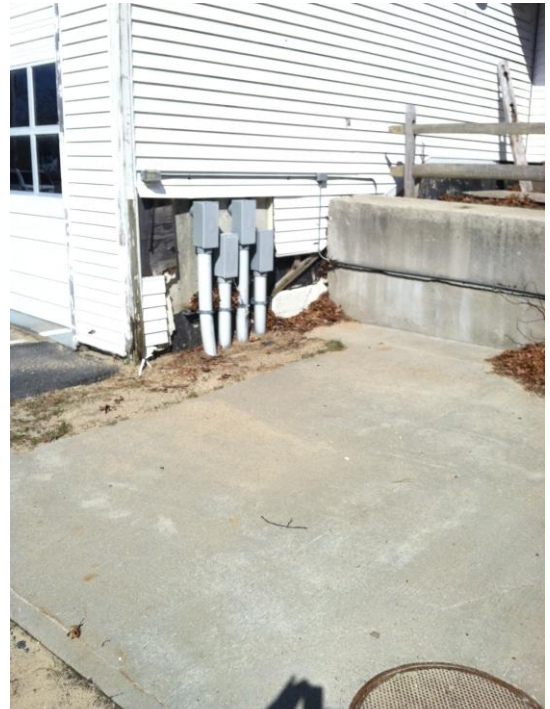
Underground conduits to fire department across street.
