Sedimentation in the Lower Herring River

Two recurring questions with respect to sedimentation:

Would restoring tidal exchange to Herring River affect:

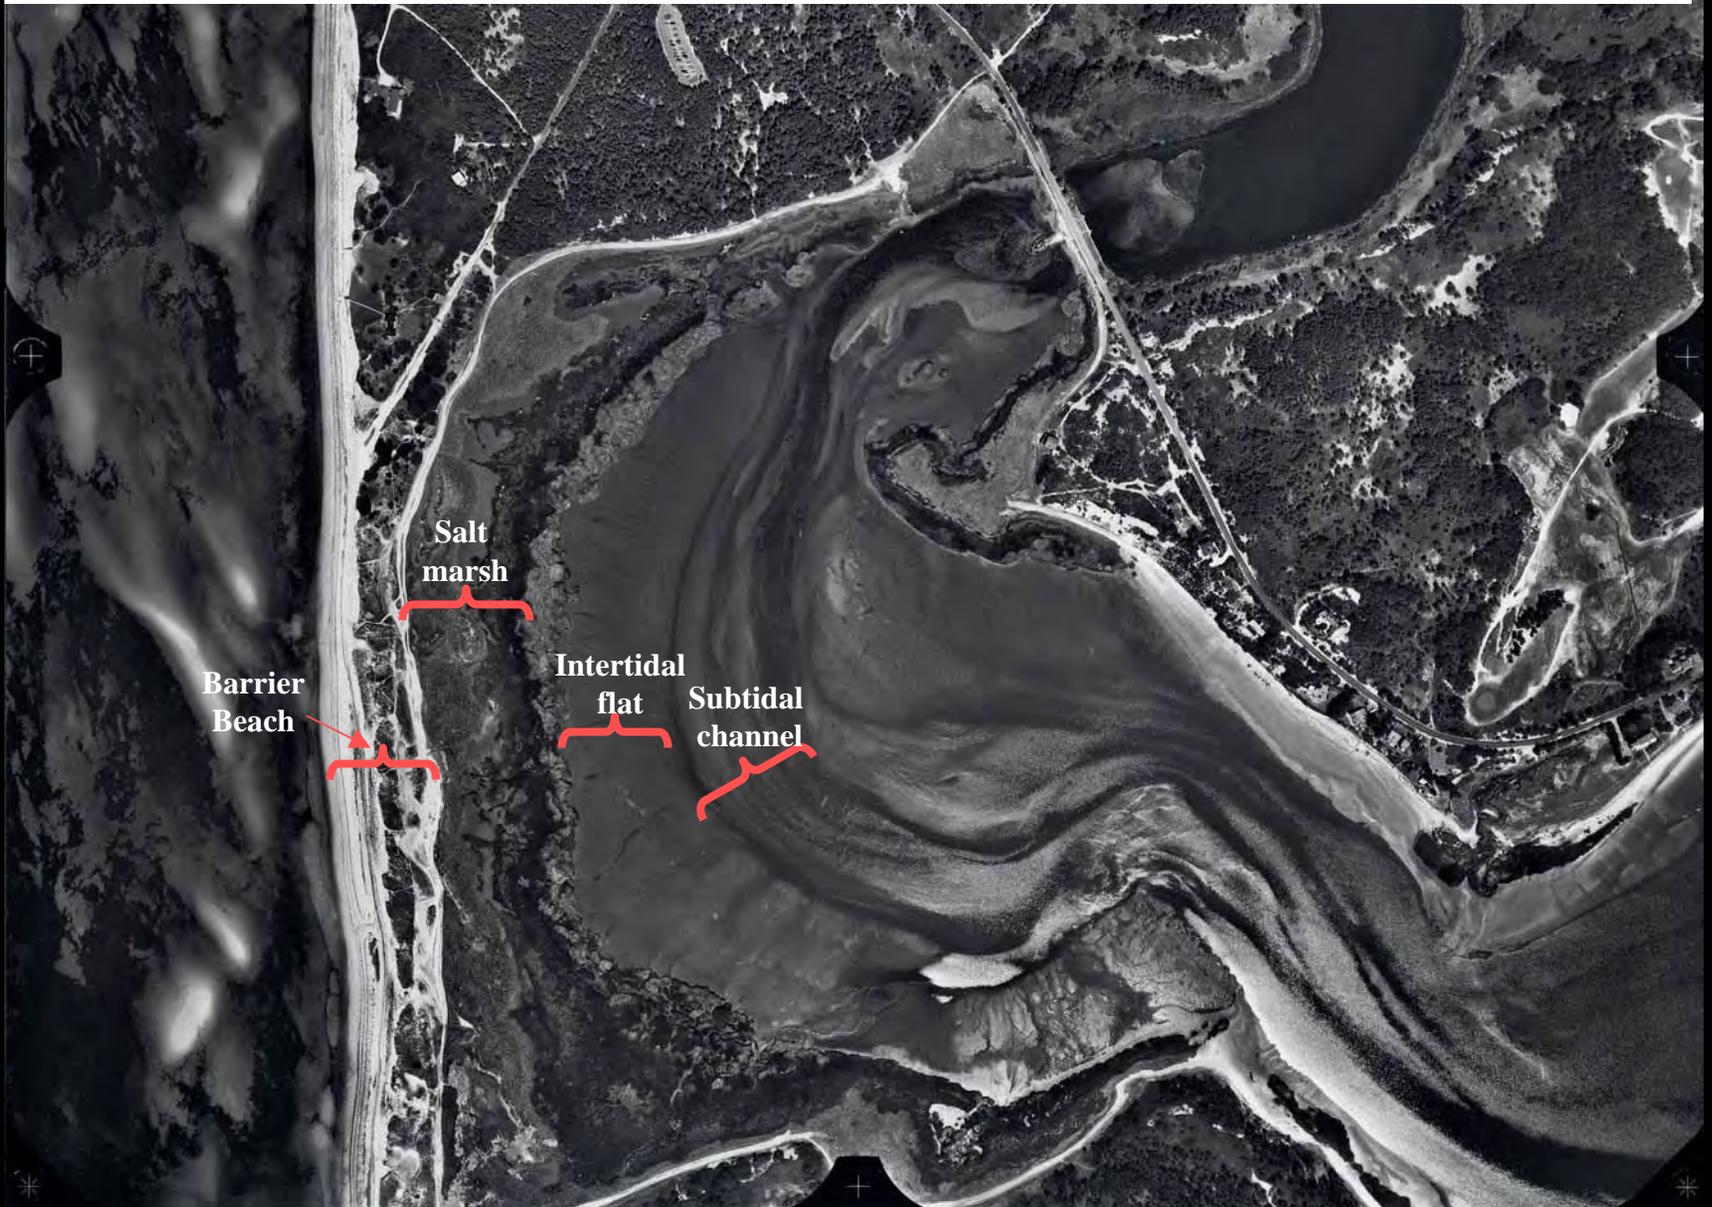
Marsh Stability: Although the barrier beach has continued to migrate eastward, the salt marsh behind it, and facing the river channel, has maintained its width for many decades.

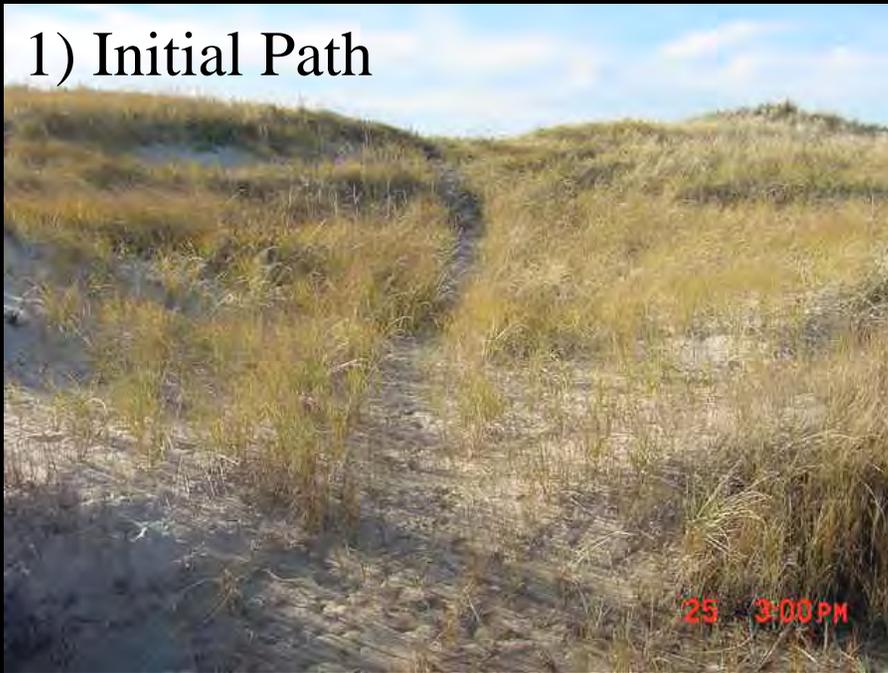
1) Initial Path

Pedestrian traffic across The Gut can destroy stabilizing vegetation and lead to the erosion of sand and overwashes.

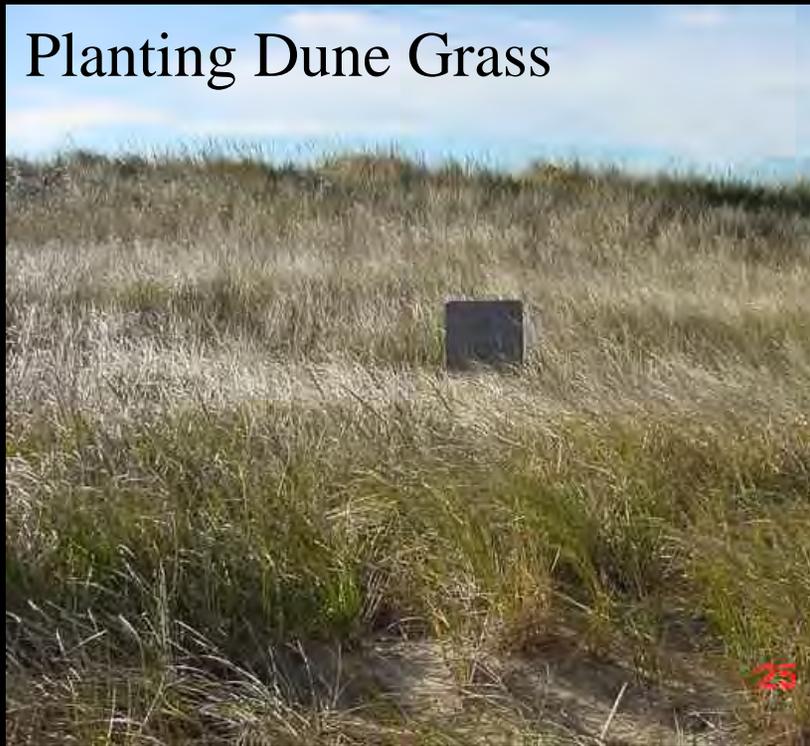
Planting Dune Grass

Dune protection by citizens, the Town and the Seashore have averted and/or repaired dune damage.

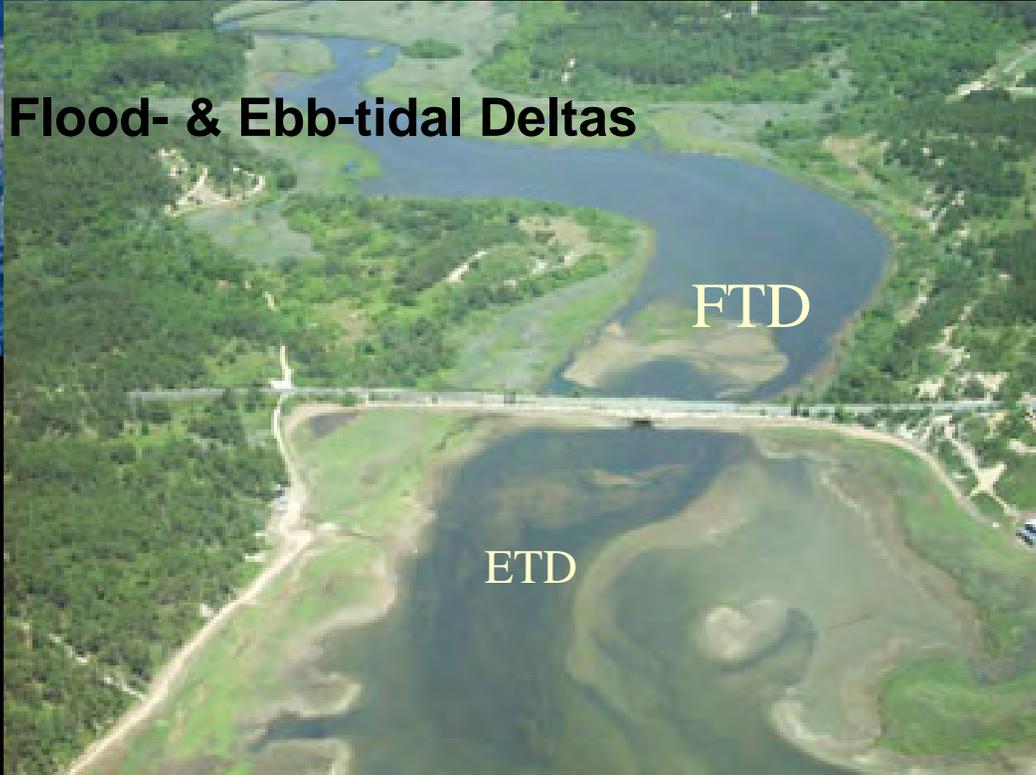
Flood- & Ebb-tidal Deltas

An aerial photograph of a coastal area with a dike. The dike runs horizontally across the middle of the image. To the north of the dike, there is a large, irregularly shaped body of water labeled 'FTD' (Flood-Tidal Delta). To the south of the dike, there is a larger, more complex body of water with several smaller channels and islands, labeled 'ETD' (Ebb-Tidal Delta). The surrounding land is green and forested.

FTD

ETD

The dike's restriction on tidal flow causes an asymmetric tidal range, with flood tide velocities much higher than ebb tides and, consequently, formation of a much more pronounced flood-tide, than ebb-tide delta.

The ebb-tide delta just seaward of the dike has been stabilized with oysters, while the floodtide delta above the structure is still forming, indicating more rapid flows..

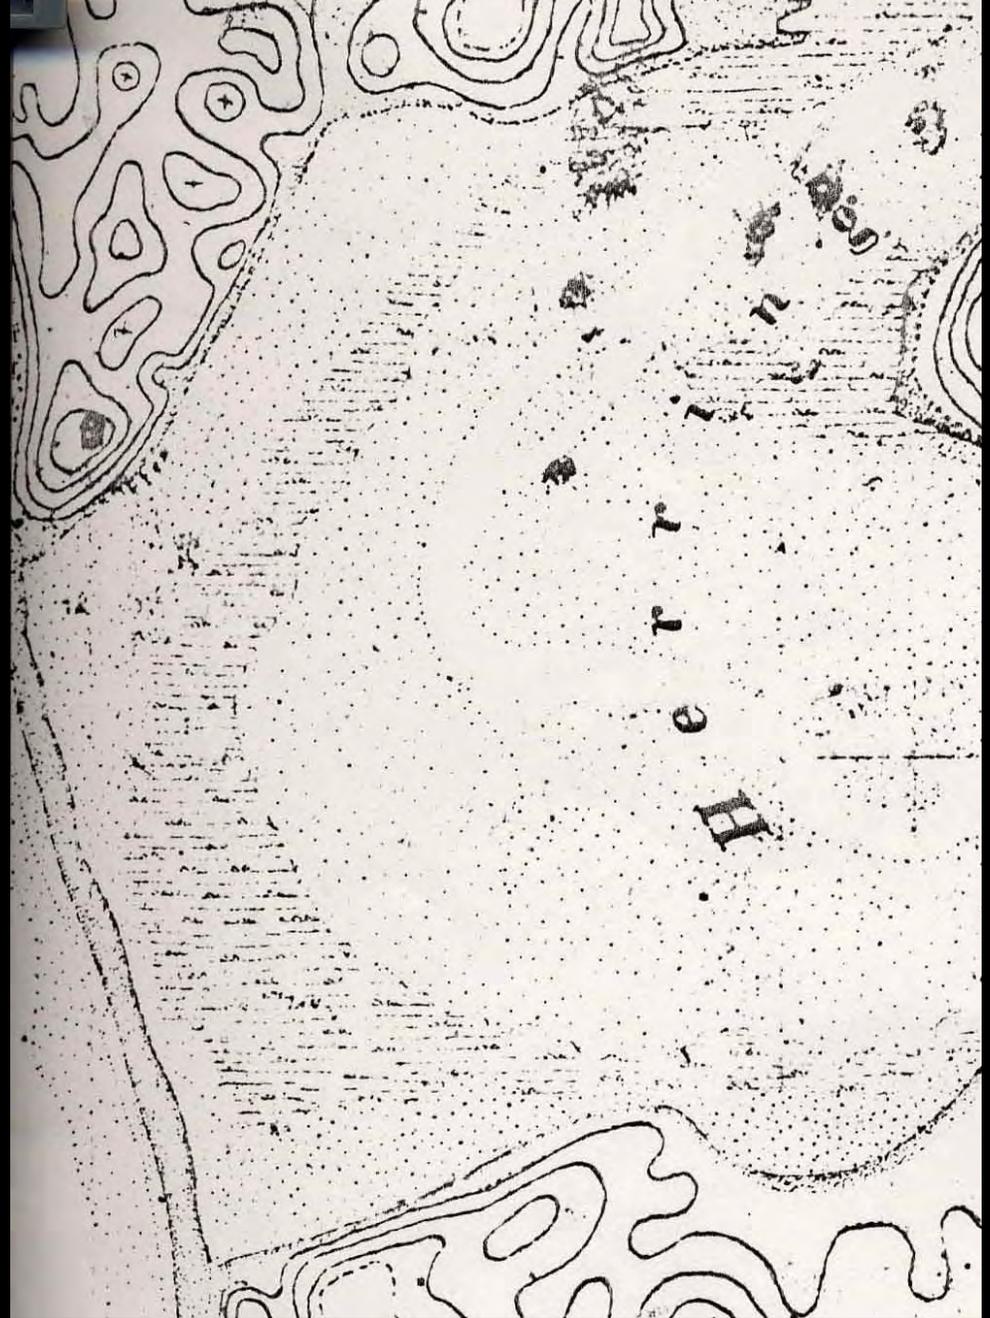
1848

The following series of historic charts and aerial photos shows that the Herring River channel below the present dike has been in the same location since at least 1848, before the dike was constructed.

Based on these maps and photos, it is clear that dike construction in 1909, dike breaching in the late 1960s and early 1970s, and dike replacement in 1974, have had little effect on the size, shape and position of the river channel, indicating that ebb velocities even with the river totally unrestricted did not affect downstream sediment movement.

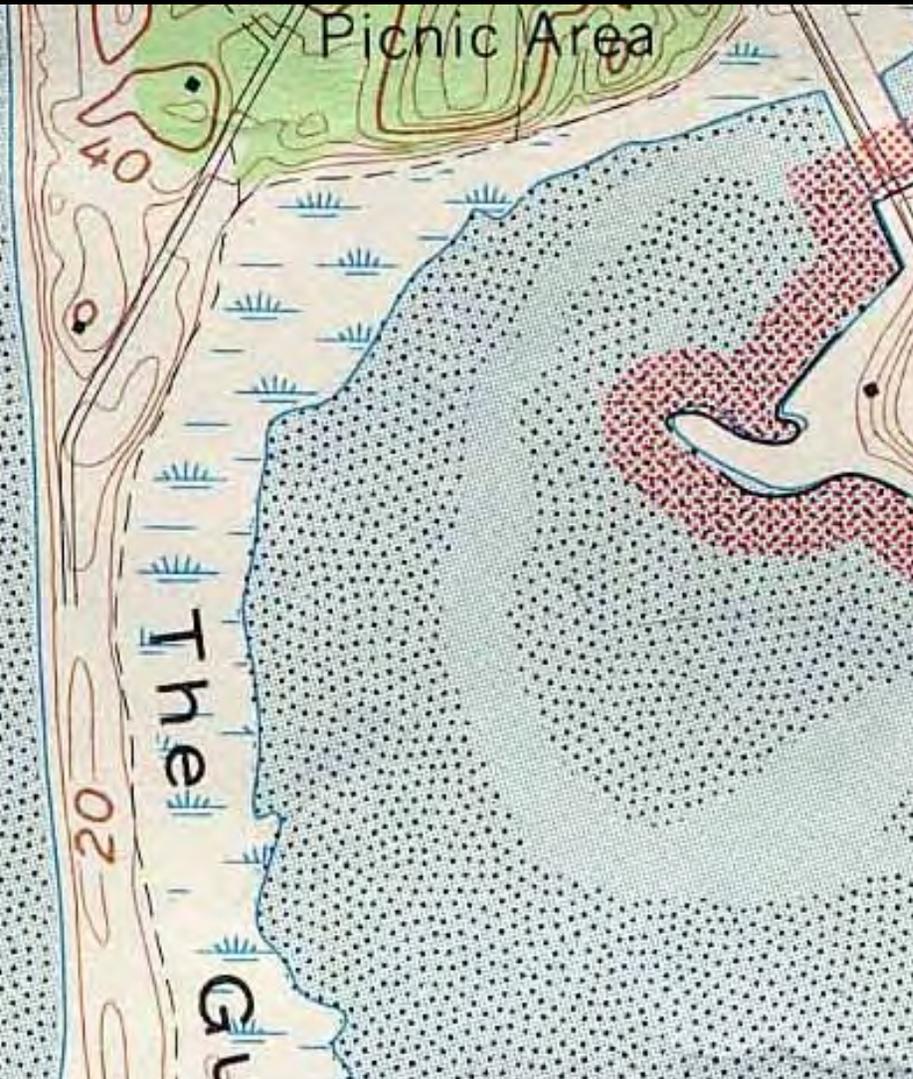
1974 (Representative 1960-2001)

1848 (Pre-dike Configuration)

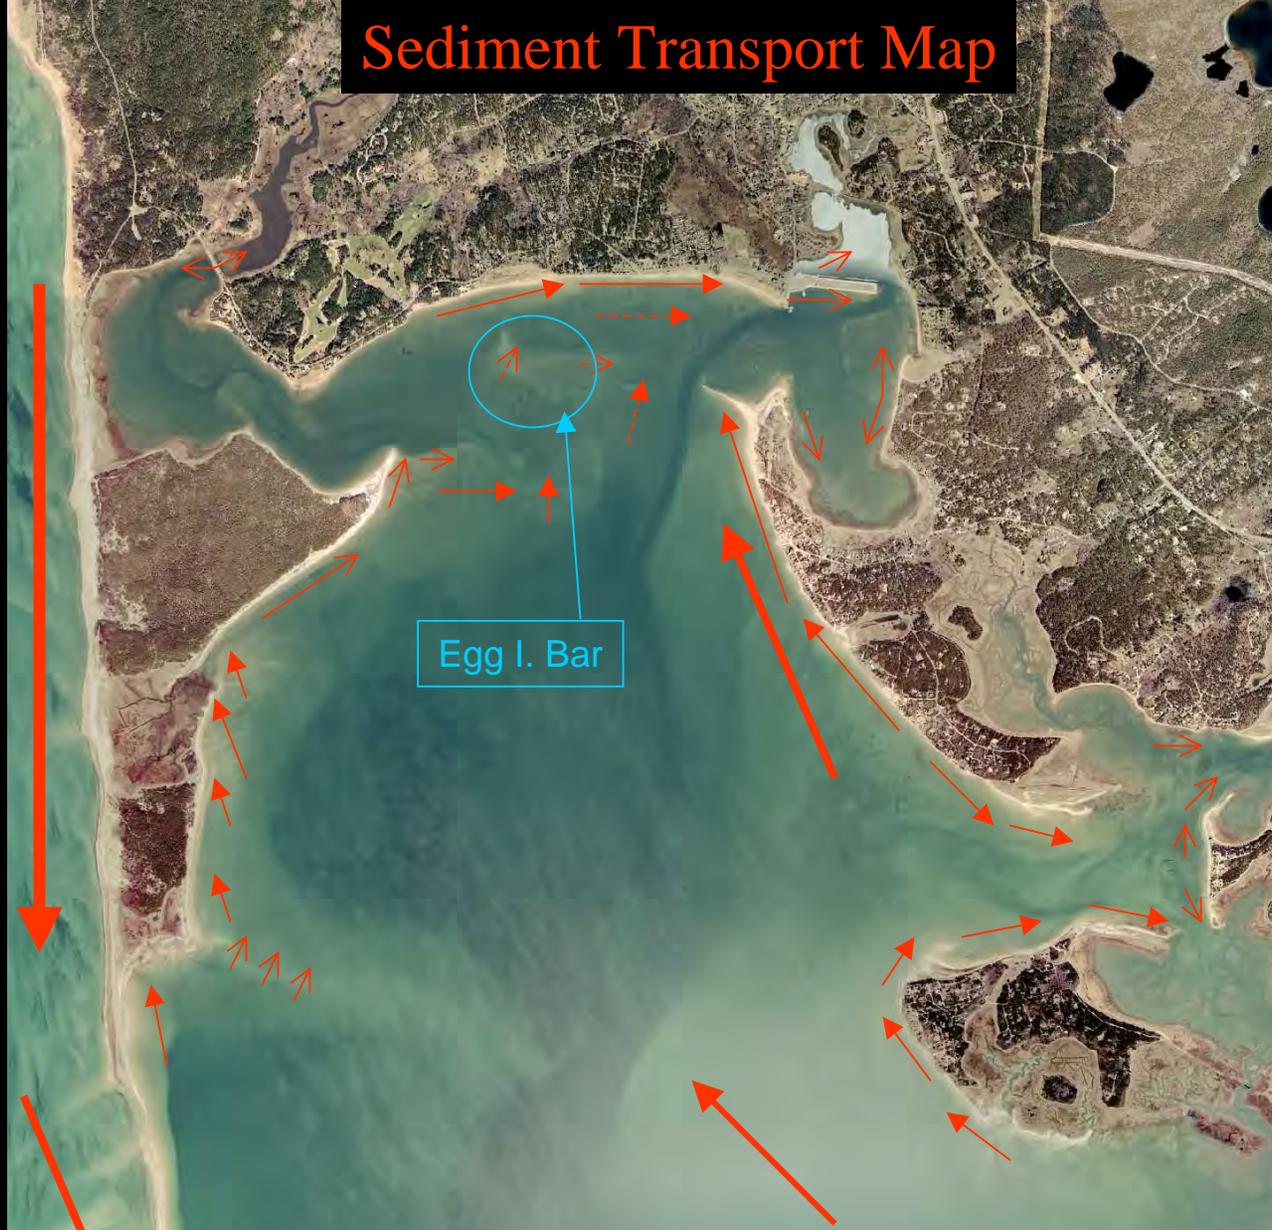
Sediment Transport Map

Sediment bed forms show the direction of sediment transport into and within Wellfleet Harbor. Egg Island bar receives sediment from the east shore of Great Island. This helps maintain the bar's position relative to mean sea level, important given ongoing sea-level rise.

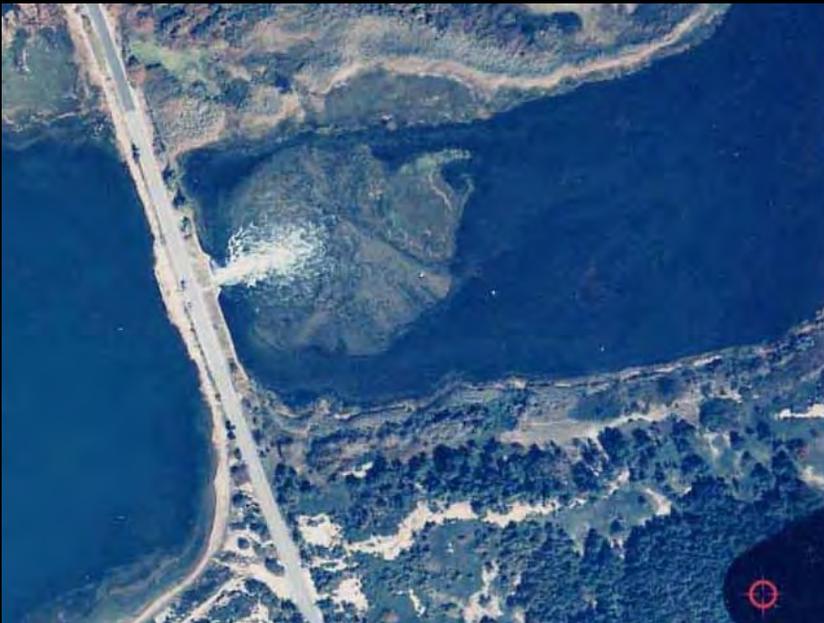
- Much of the marsh above the Herring River dike has subsided since diking and is up to a meter below the elevation of the undisturbed marsh seaward of the dike.

- A serious concern is whether this marsh can recover elevation once tidal flow is restored, in order to avoid “drowning” by constant waterlogging.

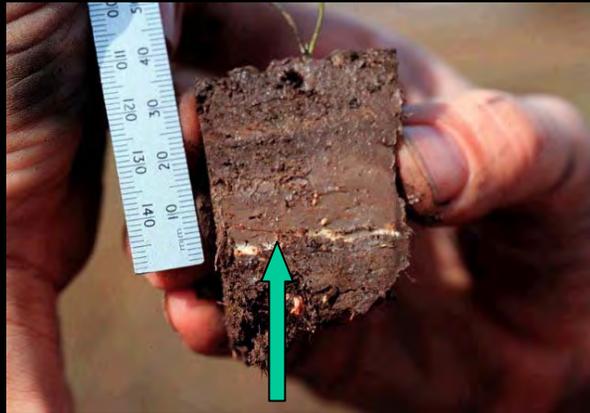
Surface Elevation Table (SET)

NPS monitors sediment accumulation and sub-surface compaction at several Cape salt marshes, including Herring River, using Surface Elevation Tables.
