Mayo Creek Restoration Committee

Final Report and Recommendations

10 June 2019

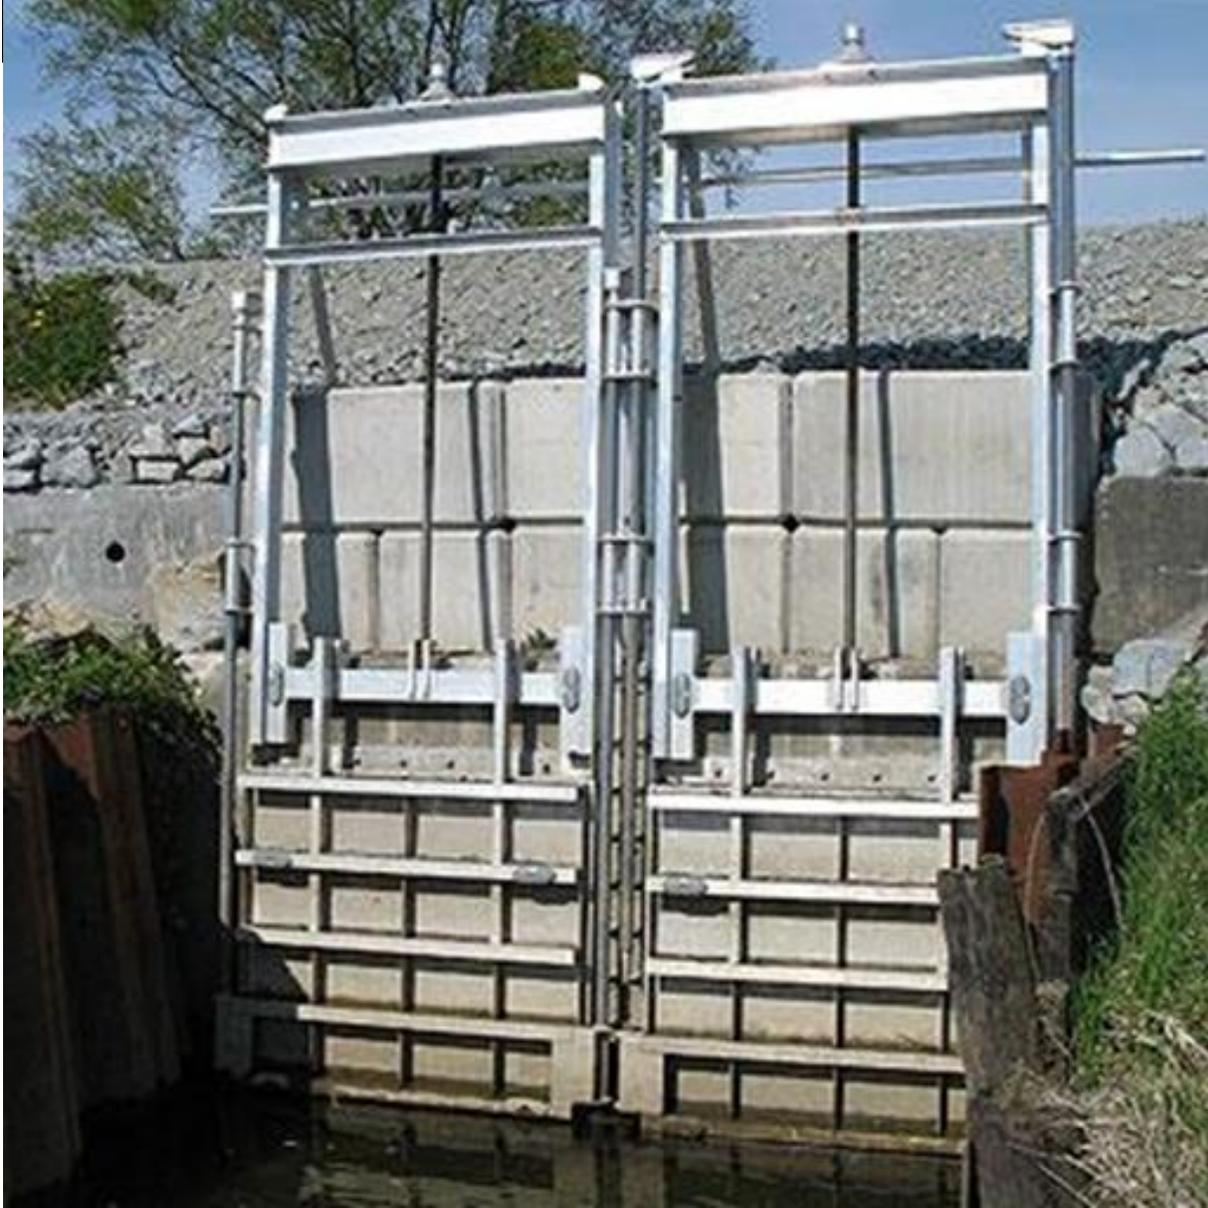
Figure 5. Example of an adjustable tide gate (Golden Harvest GH-50) that would meet Mayo Creek tidal-restoration and infrastructure-protection objectives, based on hydrodynamic modeling (Woods Hole Group 2016). Such a design would allow the Town complete control of the opening to ensure that water levels meet social and environmental

Replacement of the Commercial Street culvert with an enlarged culvert (e.g. 6 X 7 ft) with active control (adjustable gates, **Figure 5**), along with excavation of the upstream creek channel, can yield 20 acres of estuarine habitat restoration and over five feet of tidal range (as opposed to the existing 1.7 ft). Importantly, increased tidal range is achieved by two-foot higher high tides along with two-foot lower low tides (WHG 2016). These tidal ranges keep the important mean tide level in the creek, and the shoreline water table, unchanged.
