***INSPECTION AND CLEANING (SEDIMENT REMOVAL) OF THE  
LAWRENCE ROAD 500,000-GALLON HYDROSPHERE WELDED  
STEEL SPHEROID WATER STORAGE TANK LOCATED  
IN WELLFLEET, MASSACHUSETTS***

***WHITEWATER INC. - WELLFLEET  
AUBURN, MASSACHUSETTS***

***JULY 23, 2015***

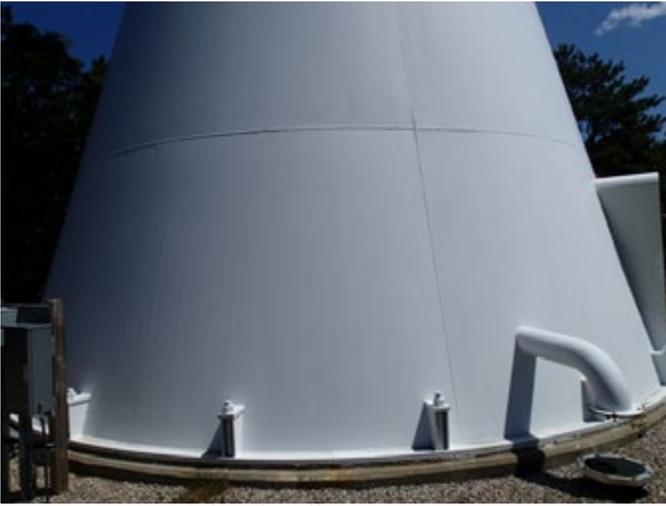
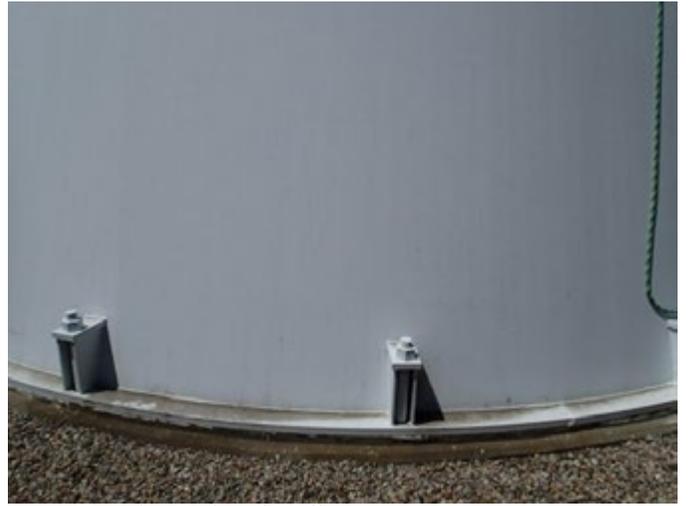
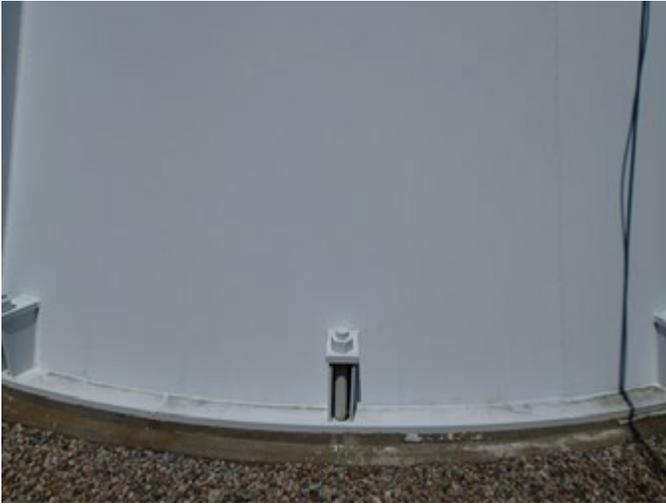
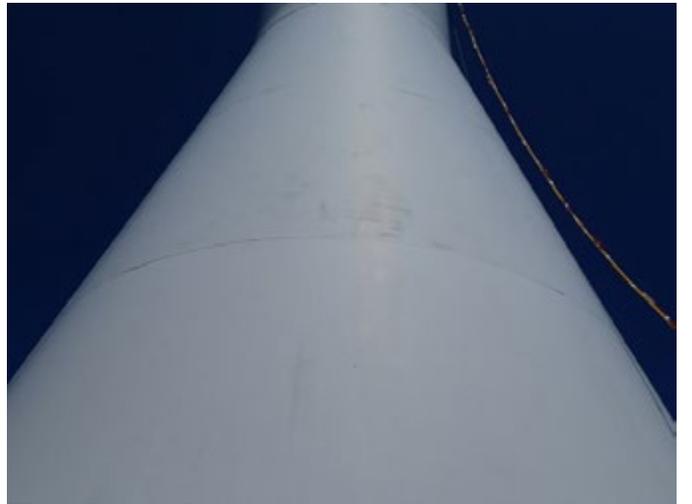
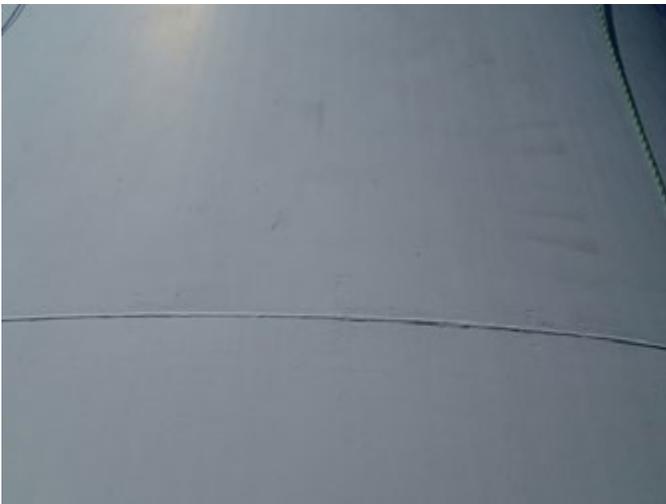
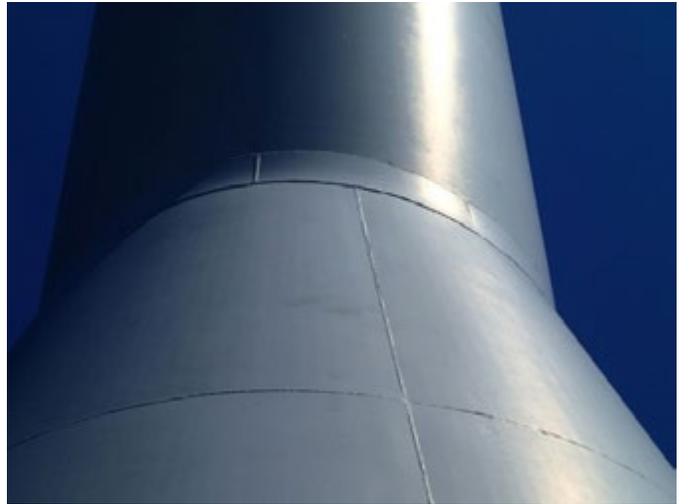
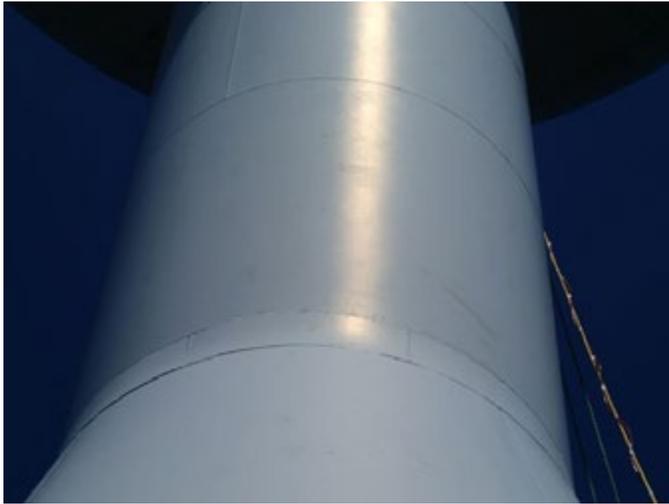
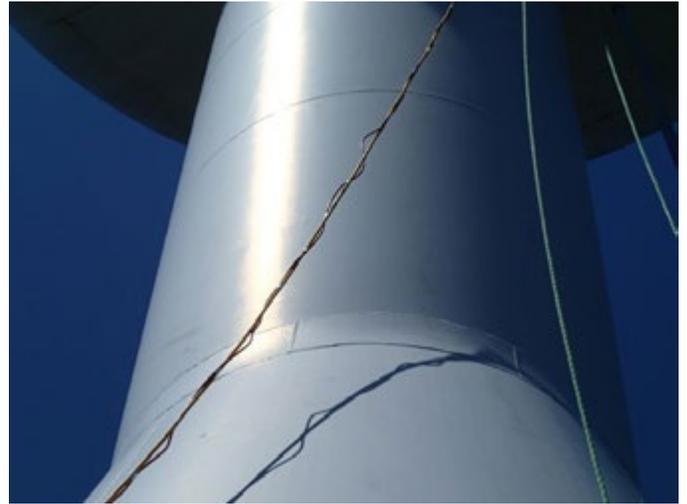
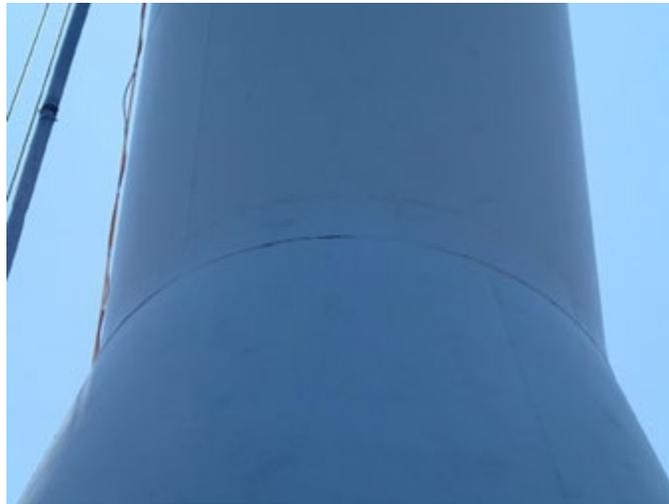
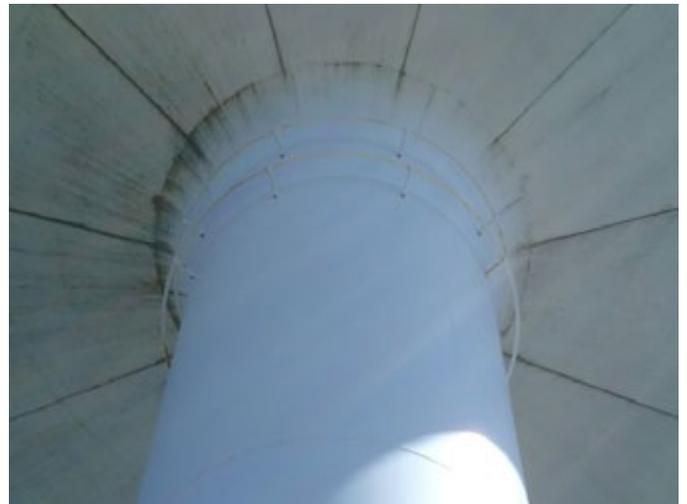
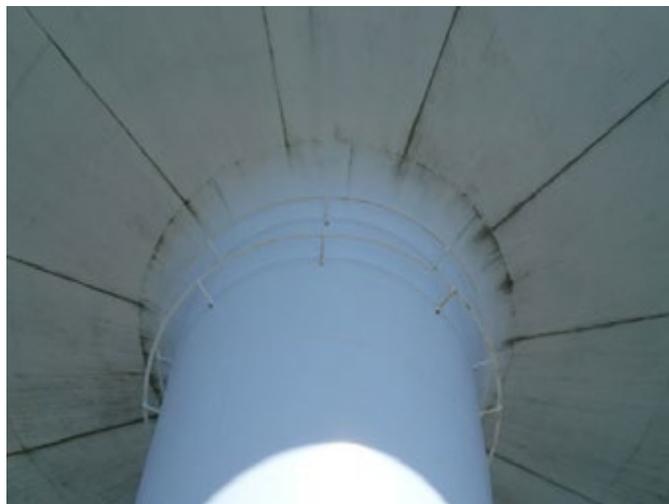
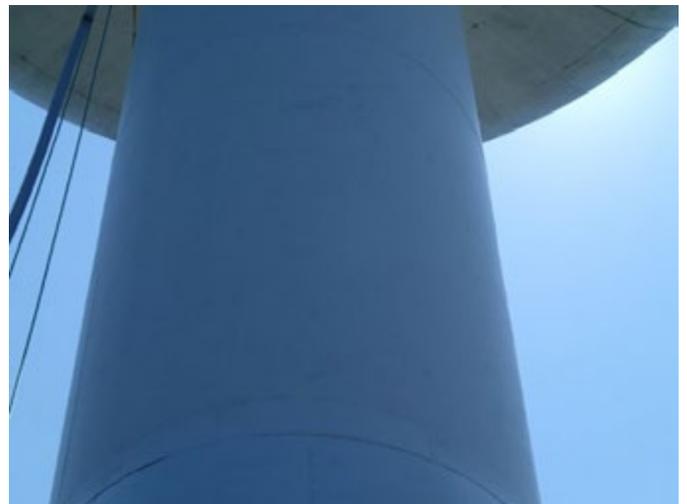
All exterior surfaces of the welded steel pedestal were found appearing sound and free of obvious fatigue (pitting) of the steel at this time.

The protective coating applied to the exterior welded steel surfaces of the pedestal was found having good adhesion value, and with an average dry film thickness of 12.33 mils.

1 *Exterior Pedestal Wall*

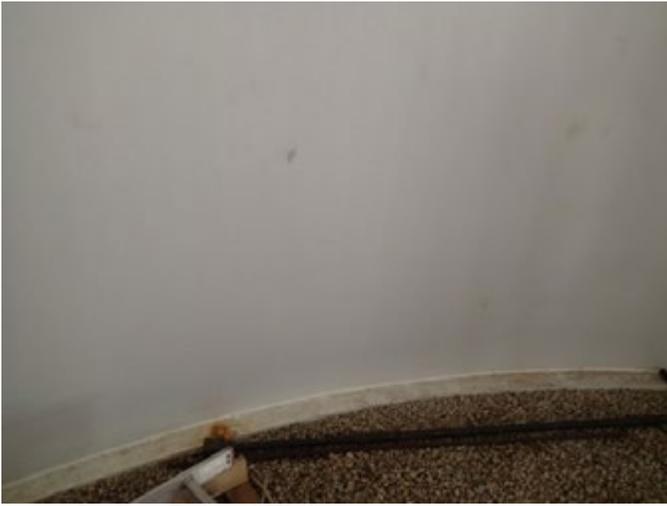
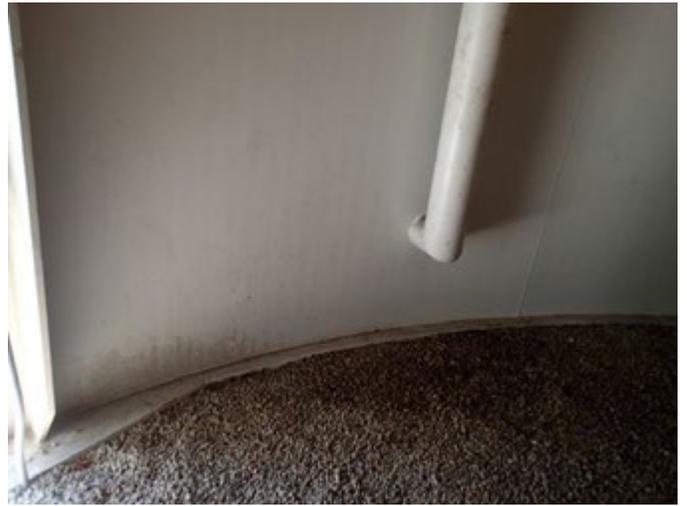
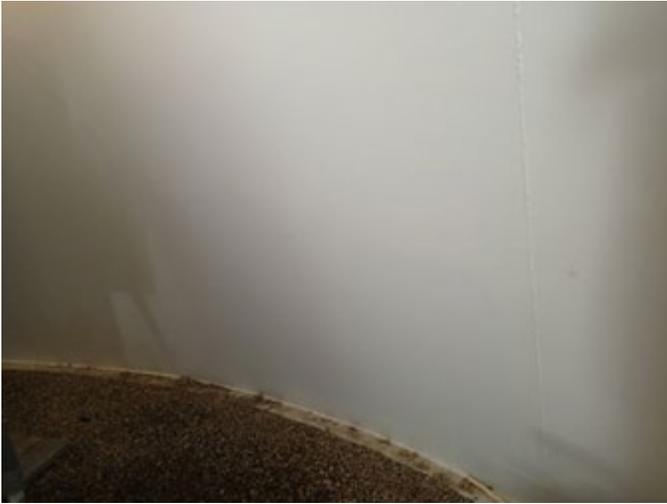
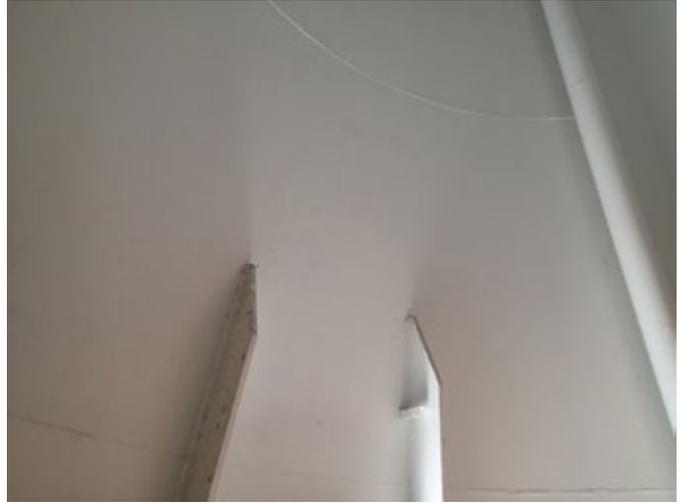
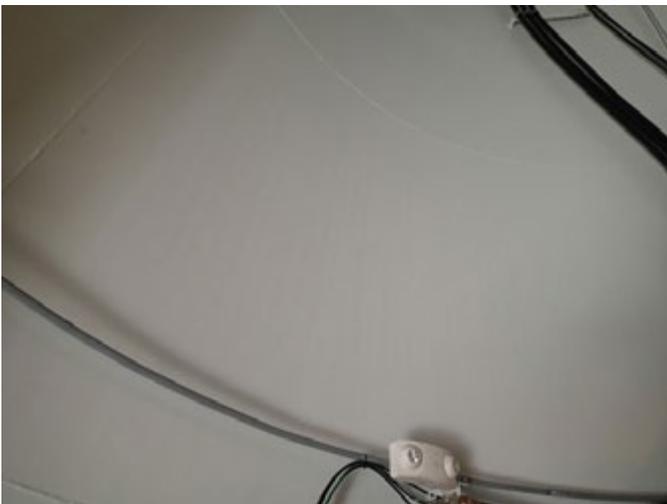
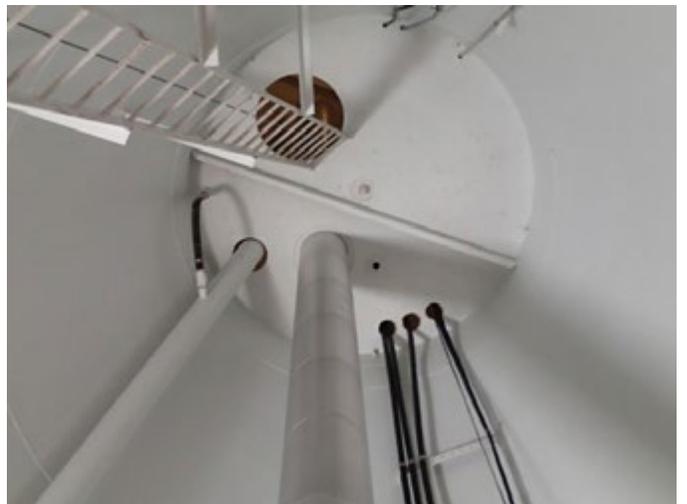
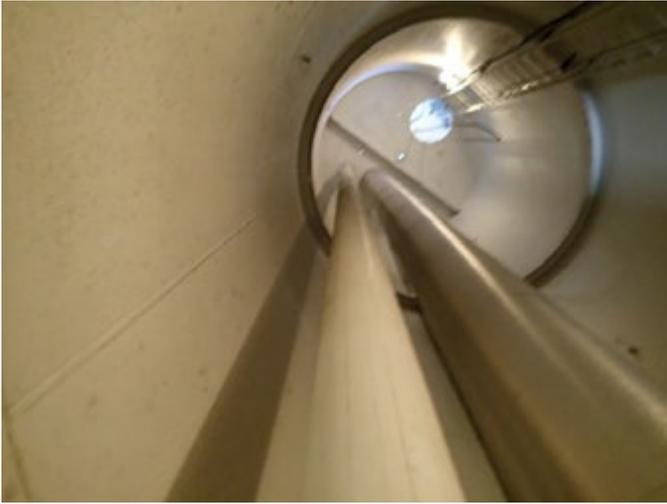
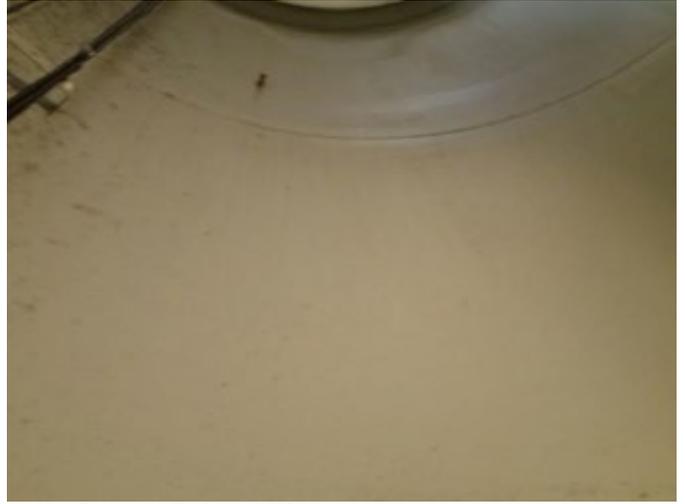
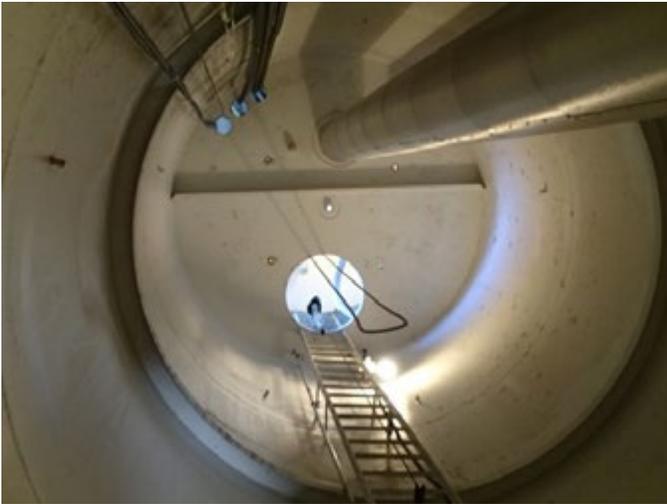
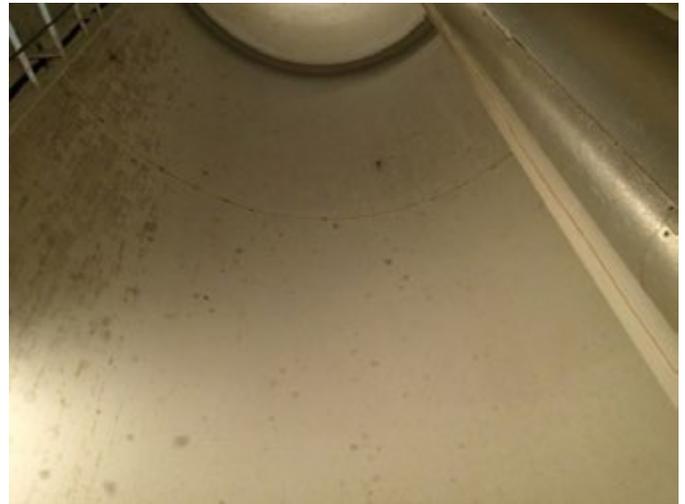
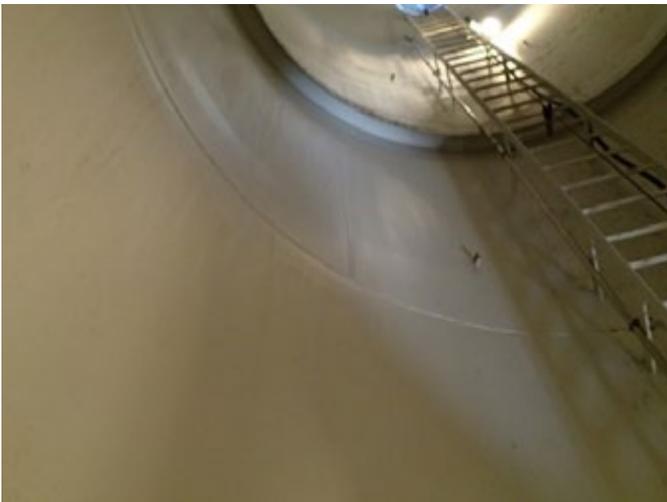
All interior surfaces of the welded steel pedestal appeared sound and free of obvious fatigue (pitting) of the steel at this time.

The protective coating applied to the interior welded steel surfaces of the pedestal was found having good adhesion value, and with an average dry film thickness of 14.02 mils.

13 *Interior Pedestal Wall*

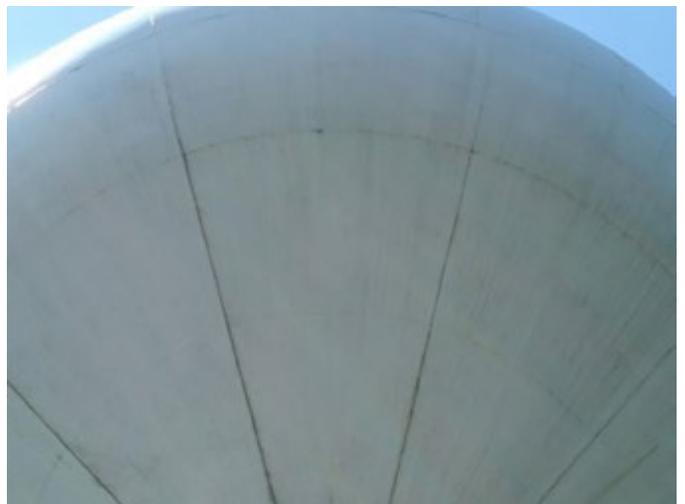
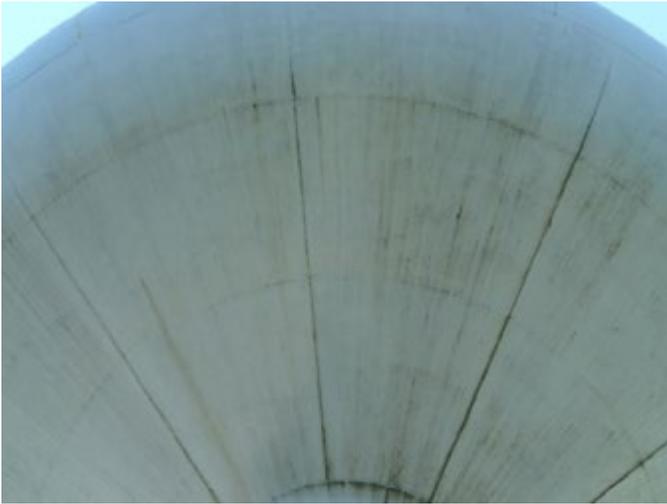
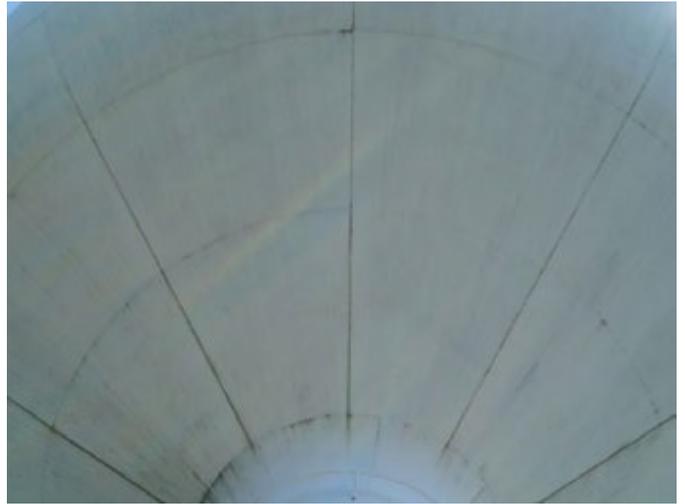
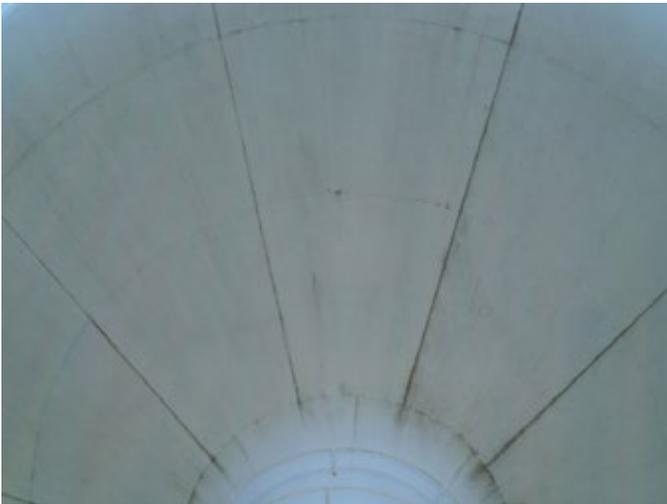
30 *Bowl Exterior With Mildew*

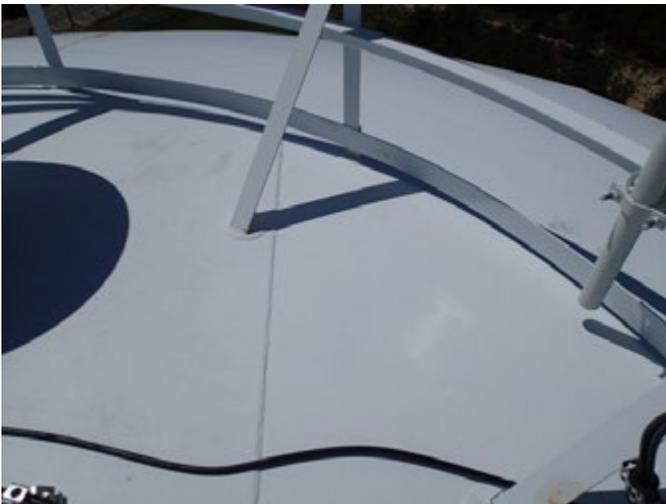
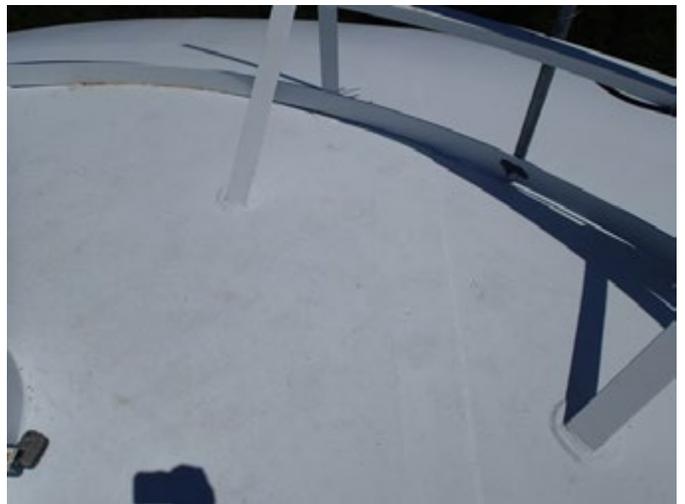
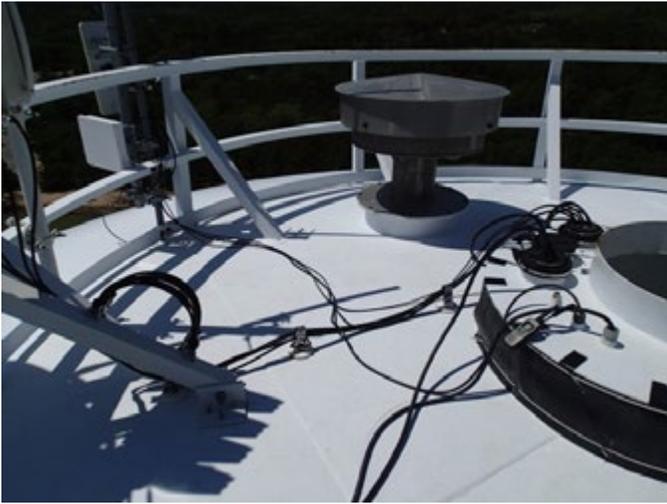
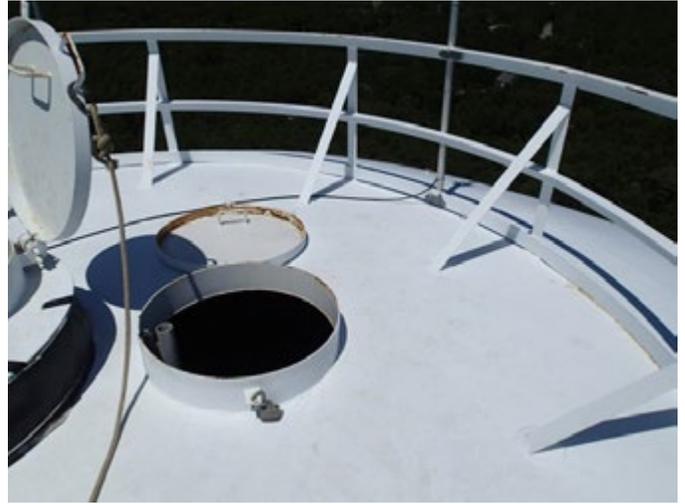
The protective coating applied to the 24' diameter steel plates that form the center of the roof was found having good adhesion value, and with an average dry film thickness of 13.46 mils.

47 *Roof Surface*

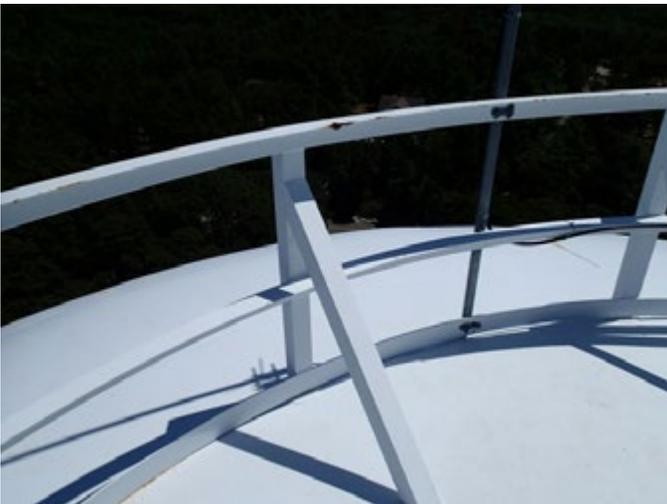
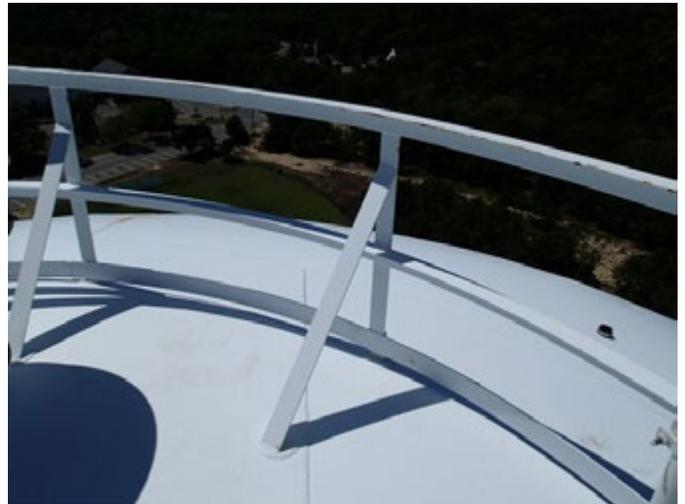
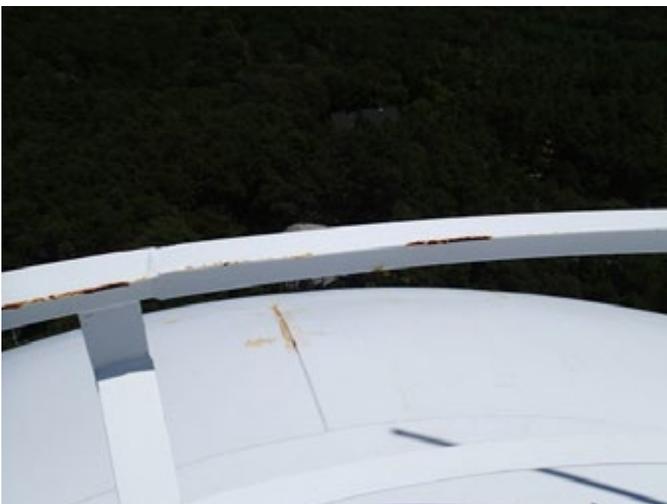
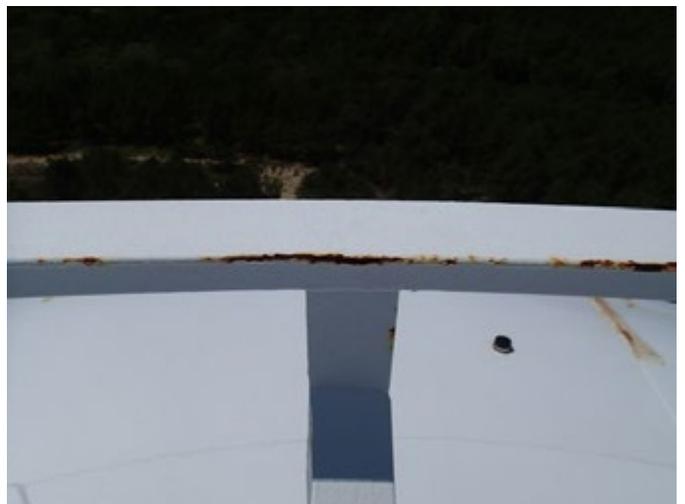
The protective coating applied to these steel safety railings was found having fair adhesion value at this time.

Although the average dry film thickness of the protective coating applied to these steel safety railings is 10.02 mils and meets the specifications set by the AWWA, adhesion loss of the coating was observed throughout less than 5% of these surfaces, resulting in exposure of the underlying steel.

No obvious fatigue or deterioration of these safety railing was found within the areas of steel exposure, rather mild surface corrosion exists at this time.

51 *Safety Railing With Coating Loss And Exposed Steel*

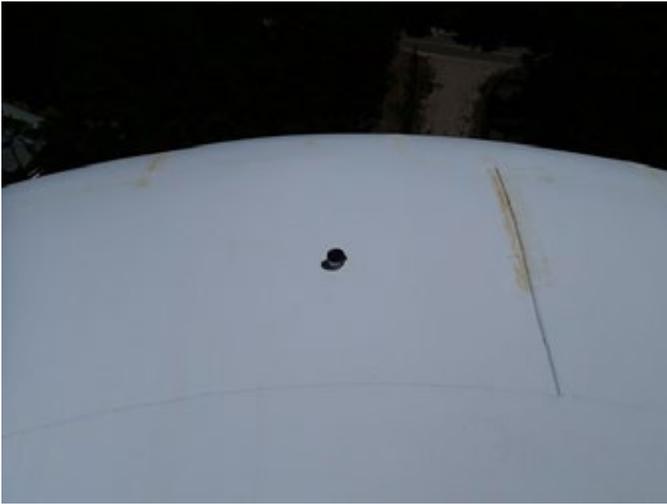
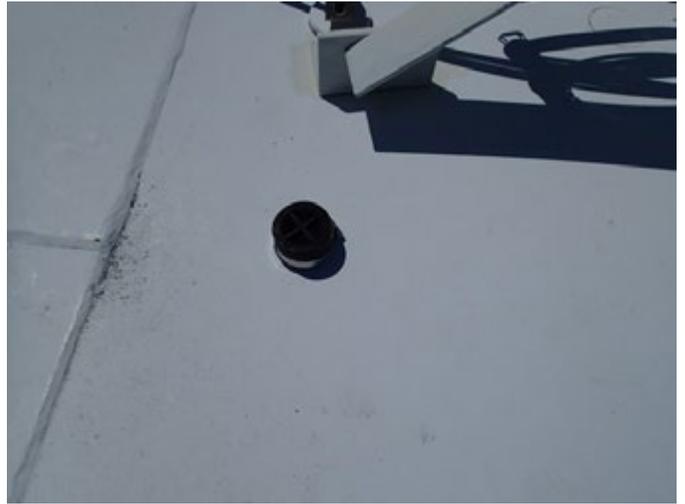
Six, 2" diameter rigging hole penetrations within the roof dome are secured with rubber caps and stainless steel band clamps, preventing access to the interior of the tank.

55 *Roof Surface/Rigging Hole With Secure Rubber Cap*

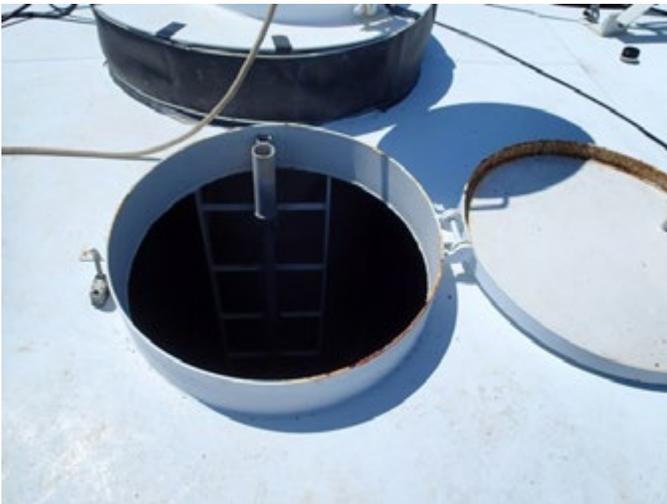
The 30" inside diameter steel hatch that provides access to the tank interior through the roof was found in good working condition and secured with a lock, preventing unwanted access to the tank interior.

The protective coating applied to the inner surfaces of this hatch was found having fair adhesion value at this time, as blotch rusting was observed throughout the outer circumference of the hatch and at the top edge of the hatch trunk where the hatch and trunk contact. The average dry film thickness of the protective coating applied these surfaces is 10.27 mils.

57 *Open Hatch*

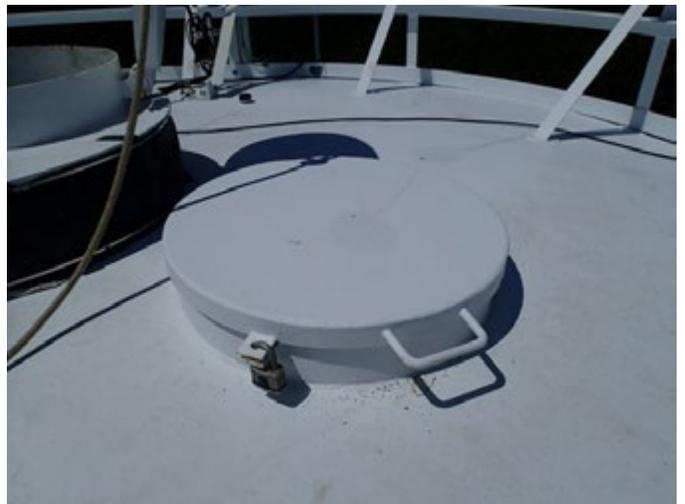
58 *Secure Hatch*

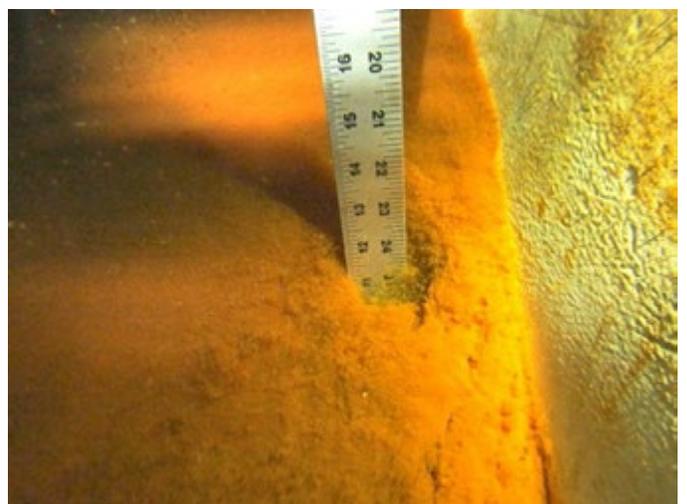
84 *Layer Of Precipitate*

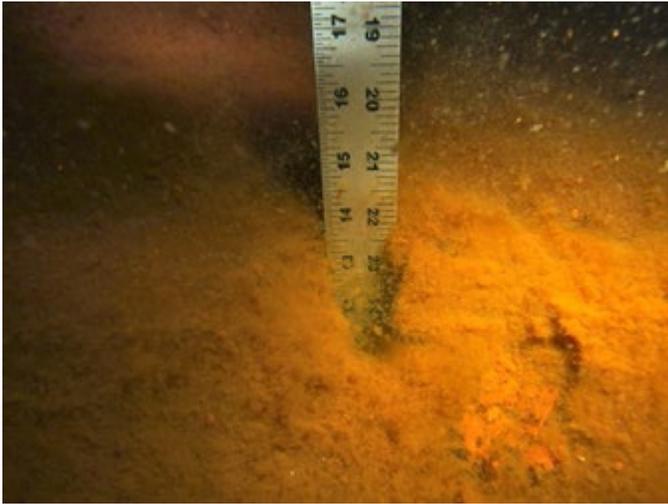
85 *Layer Of Precipitate*

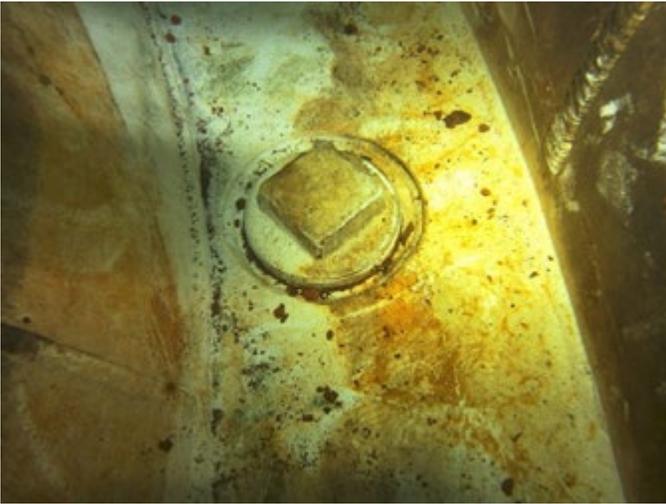
A second pipe that penetrates the floor and serves as the final bowl drain was free of obvious obstructions, while a third penetration within the floor was found secured with a plug on the interior of the tank.

103 *Piping Secured With A Plug*

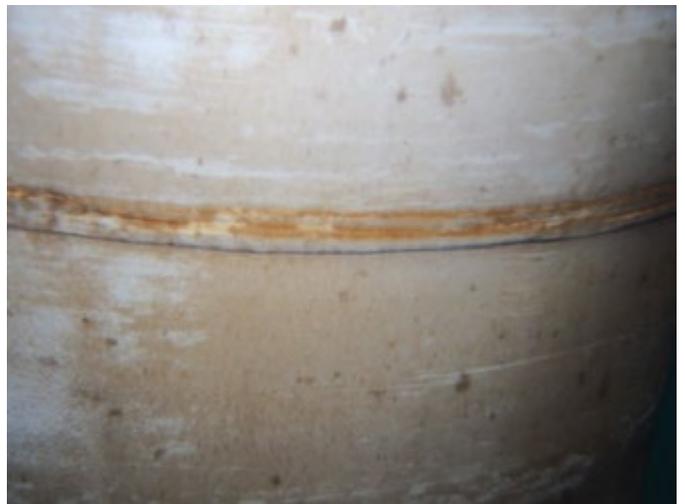
119 *Center Access Tube*

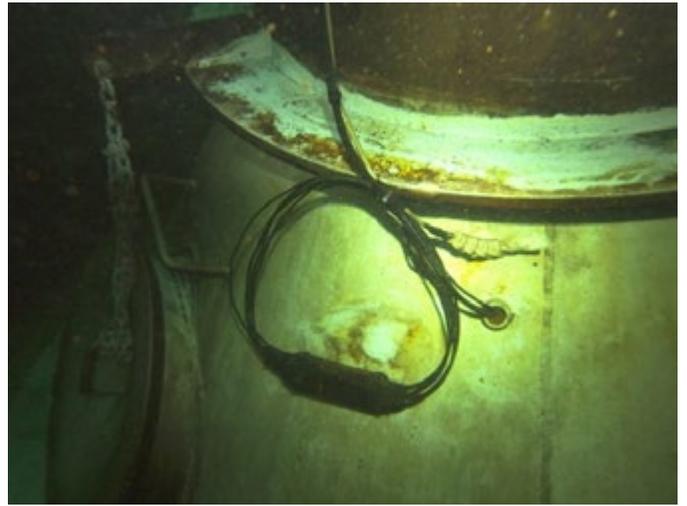
121 *Center Access Tube*

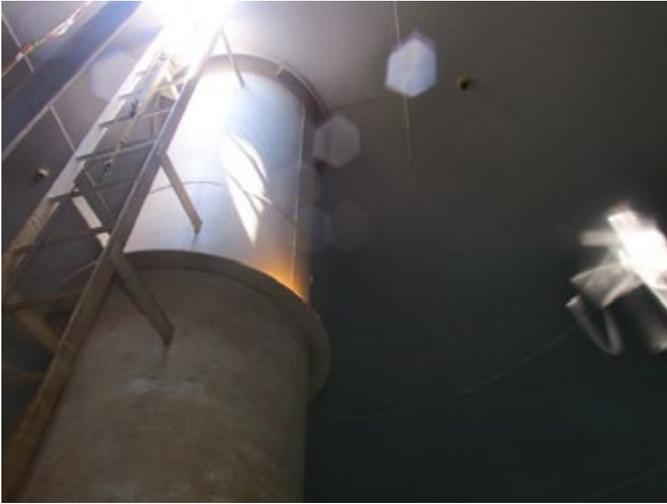
122 *Center Access Tube*

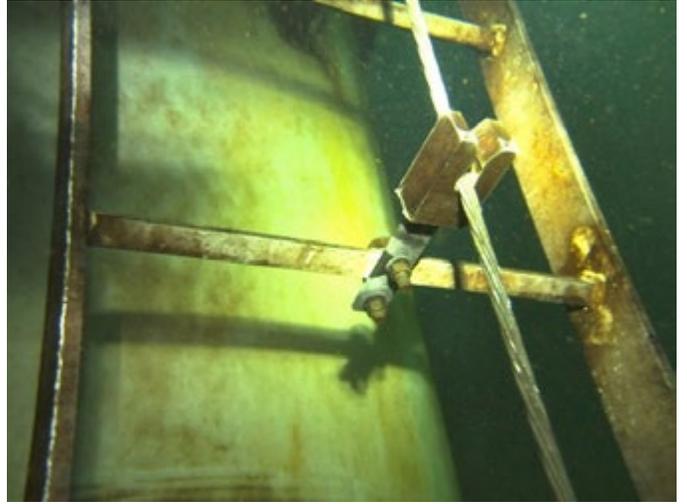
123 *Interior Ladder With A Fall Prevention Device*

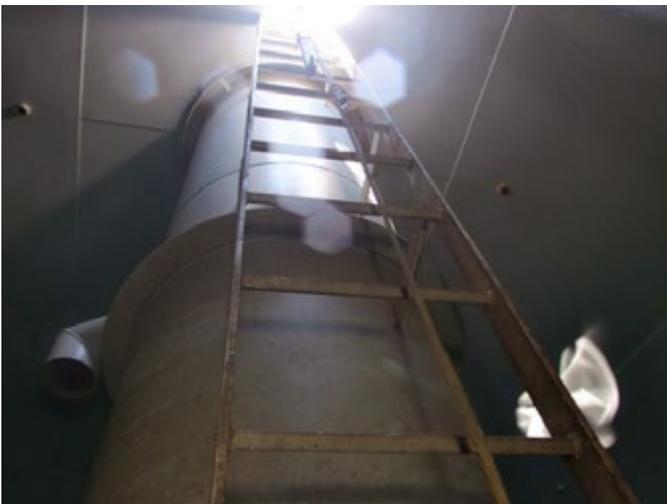
124 *Interior Ladder With A Fall Prevention Device*

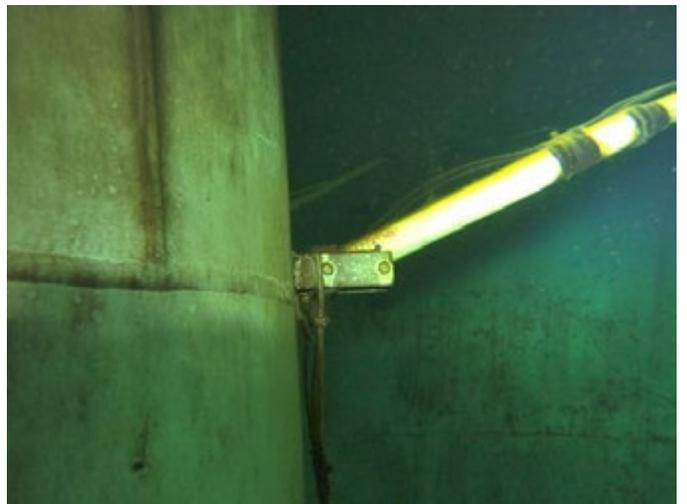
125 *Interior Ladder With A Fall Prevention Device*

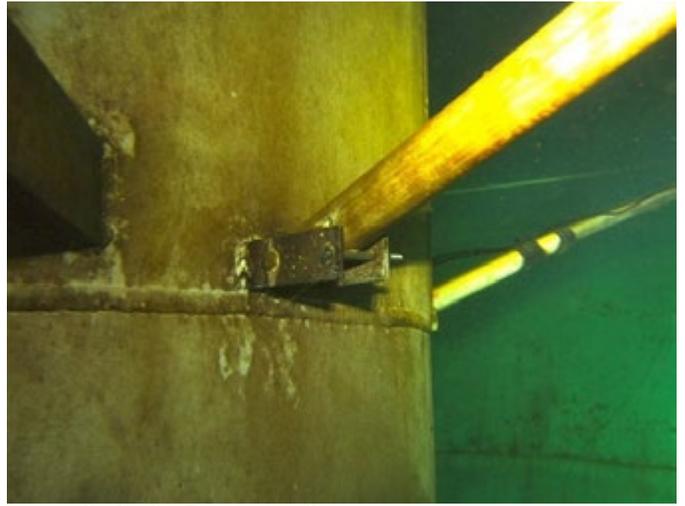
127 *Cathodic Protection System*

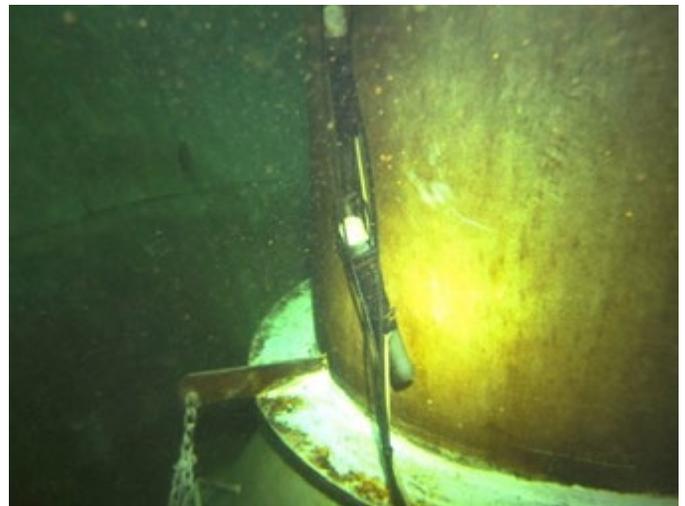
129 *Cathodic Protection System*

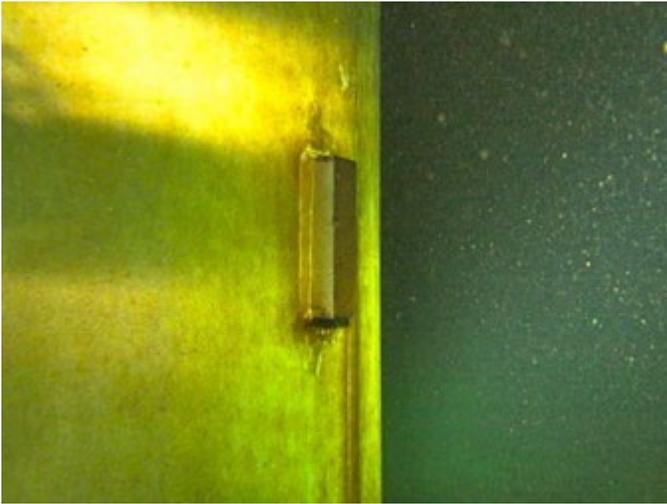
132 *Cathodic Protection System Cable*

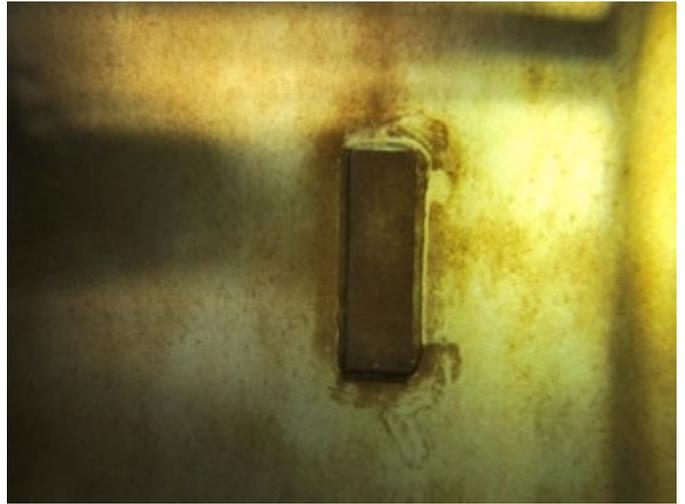
133 *Sacrificial Anode*

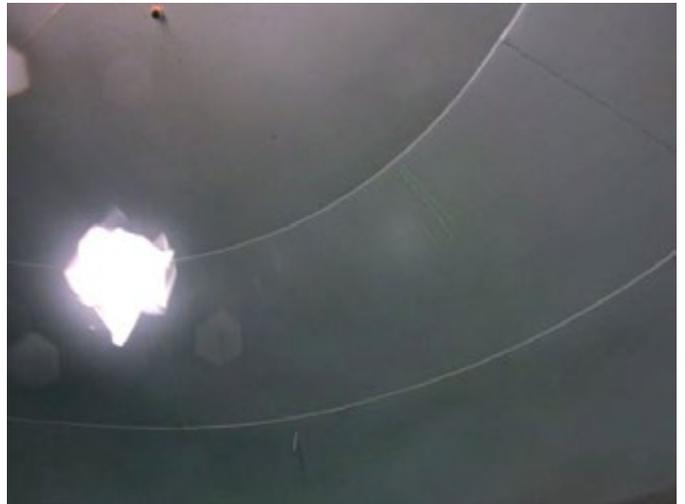
135 *Overhead*

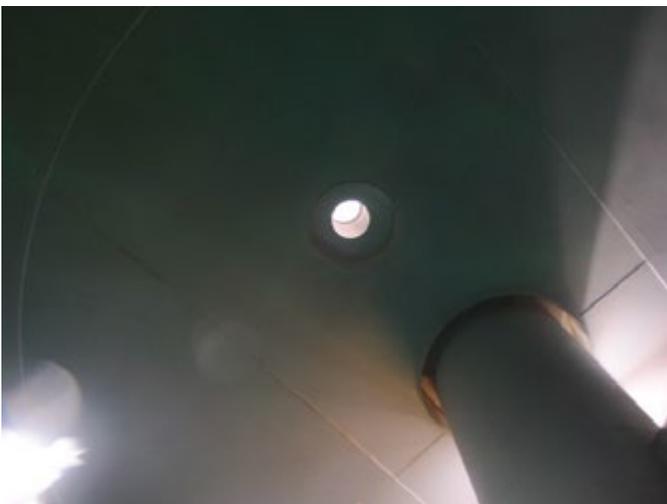
136 *Overhead*

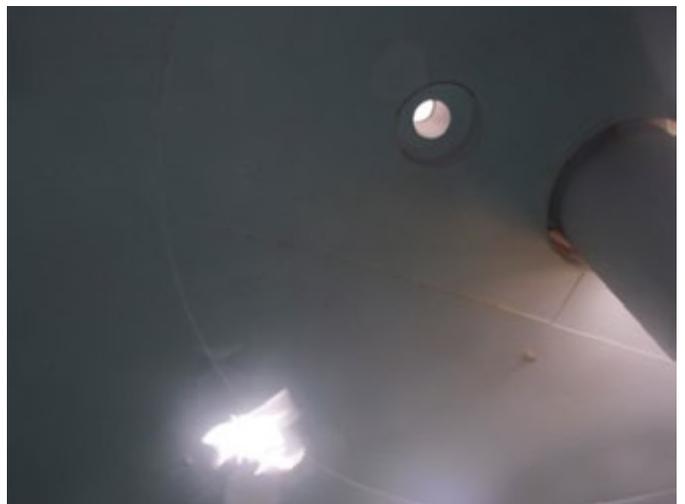
137 *Overhead*

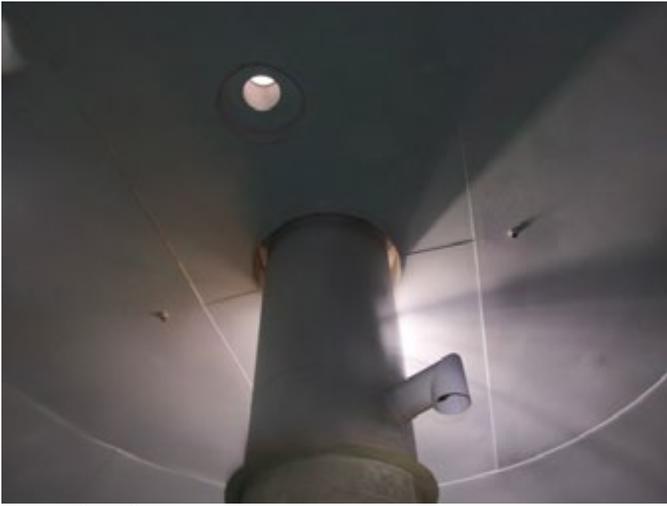
138 *Overhead*
